Overall Environmental Monitoring Report 2019

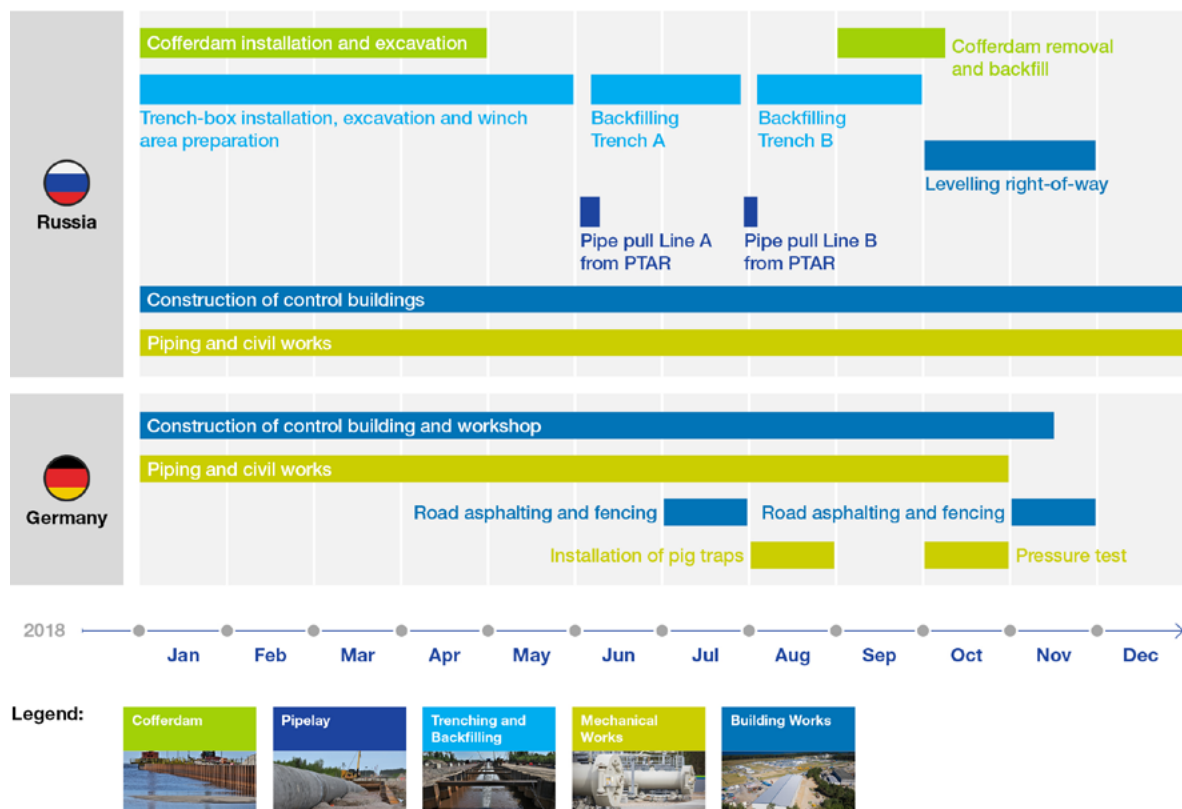
Figure 3. Onshore construction milestones in 2019

Onshore construction progressed at the Russian and German landfalls. An overview of the onshore construction milestones is given in Figure 3. Details of the onshore construction activities in Russia and Germany are outlined below in Sections 2.2 and 2.6.

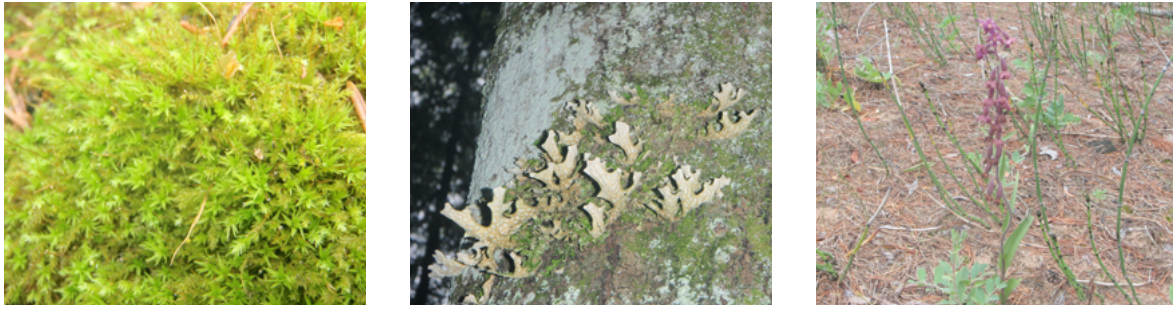
No impact from construction has been detected on the forest stand, the undergrowth or epiphytic lichens at any sampling plots. Shrub layer and ground cover were generally found to be in a good state, with the exception of a few control plots located in swampy area and in boggy forest (stations R_VEG_03, R_VEG_05 and R_VEG_13). The RDBS *Aulacomnium androgynum*, *Lobaria pulmonaria* (protected lichen), *Epipactis atrorubens* and *Drosera intermedia* monitored in the proximity of the ROW were also found to be in a good state (see Figure 10).

Figure 10. Condition of three RDBS monitored in the proximity of the ROW. From the left: *Aulacomnium androgynum* in R_VEG_20, *Lobaria pulmonaria* in R_VEG_11 and *Epipactis atrorubens* in R_VEG_17

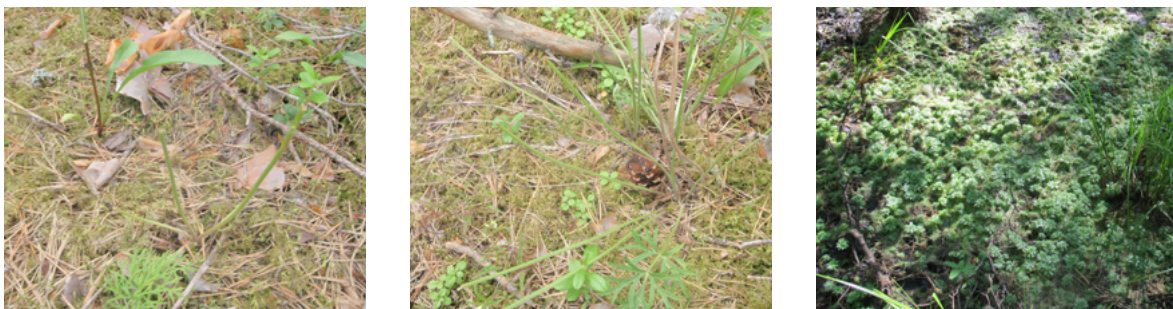
Some changes in the vegetation cover were observed, such as the presence of fallen trees, mainly on the southern side of the construction corridor. Increased exposure to light also caused the death of some forest species in the 5 metre strip on the northern side of the construction corridor and also caused changes in the grass layer of the black alder fen in one site. The presence of ungulates and other animals also caused disturbance to the ground vegetation cover of sites located along the southern border of the construction corridor. In particular, the high concentration of animals along the fence caused visible damage to individuals specimens of *Pulsatilla pratensis*, *Pulsatilla patens* and *Hottonia palustris* (see Figure 11).

Figure 11. Plants damaged by animals. From the left, *Pulsatilla pratensis* in R_VEG_09, *Pulsatilla patens* in R_VEG_24 and *Hottonia palustris* at R_VEG_19

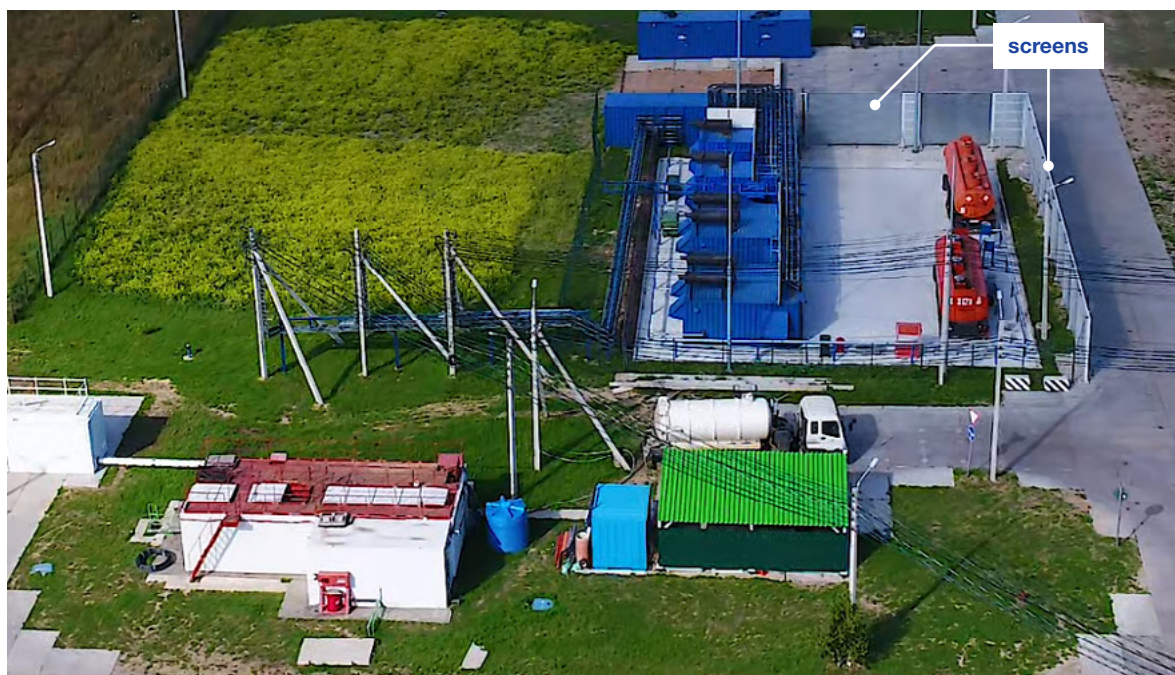
Figure 22. Screens installed around the generators to limit air noise immissions.

The sanitary authority recommended that the generator area be protected with screens. These were installed as soon as possible (see Figure 22).

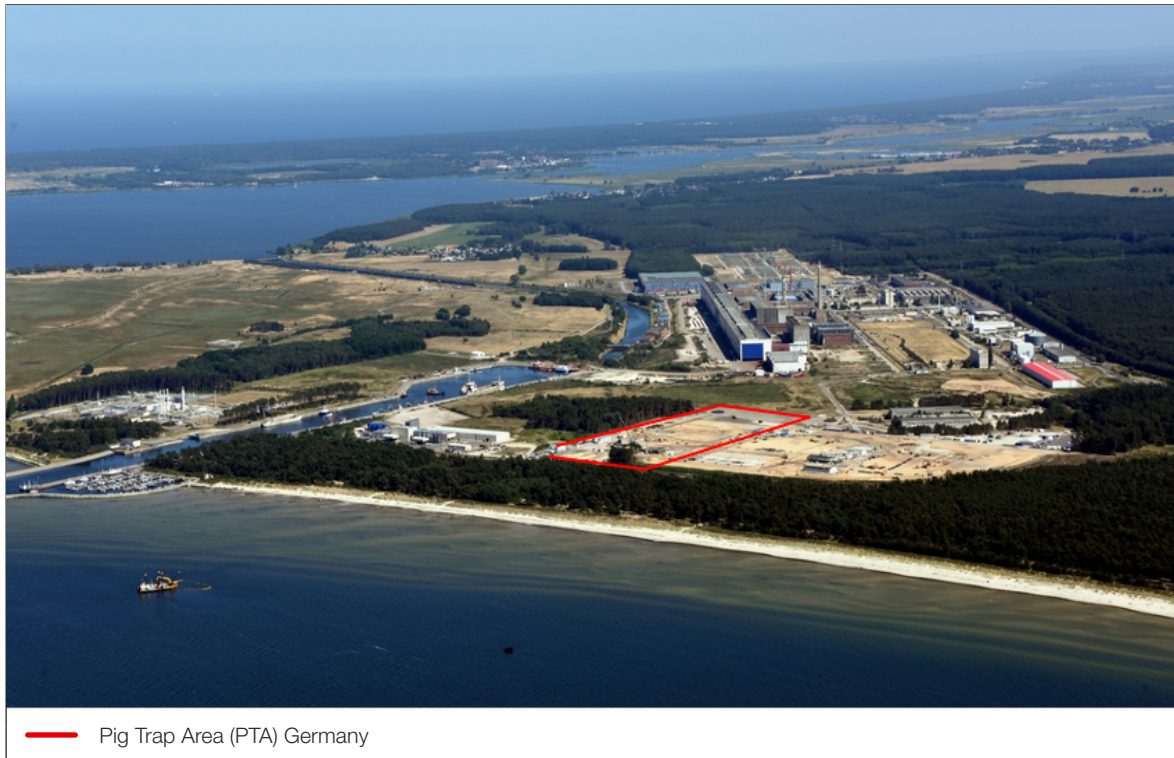
Figure 27. Pig Trap Area (PTA) Germany (red box) in the industrial park south of Lubmin industrial harbour in July 2018. The vessel in the foreground shows the location of the offshore exit pit of the shore crossing microtunnel.

Since the landfall Germany and the PTA are entirely located inside a designated industrial park (see Figure 27), monitoring requirements for onshore construction in Germany are characterised as low complexity compared with the requirements for the landfall Russia.

Airborne noise monitoring was implemented at the beginning of the construction works in 2018 and continued in 2019 according to German design criteria for construction noise measurements. Permanent sound pressure level recordings were taken throughout the year at two sites: Lubmin village, Lubmin marina (both sites are close to the Pig Trap Area and offshore route/tunnel pit, see Figure 27).

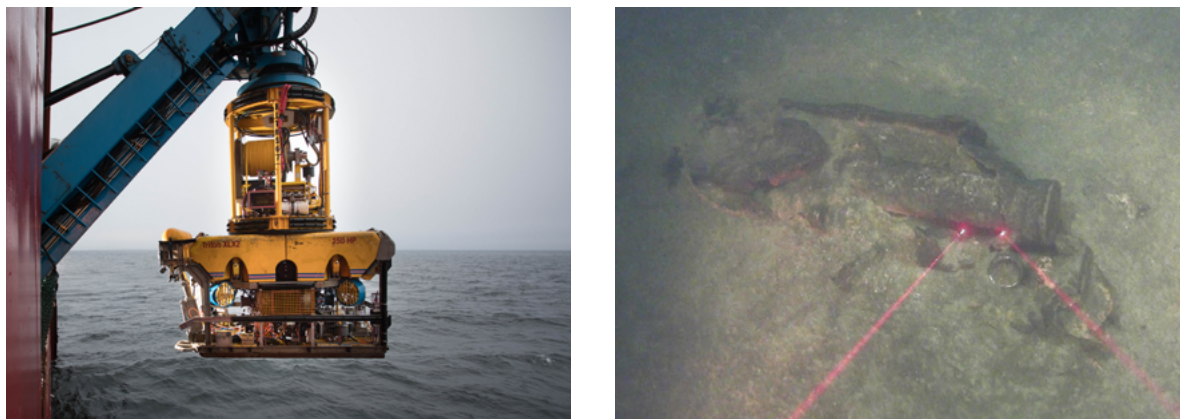
Figure 37. Left: Deployment of an ROV for inspection of a munition objects. Right: Example of munition object, showing a chemical mustard gas bomb with heavily corroded casing (re-routed around during the design phase).

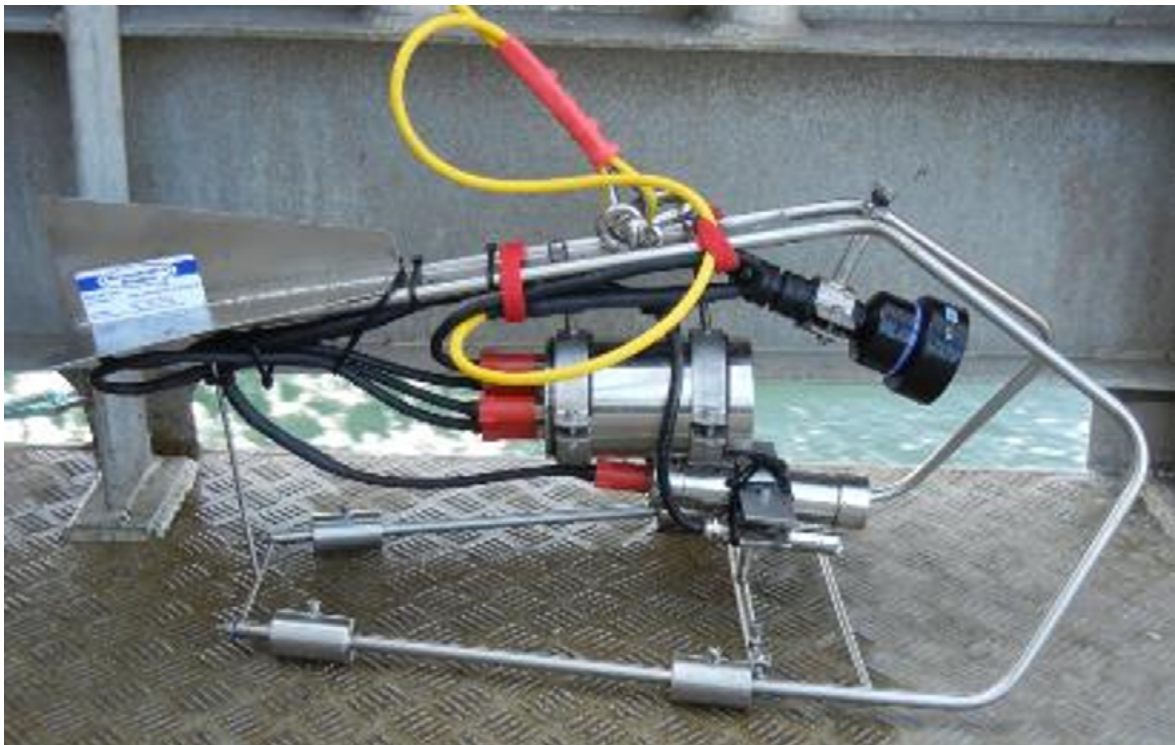
Figure 60. Towed underwater video camera system and drop camera for still images.

- > underwater video and still image surveys by means of a towed underwater video camera system and a drop camera for still images (see Figure 60);
- > sampling of epibenthic organisms attached to hard substrate (stones) by SCUBA divers.

The following parameter is quantified from underwater video and still images: stone cover, algae and hydrozoan cover, blue mussel *Mytilus* spec. cover and mussel length. Samples collected by SCUBA divers are preserved with 4% borax-buffered formaldehyde and transferred into the laboratory for treatment using a stereomicroscope. Lab analysis includes species identification, counting of specimen per species and fresh weight measurements. In addition, shell length of bivalves will be measured. Finally, the data on reef epifauna obtained will be subject to a number of statistical analyses.

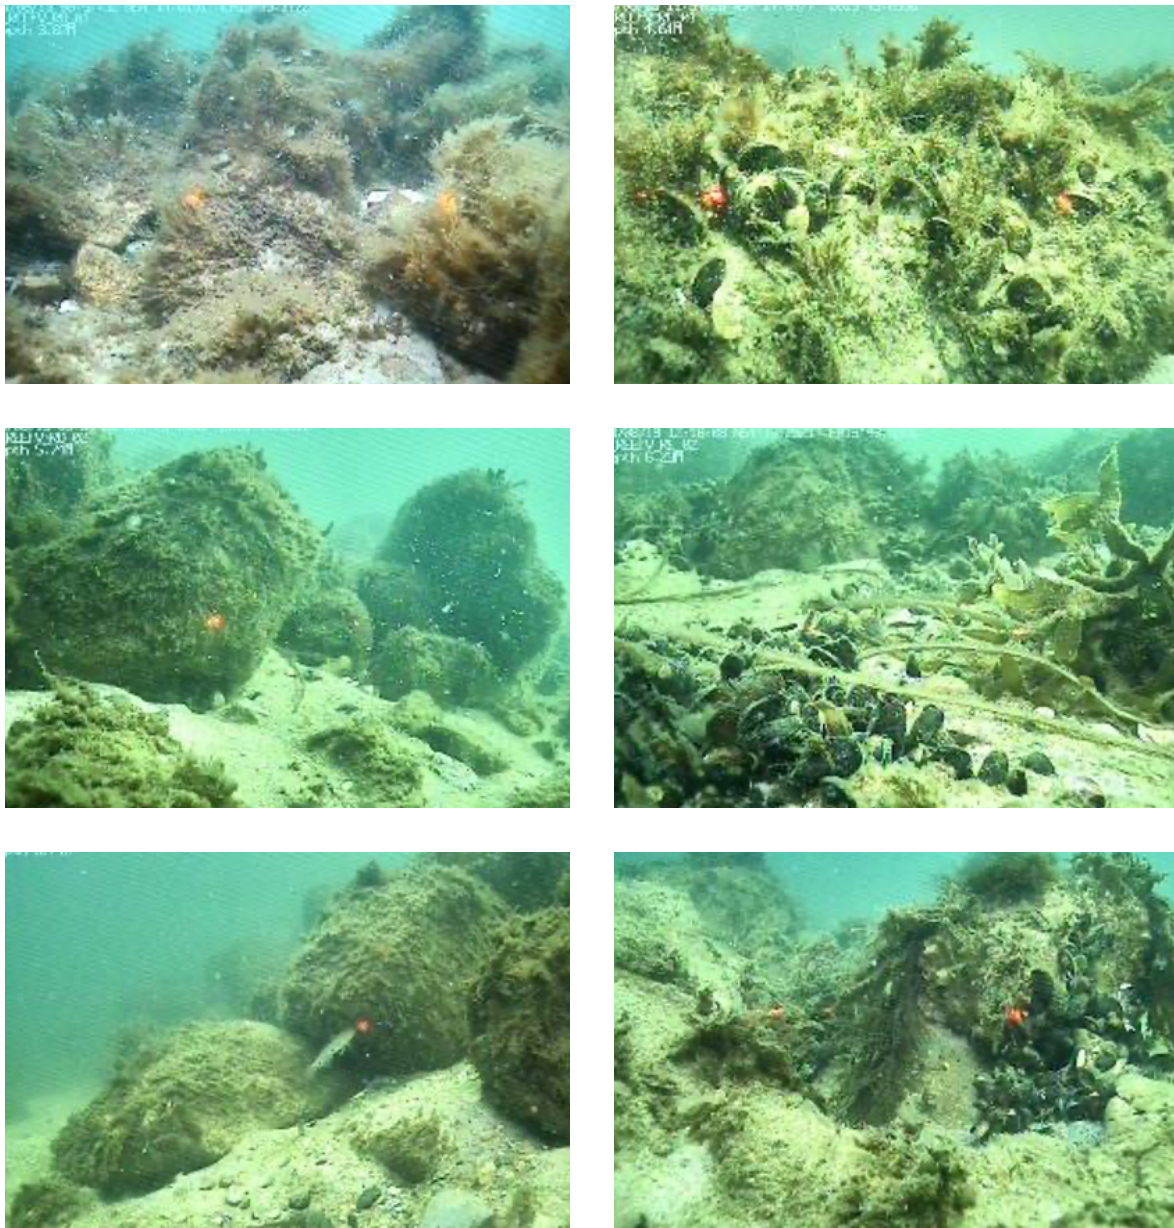
Figure 62. Still images of re-instated reefs (left) and untouched reference reefs (right) at Boddenrandschwelle taken eight months after pipeline construction. The major difference between sites is the absence of large-sized blue mussels *Mytilus spec.* and Bladder wrack *Fucus vesiculosus* at reinstatement sites.

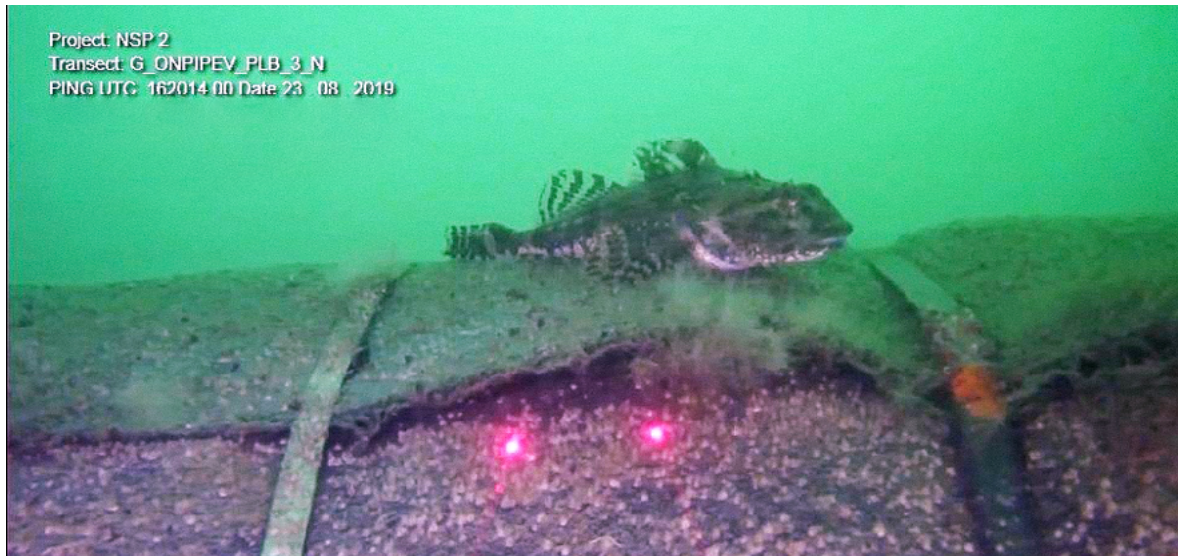
Figure 65. Demersal fishes are attracted by biofouling invertebrate epifauna growing on the NSP and NSP2 pipelines: Shorthorn sculpin *Myoxocephalus scorpius*.

Biofouling epifauna on the NSP1 pipeline was growing for three years until 2013 and unexpectedly declining afterwards. Since there is no natural reason for this unpredicted pattern of succession, it is assumed that bottom trawl fishery “cleans” the NSP1 pipeline from time to time. This hypotheses is supported by the fact that trawl fishery has changed their spatial pattern in the German EEZ since 2013 (VMS tracking data). The few remaining trawlers nowadays are operating predominantly in line with the pipeline route, since they have discovered that the biofouling epifauna has attracted demersal fish (see Figure 64 and Figure 65).

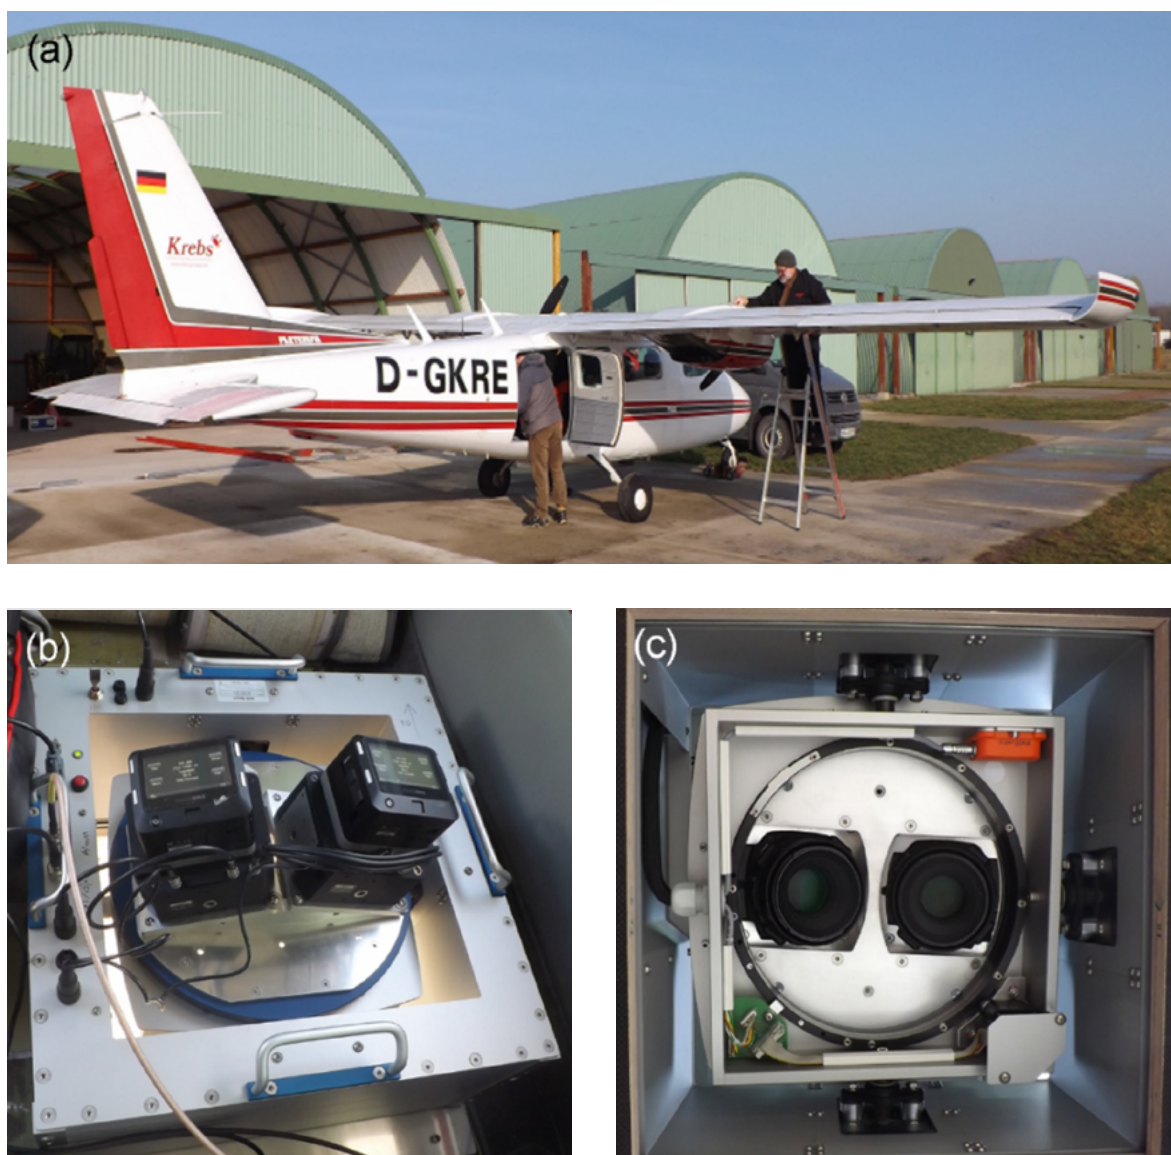
Figure 69. Survey platform for digital seabird surveys: Partenavia P68c. Detail views of the camera system.

For the digital bird survey, a twin engine Partenavia P68 aircraft is used with a hatch allowing the installation of the camera system (see Figure 69). For image capturing with DAISI, two iXA 180 Phase One aerial cameras are in use. Each camera has a resolution of 5.2 micron and addresses 10.328 × 7.760 pixels (80 MPI) with a dynamic range of > 72 dB. In order to implement this resolution, a CCD sensor with an effective size of 53.7 × 40.4 mm is used as input capture unit. The frame rate is 1.5 seconds in theory but in practice 1.8 seconds per frame. During recording, the cameras are operated with exposure times as short as 1/1,600 second to a maximum of 1/1,000 second and with the central shutter. To achieve a resolution of 2 cm, lenses with image stabilisation (FMC – Forward Motion Compensation) are used (Fast Sync lenses – FS). To obtain the most homogeneous and sharp picture as possible, both cameras are mounted on an AeroStab-Twin stabilizer. This device permanently adjusts the cameras vertically straight down when the aircraft rolls or tilts.
