Nord Stream 2 Natural Gas Pipeline construction and operation in the Finnish EEZ Environmental and Technical Monitoring Quarterly Report Q2 2018

Date	24.9.2018
Project	PO 17-5149
Client	Nord Stream 2 AG
Document ID	W-PE-EMO-PFI-RQU-892-RQU218EN-06

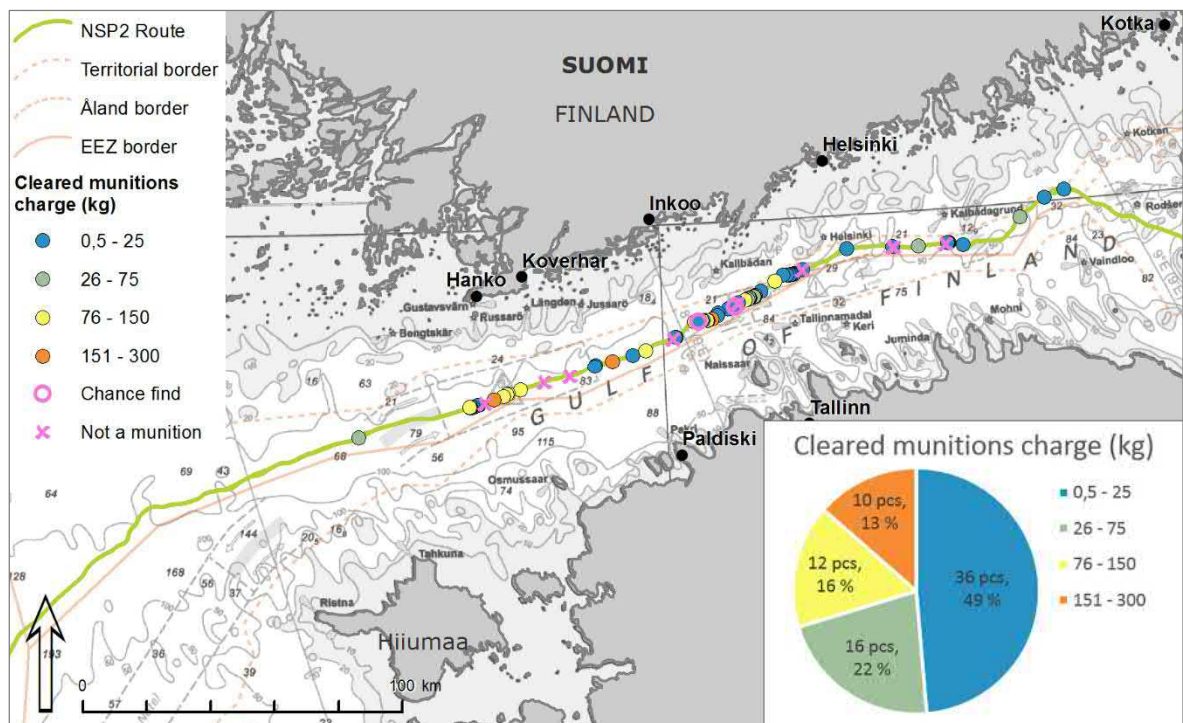
Figure 2. Total number of cleared munitions was 74. During the clearance 15 expected munition objects were found not to be munitions. Also 2 chance finds were discovered.

The work was divided between two companies MMT/Ramora and N-Sea/Bodac. Out of 87 planned clearance targets 15 were found not to be munitions. Additionally, 2 chance finds were cleared making the total number of detonated unexploded ordnance 74 (Table 3).

During the munitions clearance campaign two chance finds were added to the scope. These were identified through additional inspections of previously identified targets. One was identified as Russian depth charge of 25 kg charge, and the other as a Russian fish mine of a 10 kg charge. Both were previously interpreted as boulders in July 2016 survey. Rerouting of the pipelines was not feasible because of uneven sea bottom.

The sediment displacement through the detonations exceeded 5 m³ at 10 targets, the biggest displacement being 30,8 m³ (R-R09-7495). The Environmental impact assessment on Munition by Munition basis (updated April 2018, W-PE-EIA-PFI-REP-999-MBYM00EN-08) indirectly indicated bigger effect for this object. The sediment release was assessed to be 190,3 tonnes equal to 127 m³ (10% clay, 90% hard sediment). The largest sediment displacement mass was estimated to be 368,6 t with the munition item R-R12-10082. The actual displacement volume was significantly less, 12 m³.

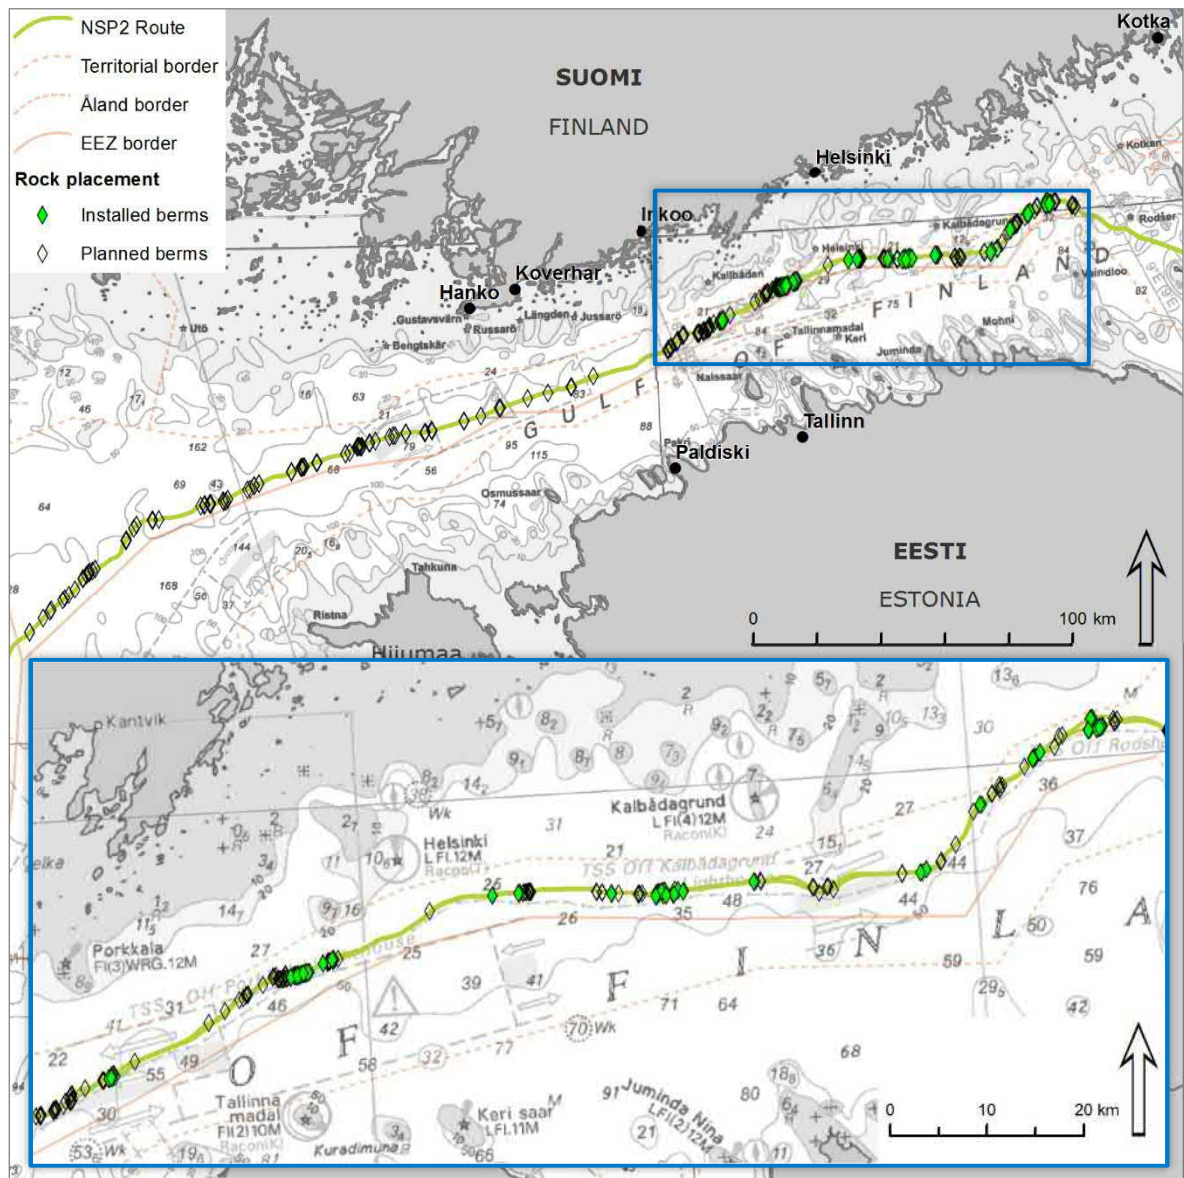
Figure 3. The first rock placement campaign. The lower map shows the area marked with the blue frame in more detail.

The first rock placement campaign took place from 29.4 to 15.6 between Inkoo and Russian border (GKP 122–237) (Figure 3). Rock placement was done for both Line A and Line B. NSP2 has accepted and approved certificates of all 44 installed berms.

The total mass of rock placement in the first campaign was 313 842 tonnes, which is equivalent to 200 847 m³.

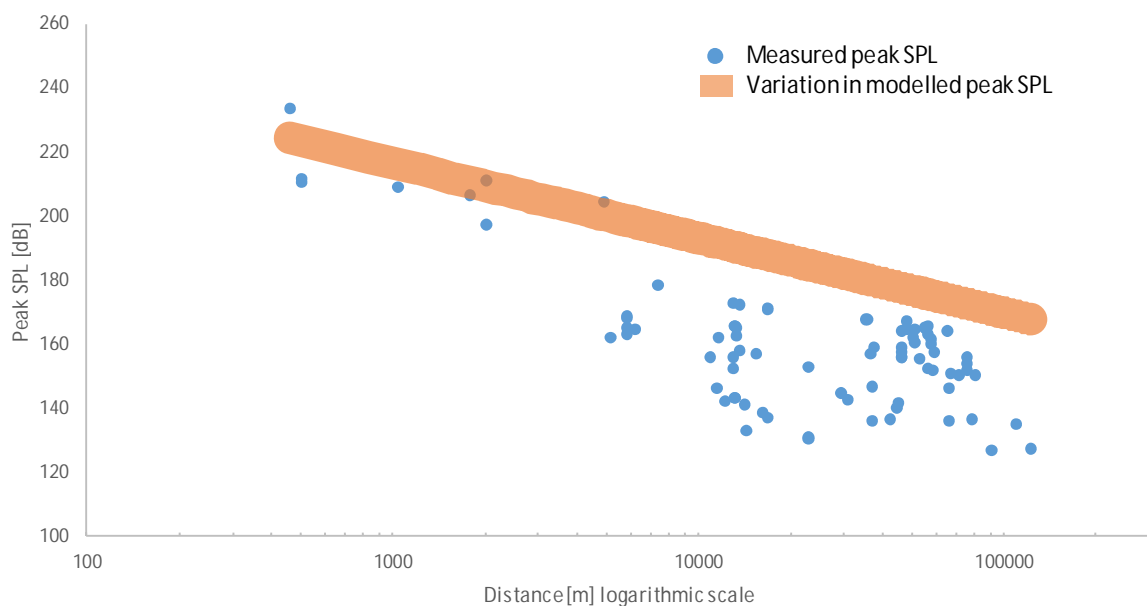
Figure 4. Peak sound pressure levels (SPL) from munitions clearance measured both by long term measurement stations and by vessel based stations. The SPL levels used in the permit application are based on modelling. They are presented as an area which covers the variation in the model results.

below the modelled range (Figure 4). Only one measured peak (R-R09ALT1-20117 at 500 meters) was 5 dB higher than the modelled value. This took place well within the estimated influence area of the ADD's. The probability for the occurrence of marine mammals increases with increasing distance from the munition. However, all the measured SPLs were clearly below the modelled values within the 5–120 km range.

There is increasing variation in the measured peak SPLs with increasing distance which was not found in the model results. Bottom topography was estimated to be the main reason for this. Islands and shallow areas effectively break the SPLs. Thus the Finnish shallow archipelago was sheltered more effectively than the deeper Estonian coastline which typically has no islands.

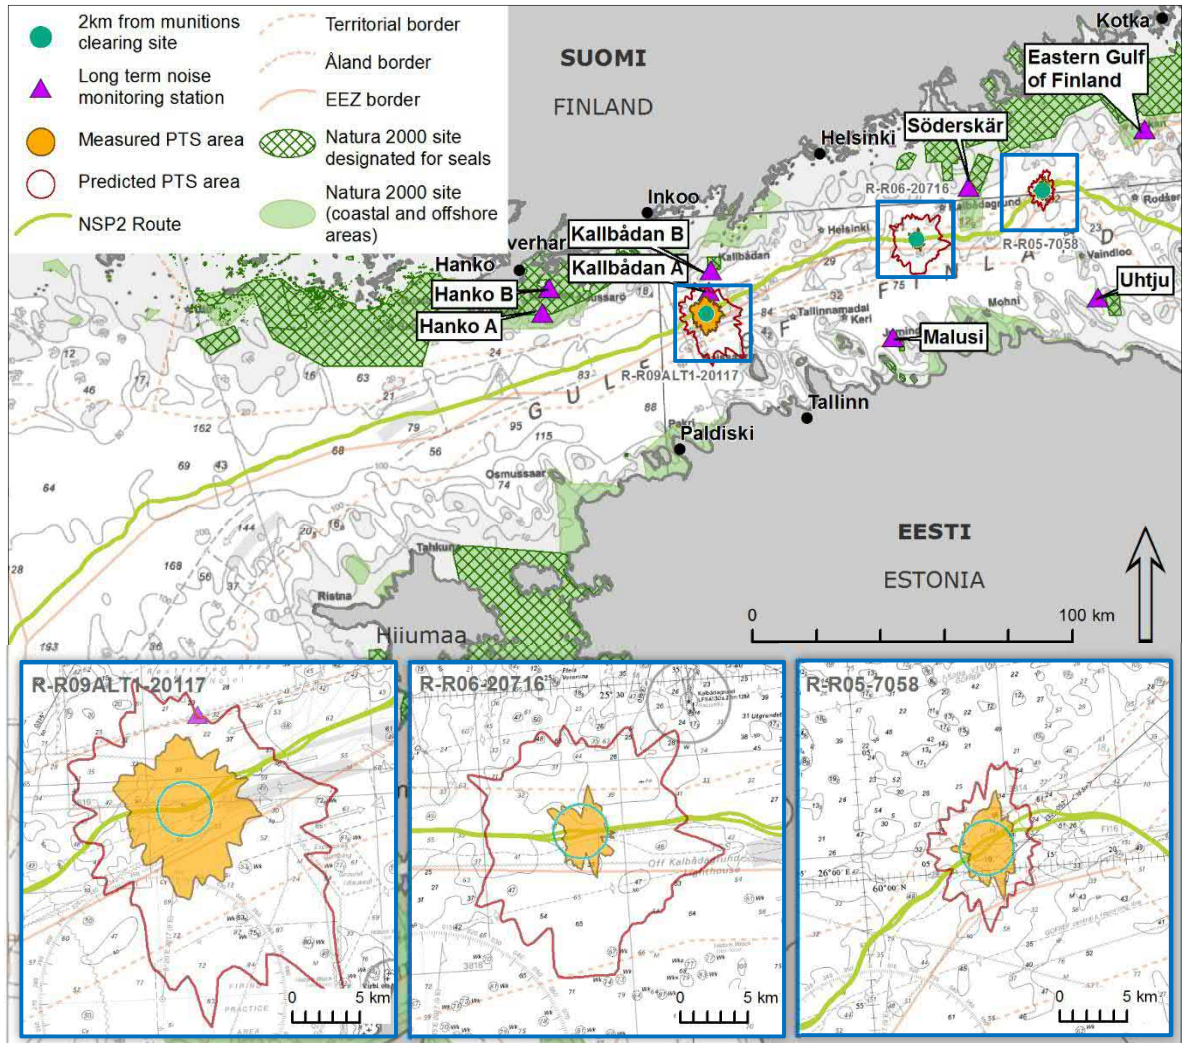
Figure 5. The map shows both the areas where the PTS levels for marine mammals was assessed to be reached in the permit application (predicted PTS area), and the actual measured areas (measured PTS area). The data for measurements was collected at 3 vessel based monitored munition clearance sites on 6– 8.5.2018.

The area where the risk of onset of PTS level for marine mammals was reached was significantly smaller than it was assessed to be in the permit application in all 3 vessel based monitored munition clearances (Figure 5). The PTS level was not reached within any of the adjacent Natura 2000 areas.

In the case of the two smaller vessel based monitored munitions, the munition appeared to be of a smaller charge size than predicted (Table 4). The size of the largest munition (300 TNT kg) was not changed in the clearance contractor re-evaluation. However, even in the case of the largest munition, there was a significant decrease in the PTS area compared to the permit application. It is possible that the use of a bubble curtain around the cleared

munition was more effective than predicted in the modelling. In addition, munitions were old and may have had a low order detonation rather than the assessed high order detonation.

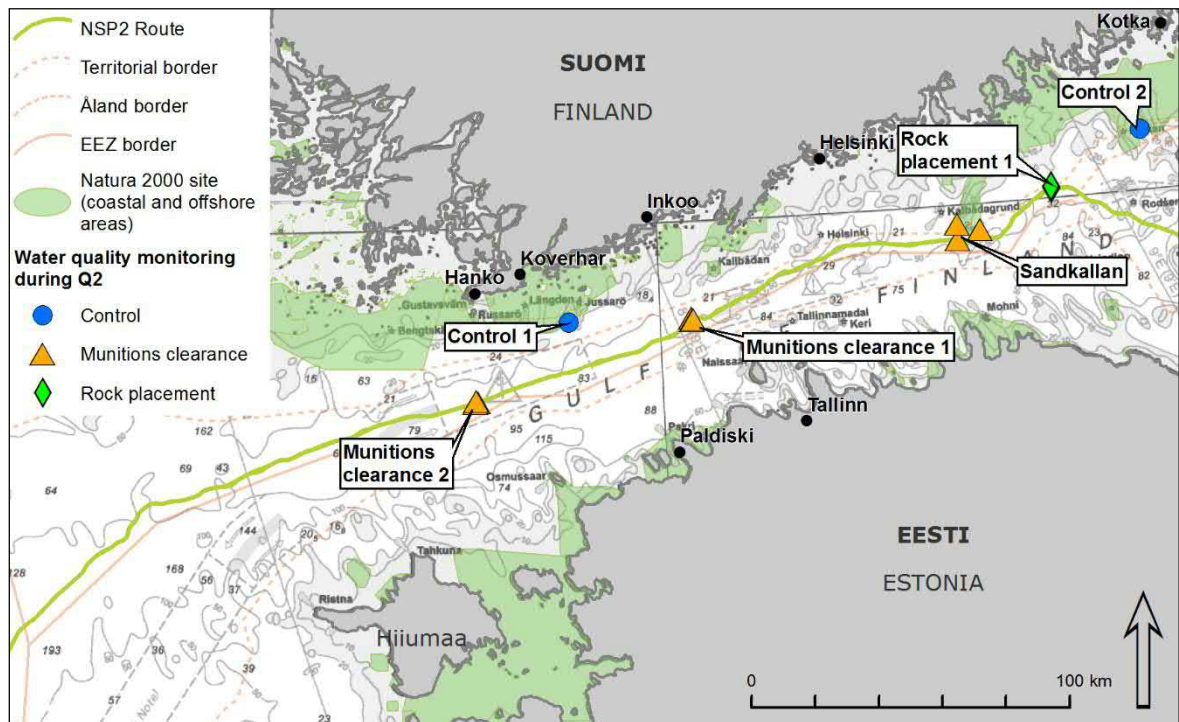
Figure 6. Water quality and current monitoring sites during Q2.

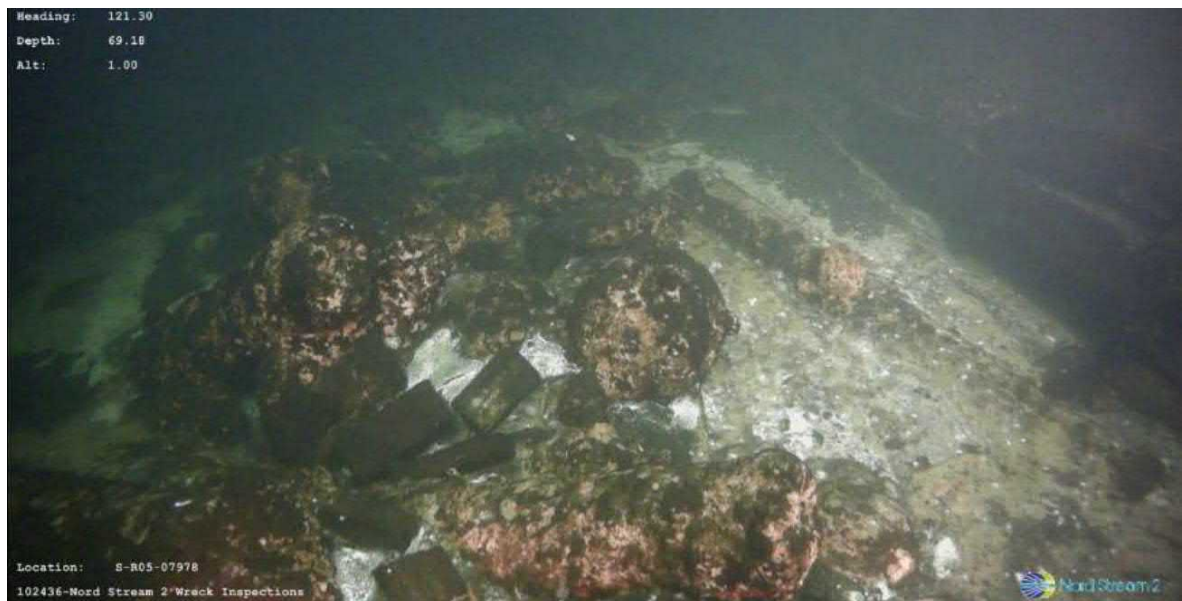
Figure 7. Wreck midship, cannons, cannon balls and debris. Picture from 2016 inspection W-SU-DET-POF-REP-808-CHO001EN-01.

The wreck inspection using Remotely Operated Vehicle (ROV) survey for the monitoring object S-R05-7978 was performed from the MV Stril Explorer on 6.5.2018. The cannon barge wreck site is regarded as an important archaeological site.

The object is located approximately 59 meters from the nearest planned pipeline.

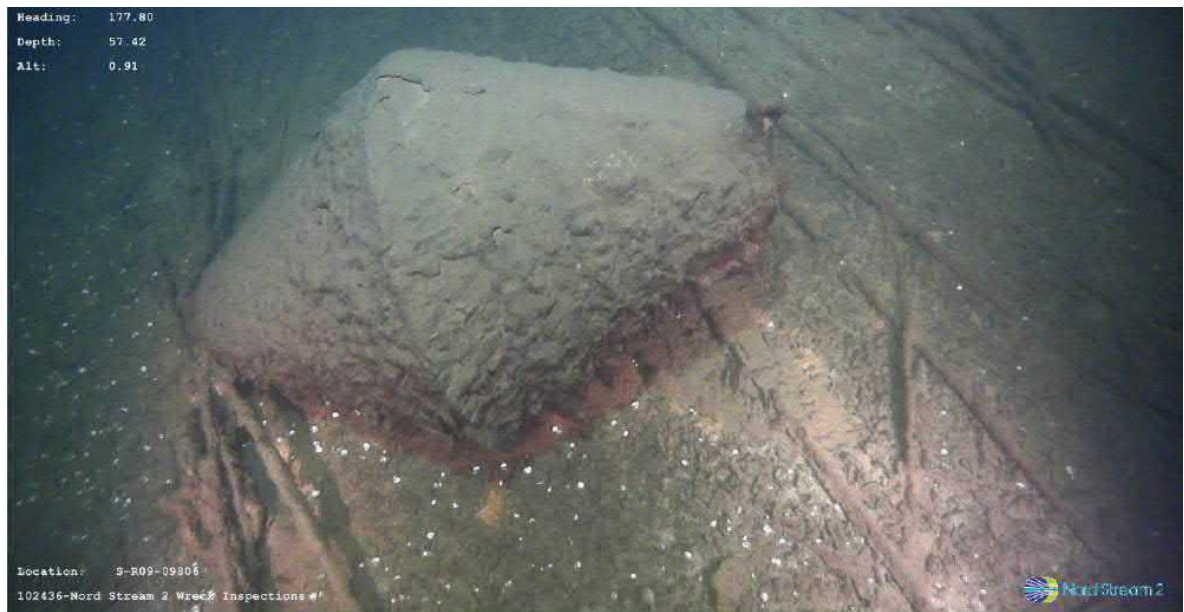
Figure 8. Buoy attached to submarine net/wires (SD-Alt1-3372-J) from 2016 inspection, W-SU-DET-POF-REP-808-WRK014EN-03.

A Multibeam Echo Sounder (MBES) sweep was performed from north to south, across the installation corridor for both cable routes, A and B. The Remotely Operated Vehicle (ROV) then proceeded to visually trace the line of floats and cables of the anti-submarine warfare net. Various, predefined targets defined by NSP2 were then each inspected, and their condition recorded for future reference.

The seabed in this area is dominated by exposed rock outcrops. The eastern margin of this outcrop forms a steep scarp face (33 % gradient). The anti-submarine net seems to have been laid along this rock outcrop.

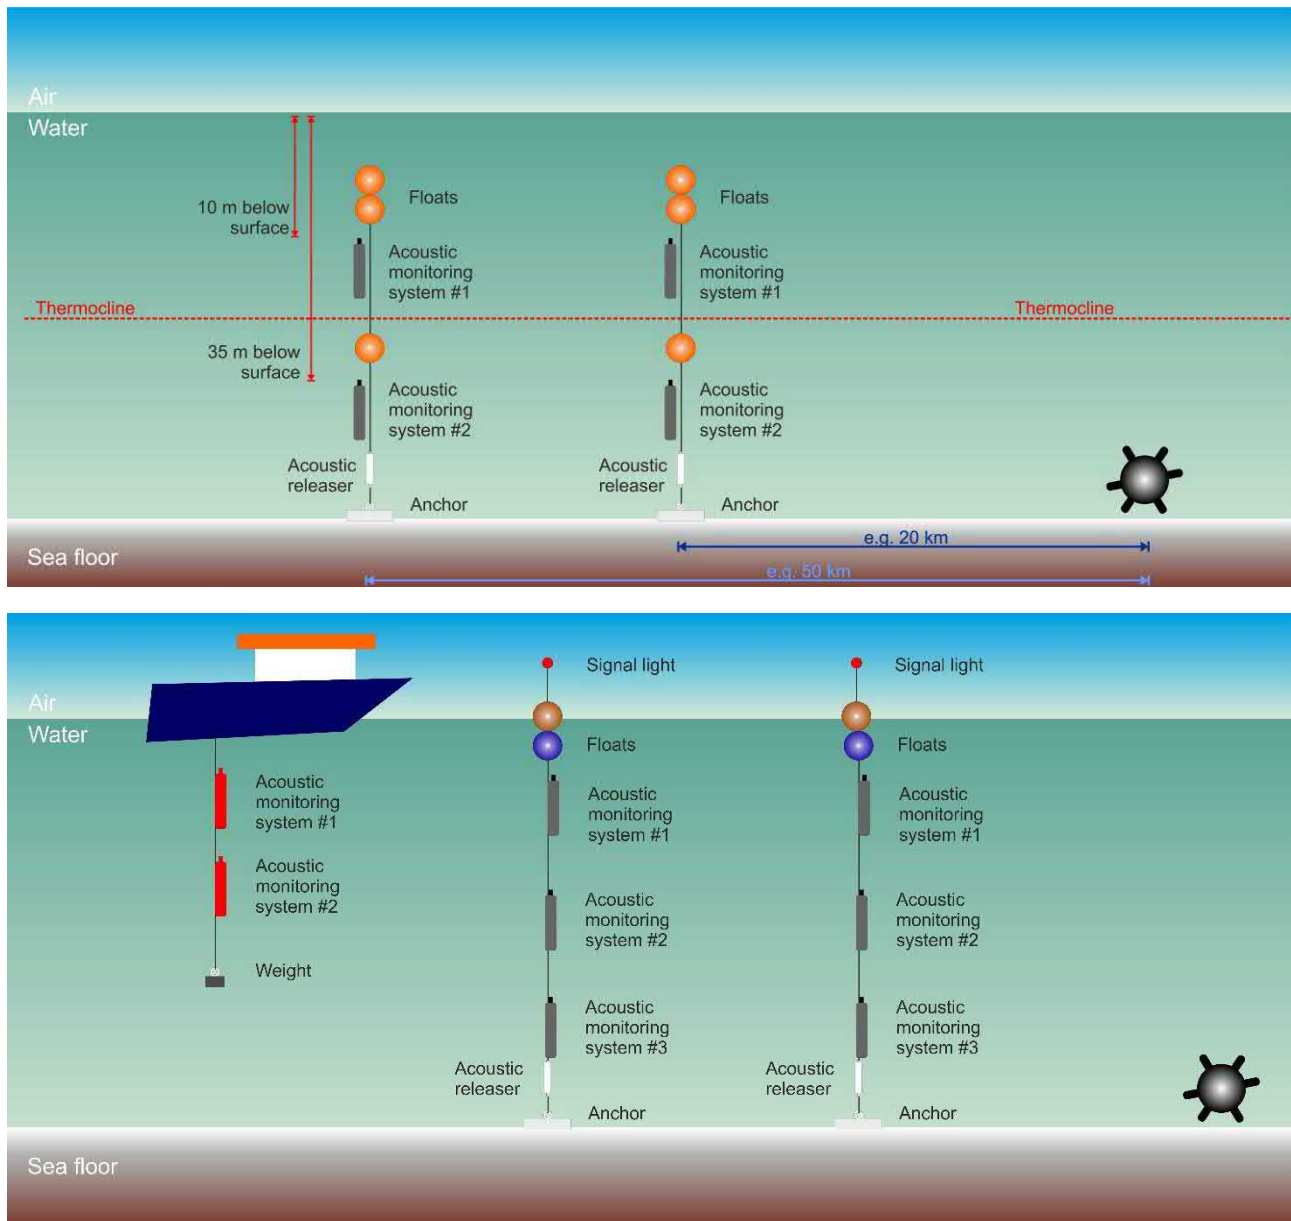
Figure 2 Upper: Schematic illustration of long-term installation, not in scale and lower: Schematic illustration of vessel based monitoring arrays.

A typical measurement installation is shown in figure 2. A set of monitoring devices were installed in a line. Moored hydrophone string is hanging from sub-surface buoys, which keep system suspended. More detailed information about used instruments can be found in Appendix 2. Before and after the measurements the hydrophones were tested and calibrated with a GRASS pistonphone. Pistonphone and Hydrophone calibration sheets are in Appendix 3. All measurement lines were identical having one monitoring device located 10 meters below the surface and second 35 meters below the surface. Water depth in all eight monitoring sites is more than 50 meters. CTD

(Conductivity Temperature Depth) and sound velocity profiles were collected during the installation and service visits in order to record background information concerning prevailing stratification.

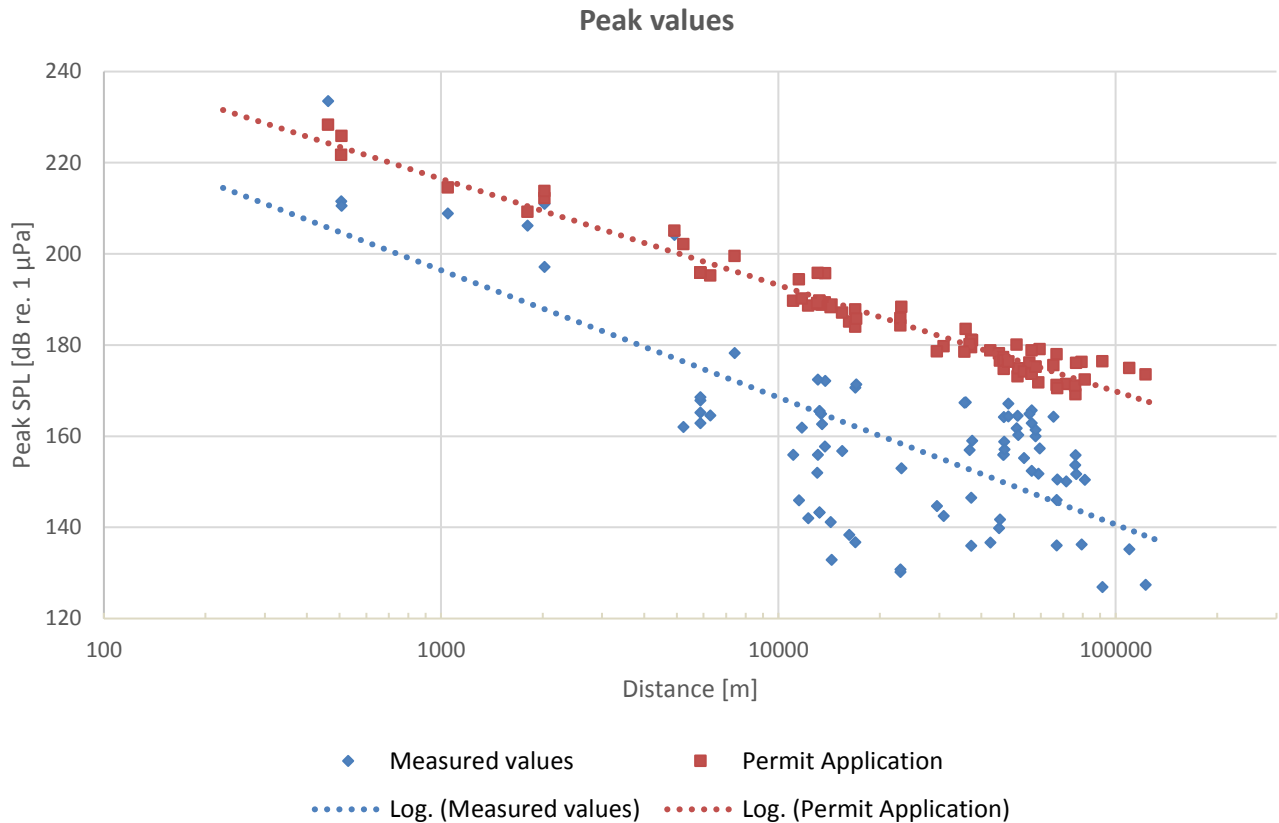
Figure 4 Measured peak pressure data from munitions clearance from 3rd of May to 14th of May.

In all except one cases, measured peak pressure levels were lower than assessed in the permit application. At 1000 m from the detonations, measured peak levels (figure 4) of 26 clearance actions were on average 20 dB lower than modelled values. Noise reduction with distance was also higher. Only one measured peak level (R-R09ALT1-20117 at 500 meters) which was recorded with vessel-based monitoring was higher (5 dB) than modelled value.

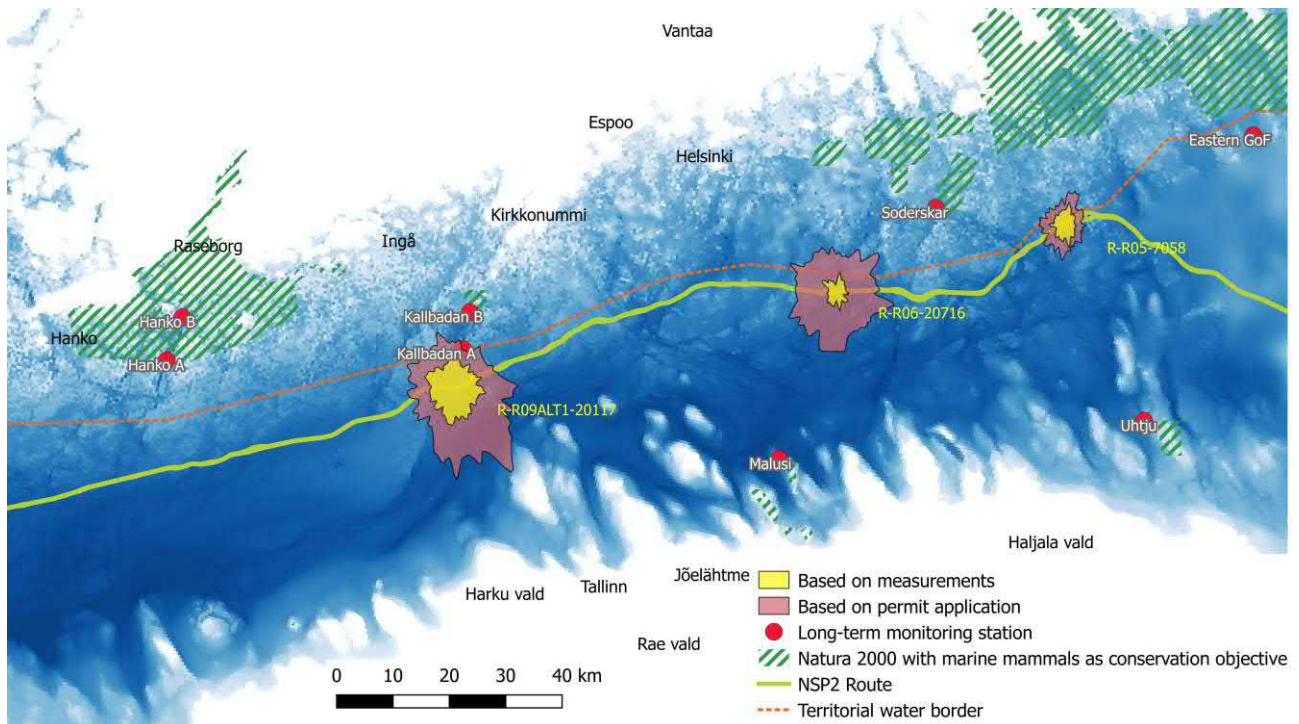
Figure 5 Distances to the PTS assessment level limit thresholds

In these three cases enough data was available from different distances to model the PTS exposure areas which are introduced in figure 5. In all three cases the PTS-zone was smaller than it was assessed in the permit application. The difference between measured and modelled values is not due to munitions being smaller than originally assessed for R-R09ALT1-20117, because its re-evaluation confirmed the original size of 300 kg. The difference is in this case due to propagation loss being in general larger than modelled. For R-R06-20716 the difference was also due to the re-evaluation - the munition was probably smaller than assessed in the permit application.

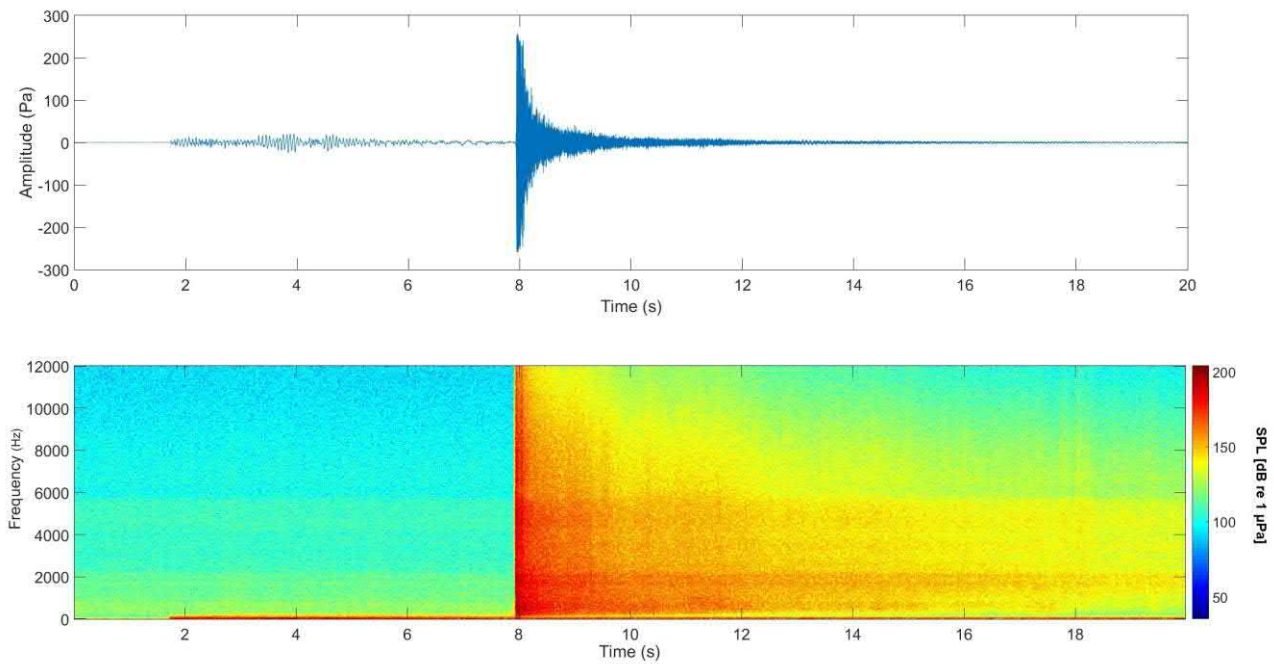
Figure 6 Munition clearance R-R08-20321 (24° 28.9076' 59° 47.1197'), German EMC 330 kg charge, measured from Kallbådan A, distance 11778 meters.

While main part of explosion's energy is transmitted through water, part of the energy is propagating in the ground. Low-frequency ground wave propagates faster and it can be seen before the main pulse is recorded on hydrophones. For example during the munition clearance R-R08-20321 ground wave arrived to Kallbadan A (11800 meters) 6.3 seconds prior to main pulse (figure 6).

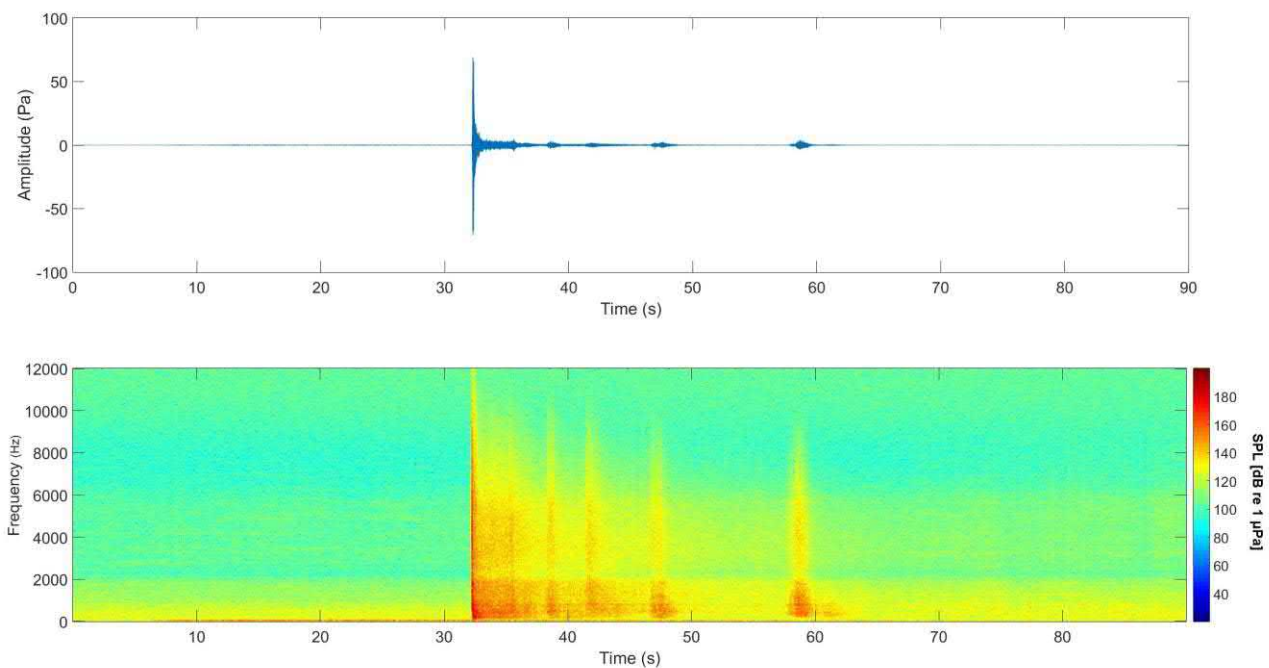
Figure 7 Munition clearance R-R08-20321 (24° 28.9076' 59° 47.1197'), German EMC 330 kg charge, measured from Malusi, distance 47984 meters.

In figure 7 the same munition clearance was measured from a distance of 48000 meters. As seen on the figure main pulse reflected 5-6 times from surrounding islands and coastline after it was first recorded.

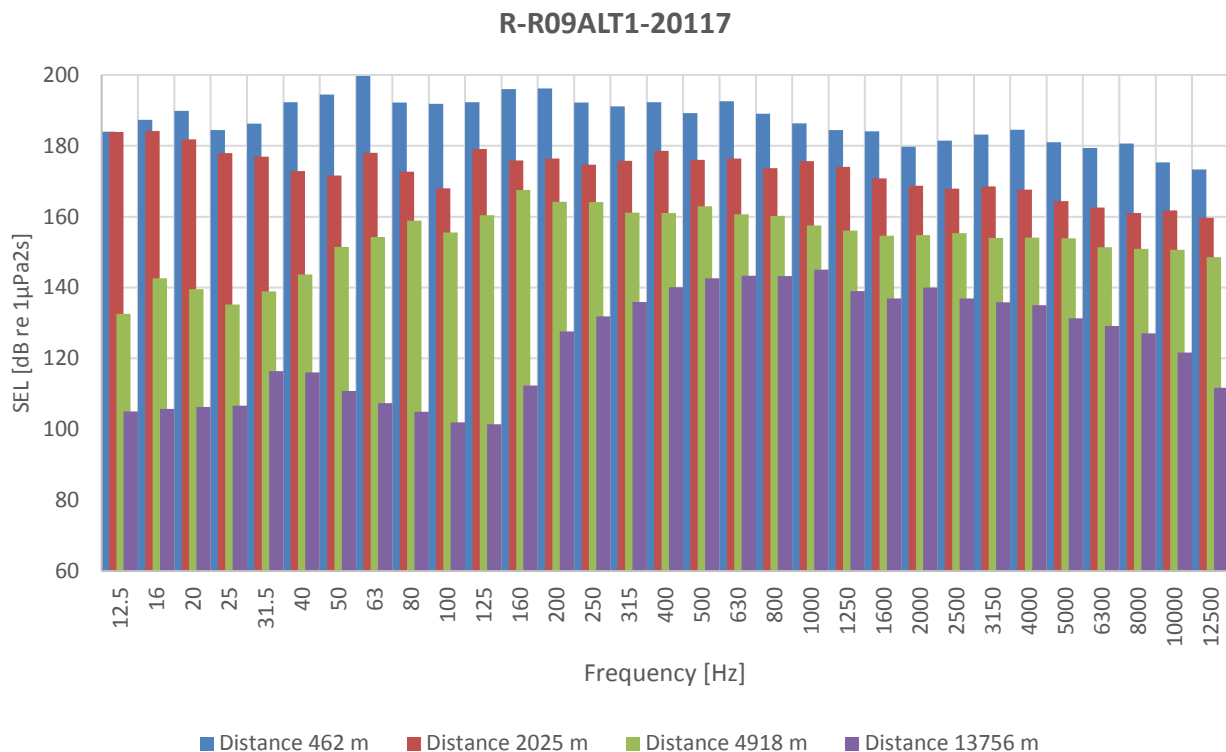
Figure 8 Munition clearance R-R09ALT1-20117 sound exposure level measured from four different distances.

In addition to wide-band results it is interesting to consider how the sound propagation varies with frequency. In figure 8 1/3 octave sound exposure level of munition event R-R09ALT1-20117 (German EMC-1, 300 kg charge) is measured from distances of 462 m, 2025 m, 4918 m and 13756 m. Propagation loss is more intensive at frequencies below 160 Hz. Low-frequency cut-off is defined by the seafloor and the depth varies in this case from 20 meters to 50 meters. Variation of sound transmission loss with frequency is dependent on water depth, sound speed profile, seabed and sea-surface loss. The frequency response will be different in the far field compared with measurements from the nearby area.

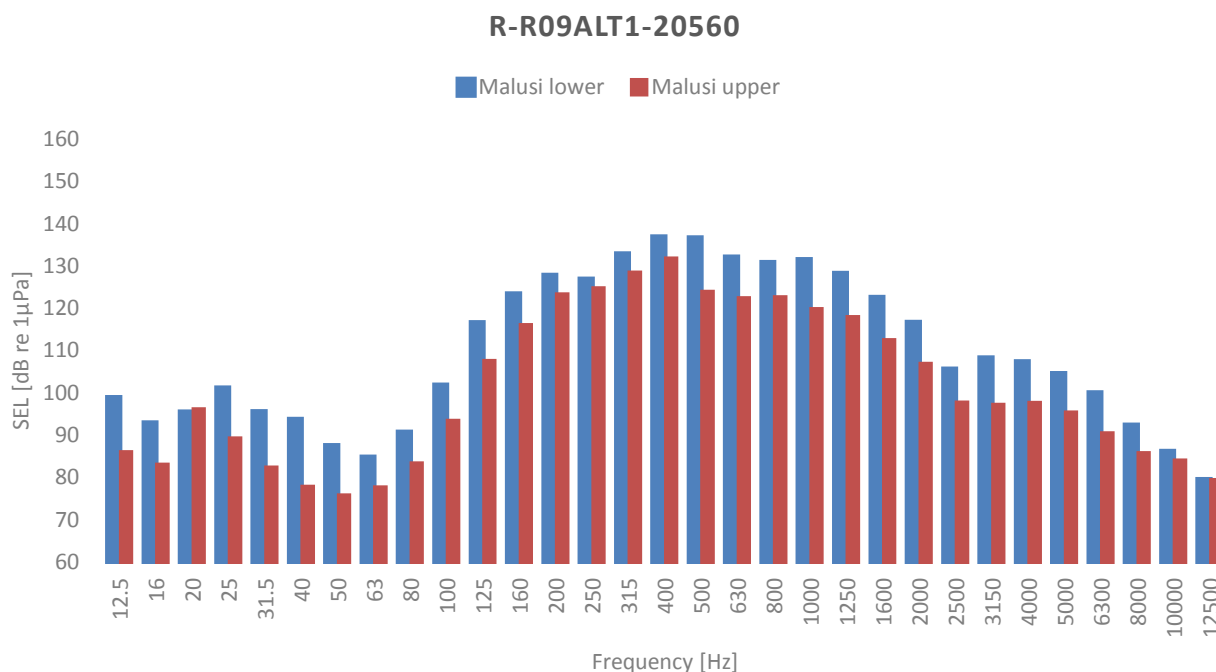
Figure 9 Munition clearance R-R09ALT1-20560 (24° 18.0863' 59° 44.5098'), shell with 17 kg TNT charge measured sound exposure level in Malusi, 10 m and 35 meters below the surface.

One of the biggest difference was measured during the munition clearance R-R09ALT1-20560 (figure 9). Form of the frequency response is similar but the amplitude difference is almost 10 dB at several 1/3 octave frequency bands meaning that less energy was seen on uppermost layer. Hydrophones were 10 m and 35 meters below the surface.

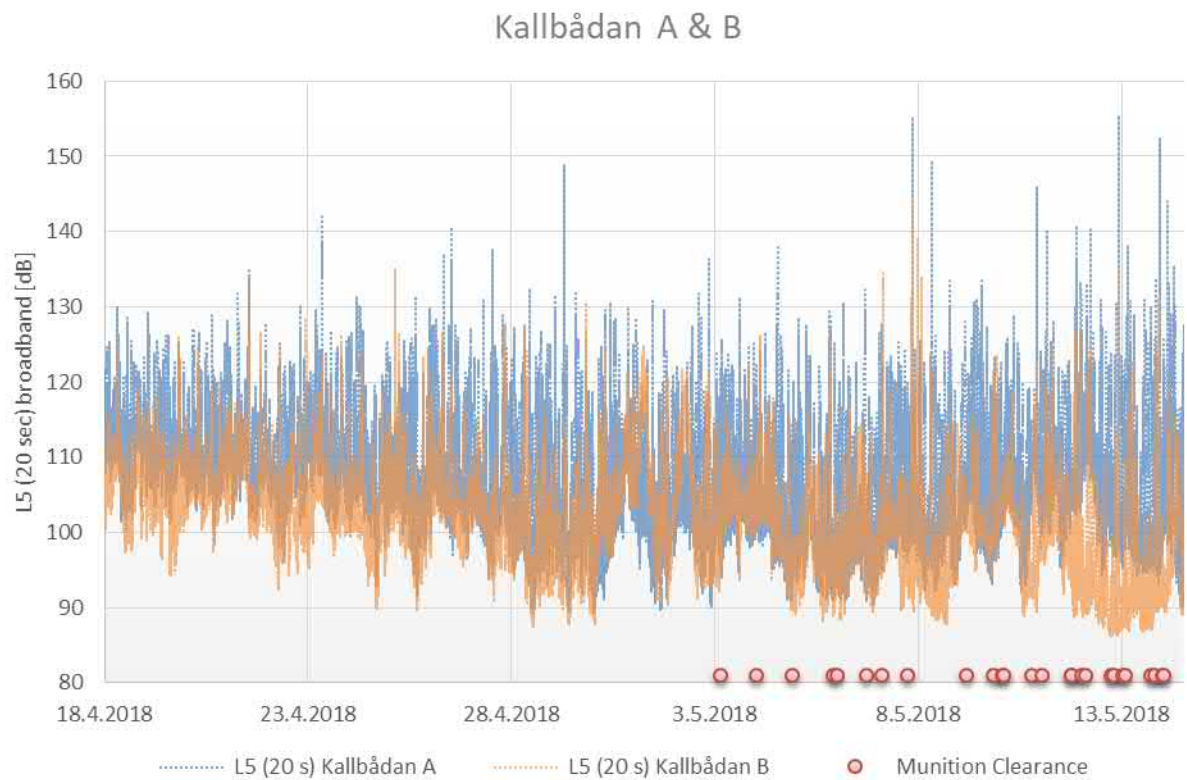
Figure 12 Time-series L5 (20 seconds) vs munition clearance events – Kallbådan A & B

construction activities was the shortest at Kallbådan A stations, the highest noise impacts were recorded, but when compared with munitions clearance times, an intensive shipping in the area was found to be the main reason for elevated readings. At Kallbådan B peak levels were 10-20 dB lower as the surrounding area has strong depth gradient and several shallow areas. Distance between Kallbådan A and Kallbådan B is 6663 meters.

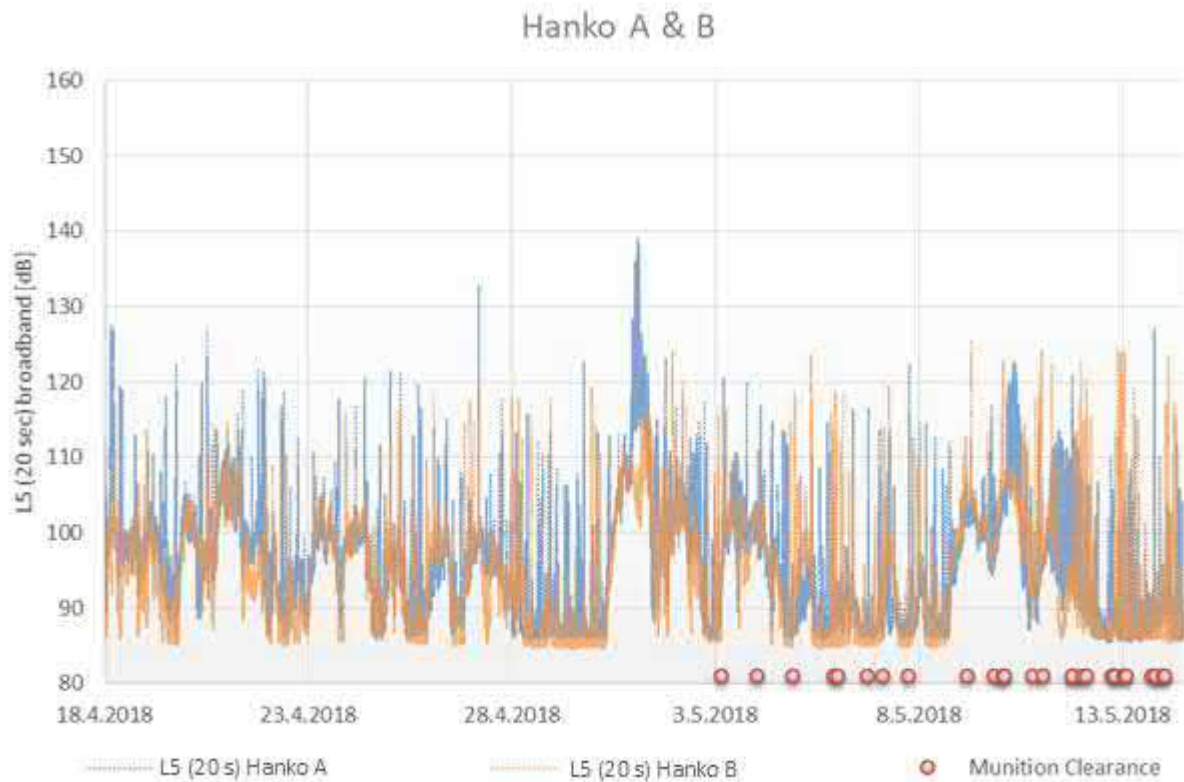
Figure 13 Time-series L5 (20 seconds) vs munition clearance events – Hanko A & B

At Hanko A & B munitions clearance between 3 of May and 14 of May had no effect to the time-series analysis. The shortest distance between the analyzed munition clearance and Hanko A/B monitoring station was over 50 km and on the east side of the measuring stations depth was under 10 meters. No significant difference was recorded between Hanko A & B stations. Peak levels are mostly caused by shipping in the area. High noise levels halfway through the measurement period are caused by stormy weather. Distance between Hanko A and Hanko B is 8143 meters.

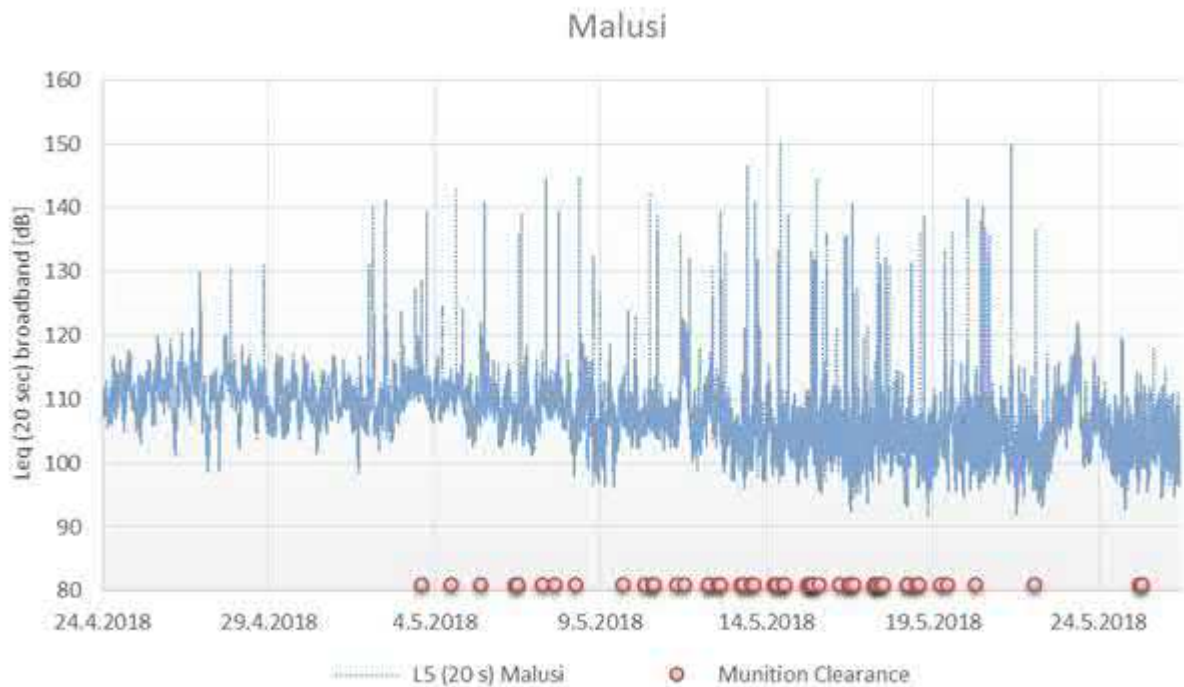
Figure 14 Time-series L5 (20 seconds) vs munition clearance events – Malusi

As expected single peaks from the munition clearance operations stand out at Malusi as it's more silent in nature. A few peak before the operations are caused by shipping. Propagation loss is lower because of the constant depth all the way to the monitoring stations Malusi and Uhtju. Peaks at Uhtju (figure 15) are caused by shipping but also munition clearance operations which were cleared on the east side of Helsinki.

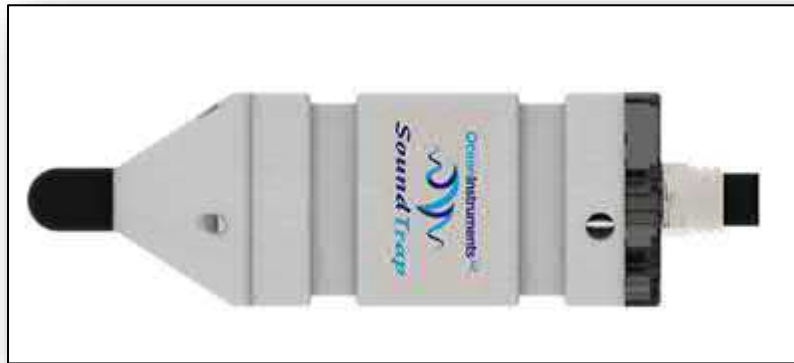
Figure 16 SoundTrap hydrophone

Long-term monitoring stations were equipped with SoundTrap and DSG-ST hydrophones. SoundTrap is an autonomous acoustic recording unit with frequency range of 20 Hz to 60 kHz and several different sample rate options from 24 to 28 kHz. During the monitoring campaigns the sample rate was set to 24 kHz. Maximum level before clipping is 190 – 210 dB re 1 μ Pa depending on the model and gain settings.

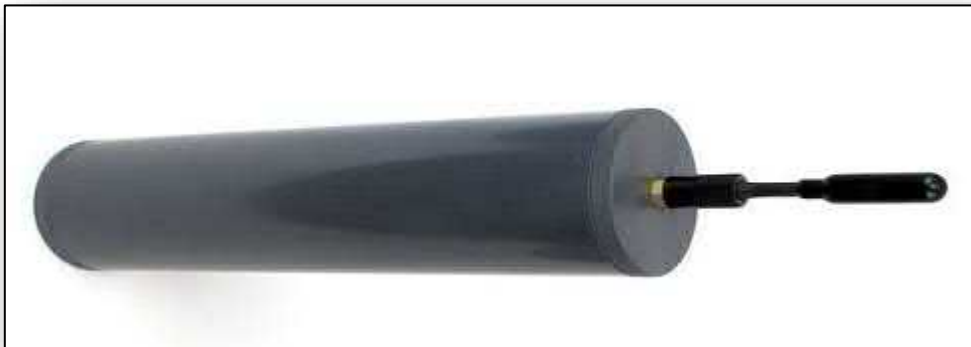
Figure 17 DSG-ST hydrophone

Loggerhead DSG Ocean Logger is a long-term autonomous acoustic recording unit. The frequency range of the selected hydrophone model, HTI-96-MIN, is 2 Hz to 30 kHz. Sample rate was set to 24 kHz.
