Nord Stream 2 AG

June 2020

W-PE-EMO-PSE-REP-805-M02019EN-02

NORD STREAM 2 ENVIRONMENTAL AND SOCIAL MONITORING IN SWEDISH WATERS, 2019

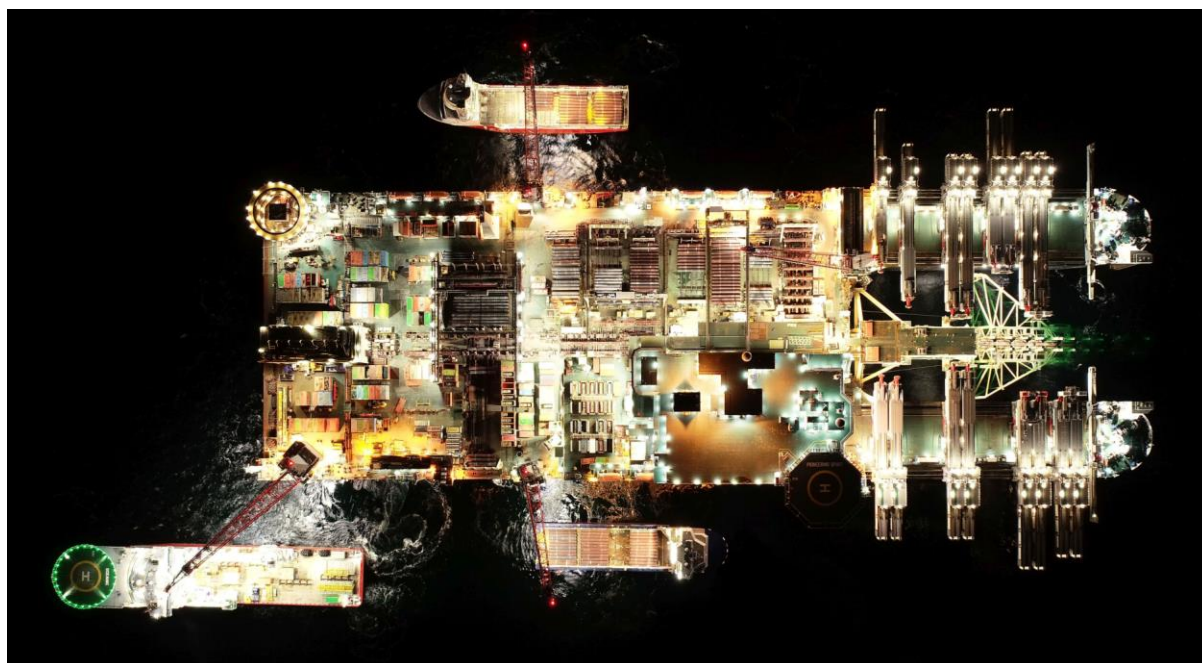
Figure 1 The dynamically positioned vessel Pioneering spirit

The other DP pipelay vessel "Pioneering Spirit", laid both lines A and B in the northern part of the Swedish route. In Swedish EEZ, she began to lay line A from the Finnish border on the 4th of February and laid southbound through Swedish EEZ to the east of Gotland until April. In April "Solitaire" and "Pioneering Spirit" swapped lines and Pioneering Spirit continued to lay line B northbound, back to the Finnish border until the end of May 2019.

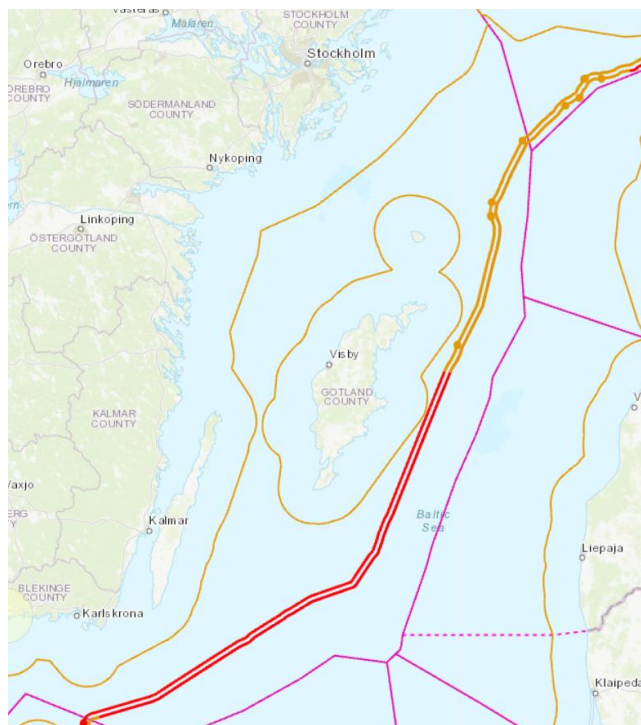
Figure 2 Distances laid by Solitaire (red) and Pioneering Spirit (orange).

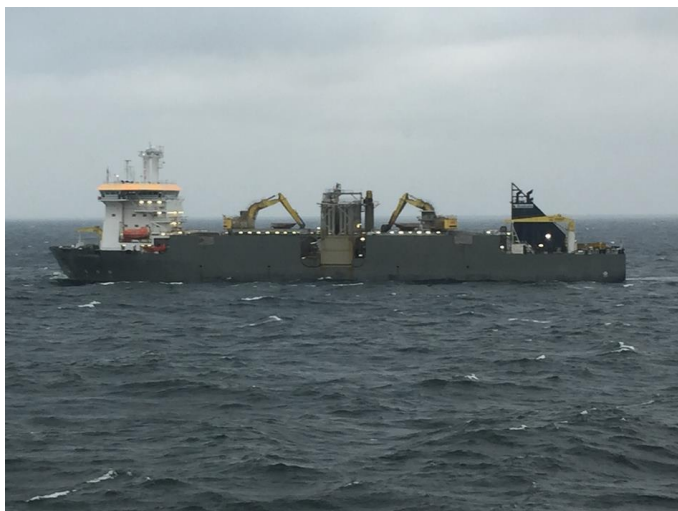
Figure 3 Rockpiper installing a rock berm in the Swedish EEZ

74 rock placement installations with a total volume of ca 105 000 m³ were installed along the route throughout 2019 by the vessels Rockpiper, Nordnes, Seahorse and Bravenes, from the joint venture BoVo (Boskalis / Van Oord). The Swedish Maritime Administration (SMA) were informed well in advance, so that they could send out navigation warnings or notice to mariners if necessary.

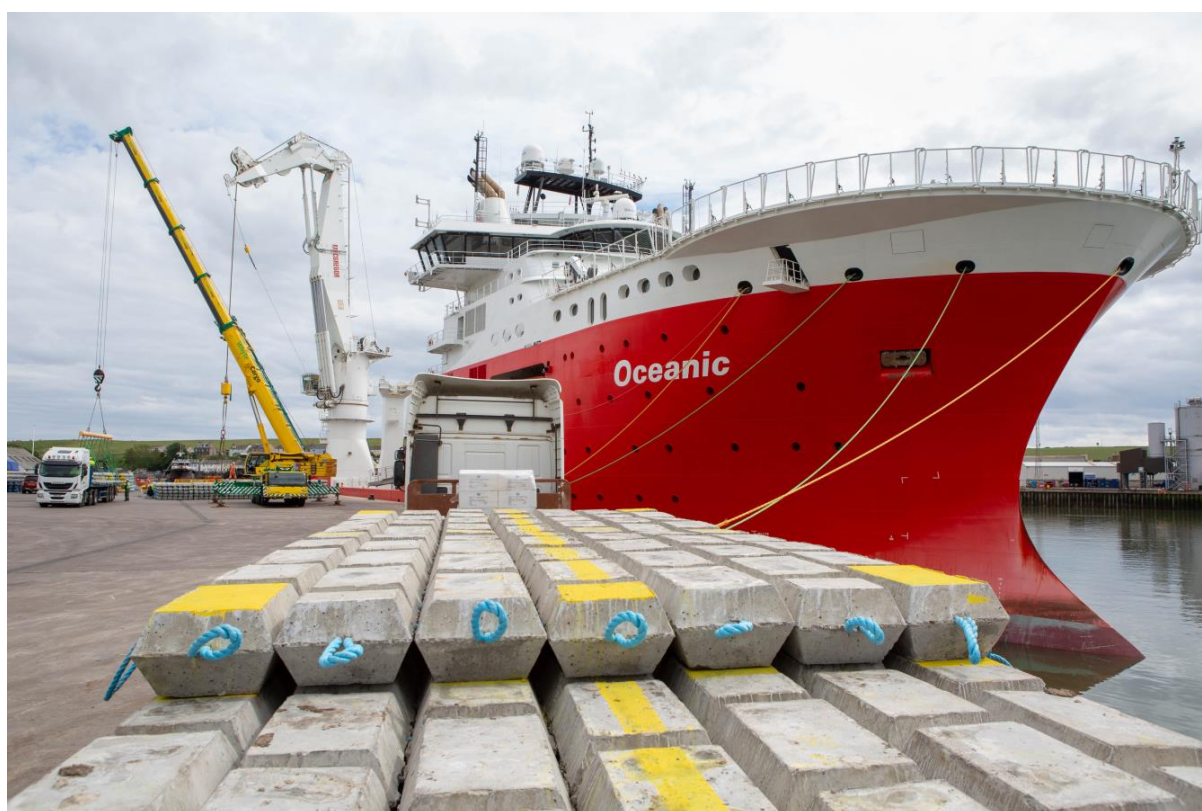
Figure 4 Mattresses to be loaded on to the vessel Oceanic

Most mattress installations were installed in 2018. The remaining mattress installations at the SWEPOL cable crossings in the southern part of the Swedish EEZ, just outside the Natura 2000 area, were installed by the vessel "OCV Oceanic" by the company Allseas in the beginning of July 2019.

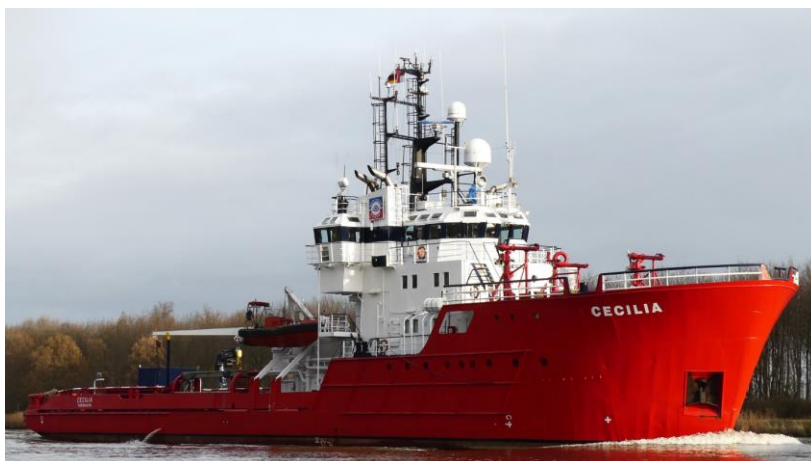
Figure 6 The turbidity monitoring vessel Cecilia

The water quality (turbidity) was monitored during the trenching activities by the vessels "Fortuna Kingfisher" (first) and "Cecilia" (later) from the contractor DHI. They measured the density of the turbidity behind the plough and followed the plume to investigate if it could travel in the direction towards the banks "Norra Midsjöbanken" and "Hoburgs bank". See chapter 4.2 for more information.

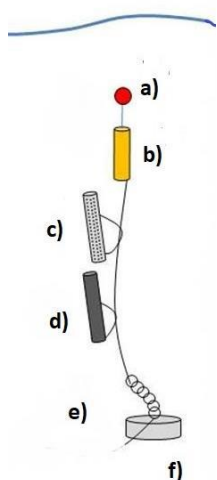
Figure 10 The mooring system for the noise and marine mammal monitoring. (a) floating buoy in depth, b) acoustic releaser, c) ambient noise monitoring sensor (SM3M/SM4M) d) marine mammals monitoring sensor (C-POD) e) elastic part of the mooring system, f) small concrete or iron anchor.

Noise measurements were provided with use of SM3M and SM4M recorders with a frequency range of 0-192 kHz. Harbour porpoises were detected by PAMGUARD using data from the mentioned recorders and with additional data from CPOD recorders designed to detect transient sound with a frequency range from 20-160 kHz. The devices were deployed using a custom-built mooring system containing a floating buoy, keeping the rig straight up from the seafloor, an acoustic releaser, the underwater noise recorder (SM3M/SM4M), the porpoise click detector (C-POD), an elastic part of the mooring system and finally a small concrete or iron anchor (see Figure 10)

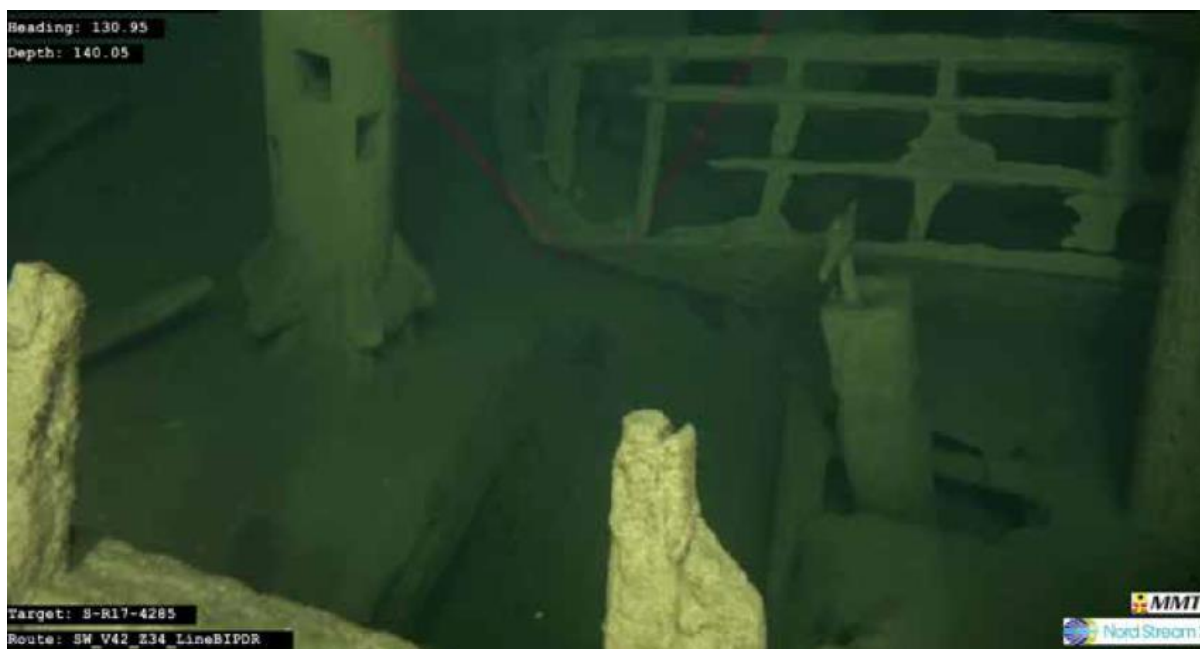
The shipwreck is undisturbed by the construction of the pipeline. A comparison of the multibeam-images from the pre-lay inspection and the post-lay inspection shows no signs of changes on the wreck and the surrounding seabed.

Figure 12 Photo from the starboard side. From the left: the capstan, the flat-bottomed ship's boat, the bilge pump and to the right end the main mast. Pre-lay. Photo: MMT

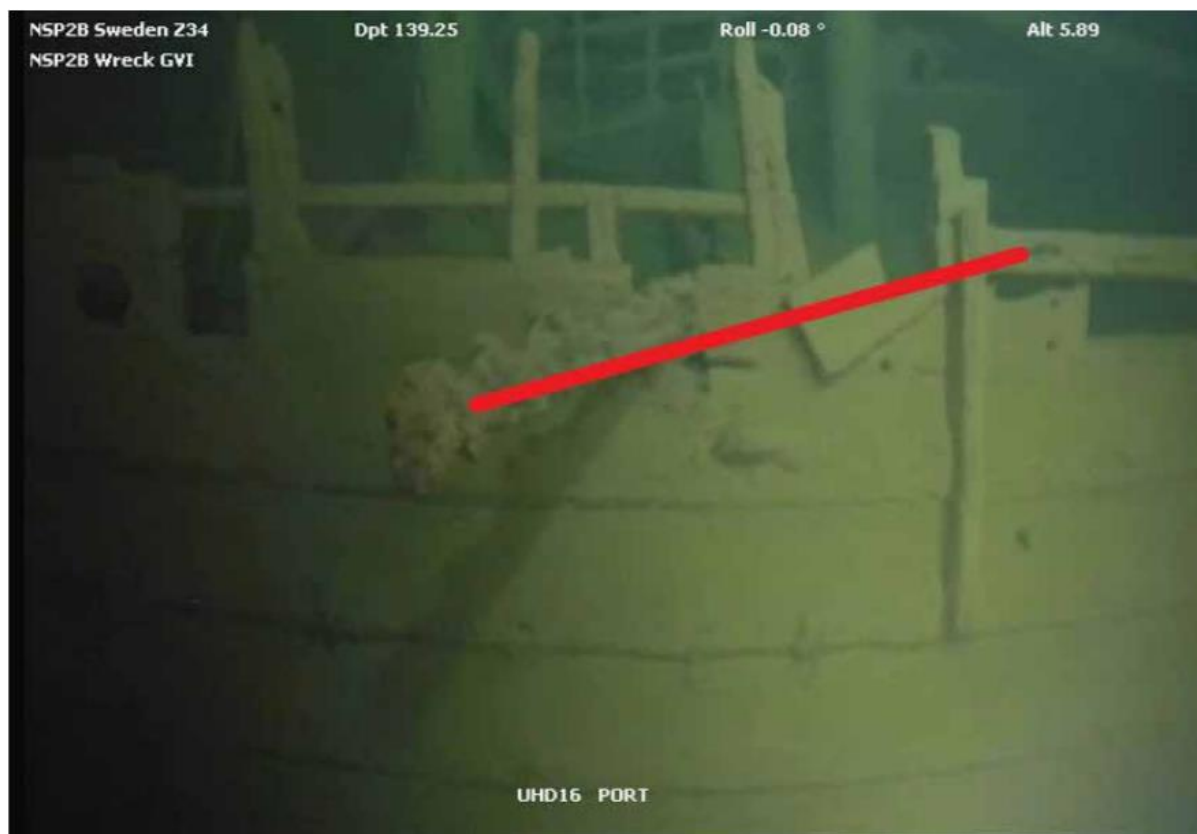
Figure 13 Photos on the possible swivel gun/beam (left) and a pulley (right) on the starboard side. Postconstruction. Photo: Allseas.

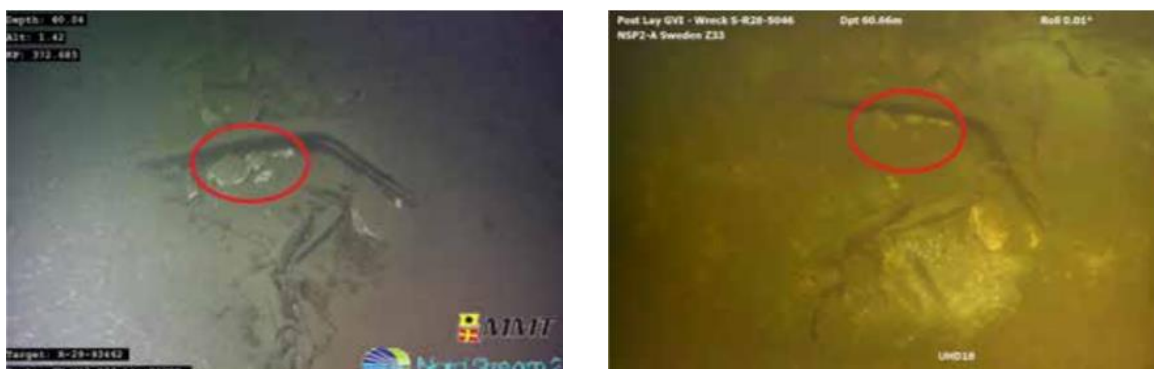
A comparison of the multibeam-images from the pre-lay and postlay-inspection shows no signs of changes on the wreck and the surrounding seabed. As seen from earlier inspections, the sedimentation seems to vary on this site. A ship timber and stones seem to have different sedimentation from the post-lay inspection. The sediment on the sea bottom and the wreck seems to be volatile and light. Therefore the sedimentation seems to change from time to time. The wreck as a whole does look unchanged between 2009 when the first survey for the Nord Stream project has been carried out compared to the post-lay inspection 2019 (Fredholm 2019b).

Figure 14 Photos of ship timber and stones. Pre-construction (left) and post lay (right). Photo: MMT and Allseas

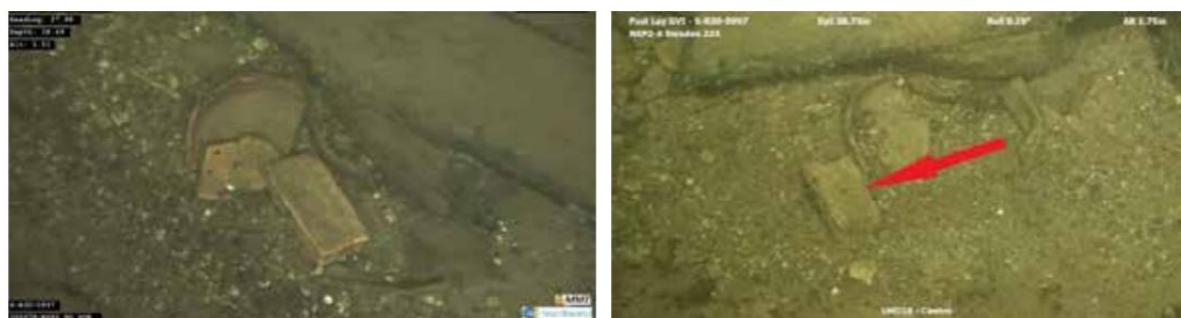
The shipwreck is considered to be undisturbed by the construction of the pipeline, but minor changes are visible. A comparison of the multibeam-images from the pre-lay inspection and the post-lay inspection shows no signs of changes on the wreck and the surrounding seabed. The ROV-inspection confirms that three of the objects eight objects "events" on the wreck have moved slightly. The minor changes possibly depend on trawling or fishing and less likely on the pipeline construction. Because it lies on just 38 meters depth it's probably affected both by waves, currents and fishing/trawling, as parts of fishing nets were visible on the wreck (Fredholm 2019a).

Figure 15 Event A, where a brick has moved around 20 cm. Pre-construction (left) and post lay (right). Photo: MMT and Allseas

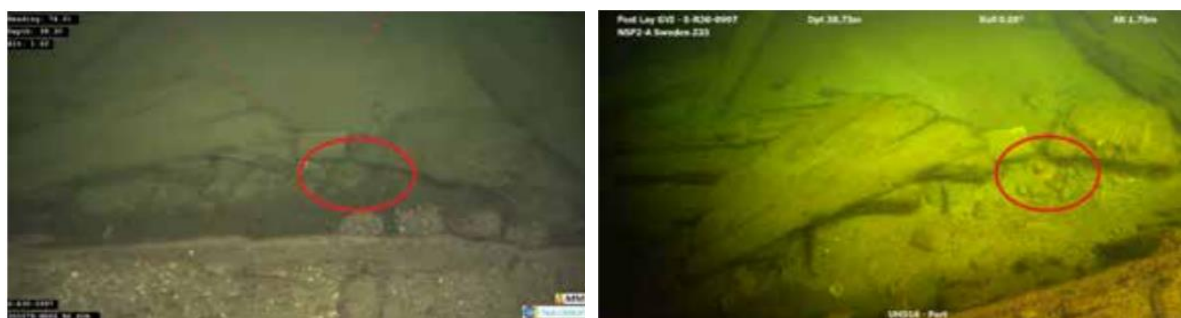
Figure 16 Event B, possible lid pot, where a wooden object might have moved a few cm. Pre-construction (left). Photo: MMT and Allseas

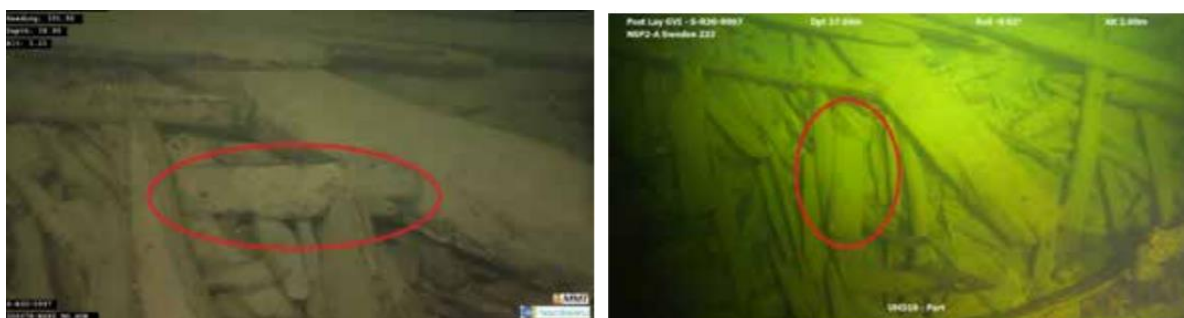
Figure 17 Event H; a block, where a plank has moved. Pre-construction (left) and post lay (right).
