Overall Environmental Monitoring Report 2018

Construction of the Nord Stream 2 pipeline commenced in 2018 in Russia, Finland, Sweden and Germany upon receipt of the respective permits. Environmental monitoring is carried out before, during and after construction to demonstrate that impacts are in line with the environmental impact assessment (EIA) reports and certain permit conditions, as well as in compliance with the International Finance Corporation (IFC) Environmental and Social Performance Standards.

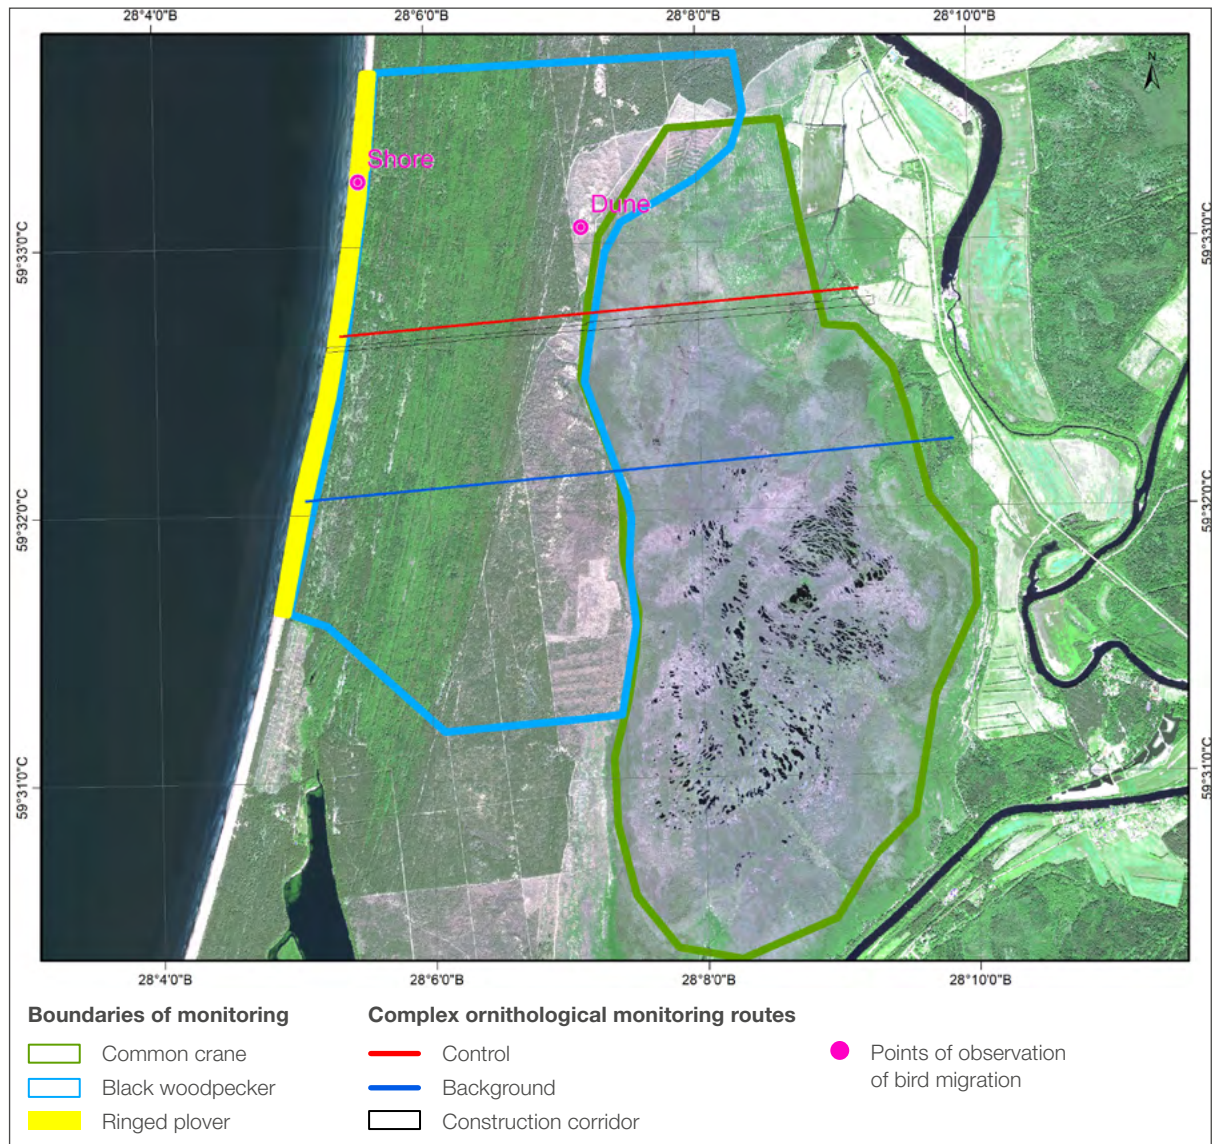
Figure 7. Overview of bird monitoring locations at the Russian landfall.

Each of the above targets for bird monitoring was monitored according to specifically tailored methodologies. A brief description of the methodology is provided below, and an overview of the monitoring locations is provided in Figure 7.

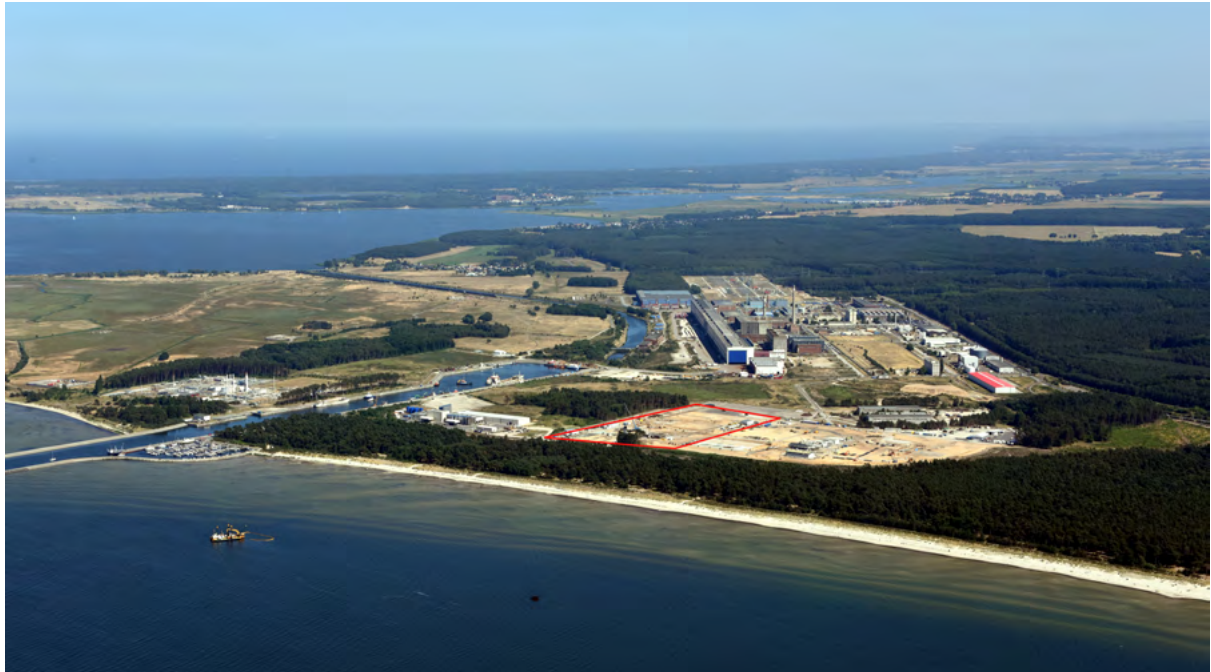
Figure 11. Pig Trap Area (PTA) Germany (red box) in the industrial park south of Lubmin industrial harbour in July 2018. The vessel in the foreground shows the location of the offshore exit pit of the shore crossing microtunnel.

Since the landfall Germany and the PTA are entirely located inside a designated industrial park (see Figure 11), monitoring requirements for onshore construction in Germany are characterised as low complexity compared with the requirements for the landfall Russia.

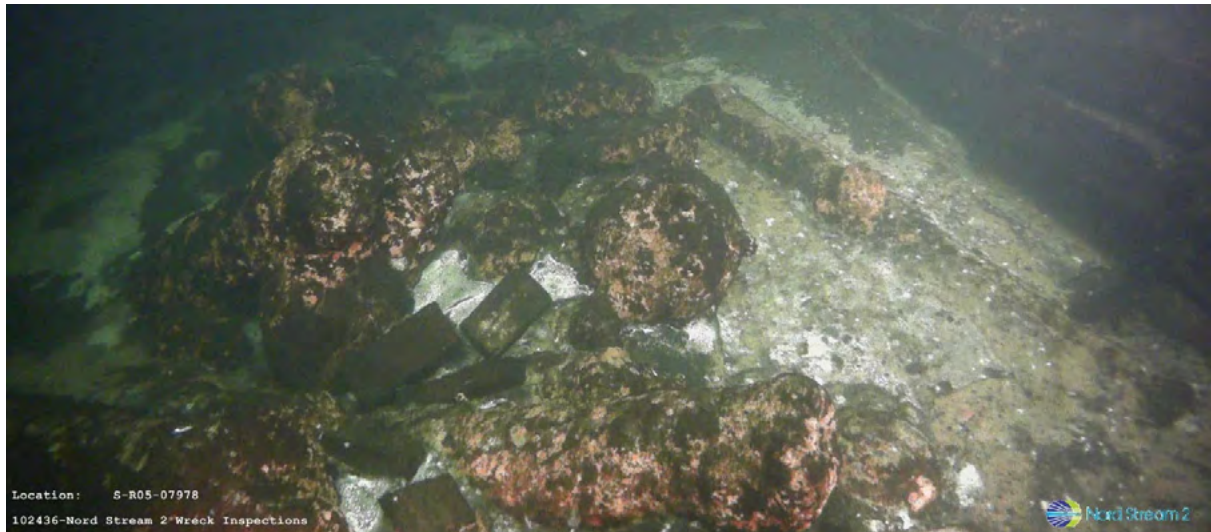
Figure 15. Wreck mid ship, cannons, cannon balls and debris.

The wreck consists of the remains of a cannon barge with numerous iron cannons (at least 20) which can be seen on each side of the vessel. The cannons are placed side by side along the vessel with alternate positioning of the rear and front ends. Among the iron cannons there is also a well-preserved bronze mortar (see Figure 15). The wreck is considered to be of cultural and historical interest. The cannon barge could provide new insight and information about warfare, engineering and everyday life during the second half of the 18th century in the Baltic /24/.

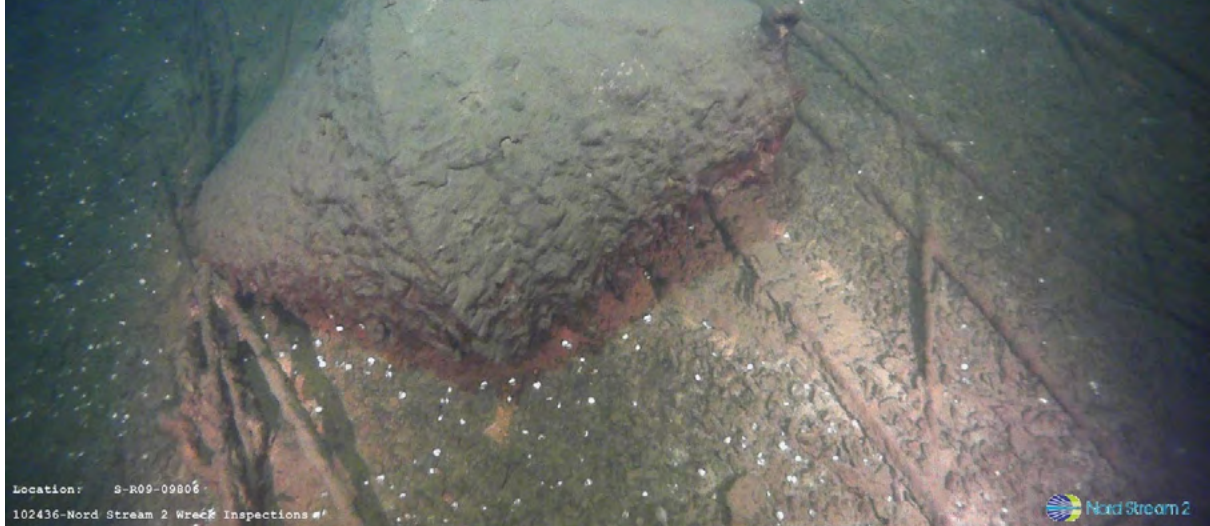
Figure 16. Buoy attached to submarine net/wires.

The World War II anti-submarine net was laid along a rock outcrop, which dominates the surroundings. The eastern margin of this outcrop forms a steep scarp face with a 33 % gradient. Water depth ranges from 58 m on the plain to 53 m at the top of the rock outcrop.

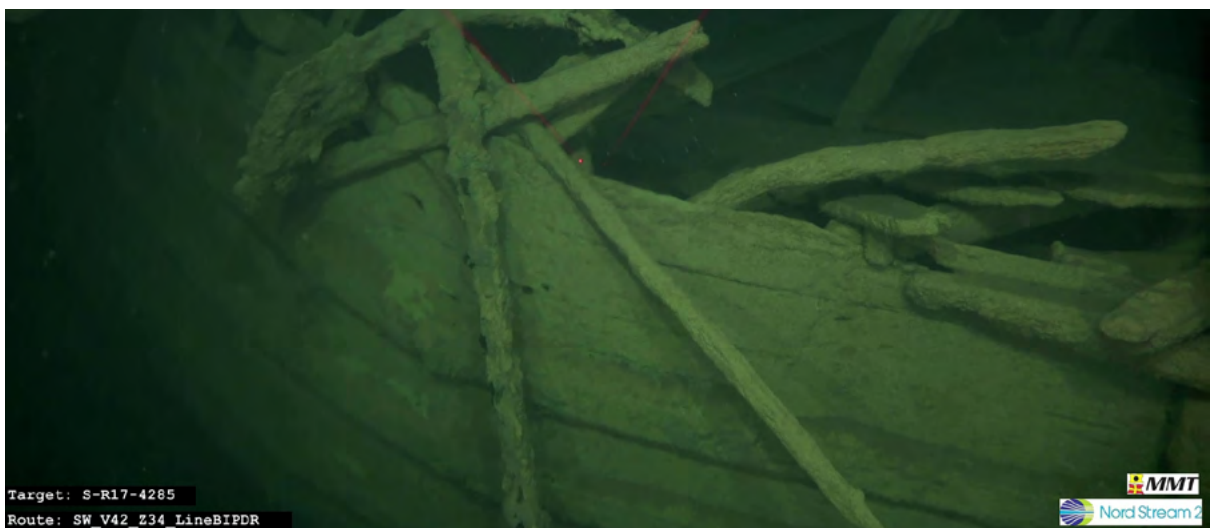
Figure 17. Anchor hanging on the starboard side near the bow and another stands on the seafloor just off the bow.

The object is a wooden wreck that is 17 m long and 5 m wide. The construction, anchor, ships boat, capstan, and other details indicate a 17th or an 18th century construction date. The wreck is carvel-built. It has two standing masts, a mainmast and a foremast in the bow. An anchor is hanging on the starboard side near the bow and another stands on the seafloor just off the bow (see Figure 17). A “ship’s boat” lies on deck on the port side. The ships boat has a flat bottom and the sides are clinker built /25/.

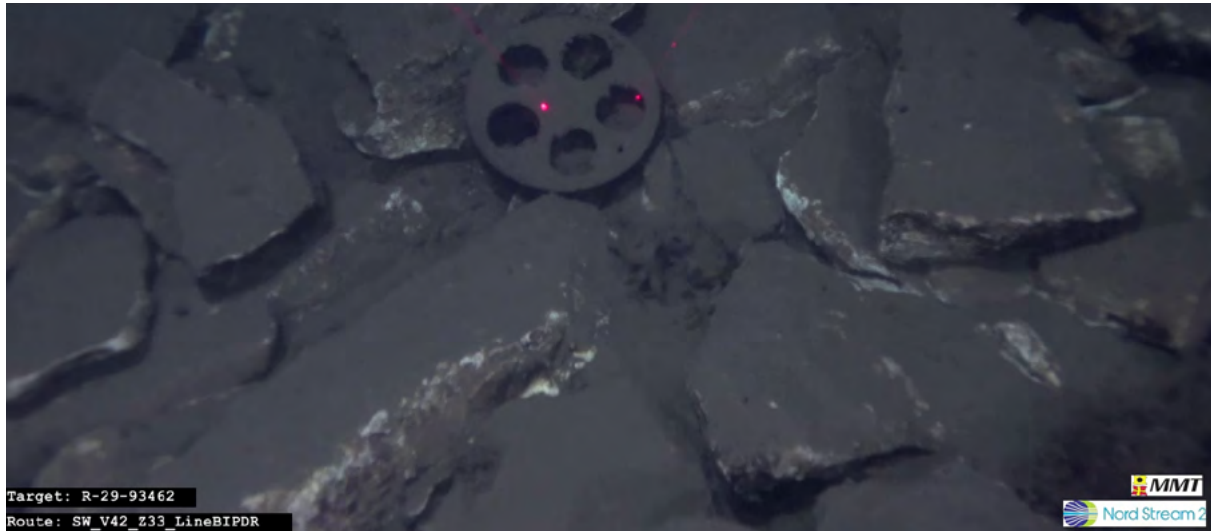
Figure 18. The cargo or ballast stones and an unknown small wheel.

This wreck has already been investigated for the Nord Stream project (wreck number S-29-93462). It is a clinker built ship with a cargo (ballast) of limestone and barrels with iron, possibly the so-called Osmund iron that was a common Swedish export commodity in medieval times until the 17th century (see Figure 18), /25/.

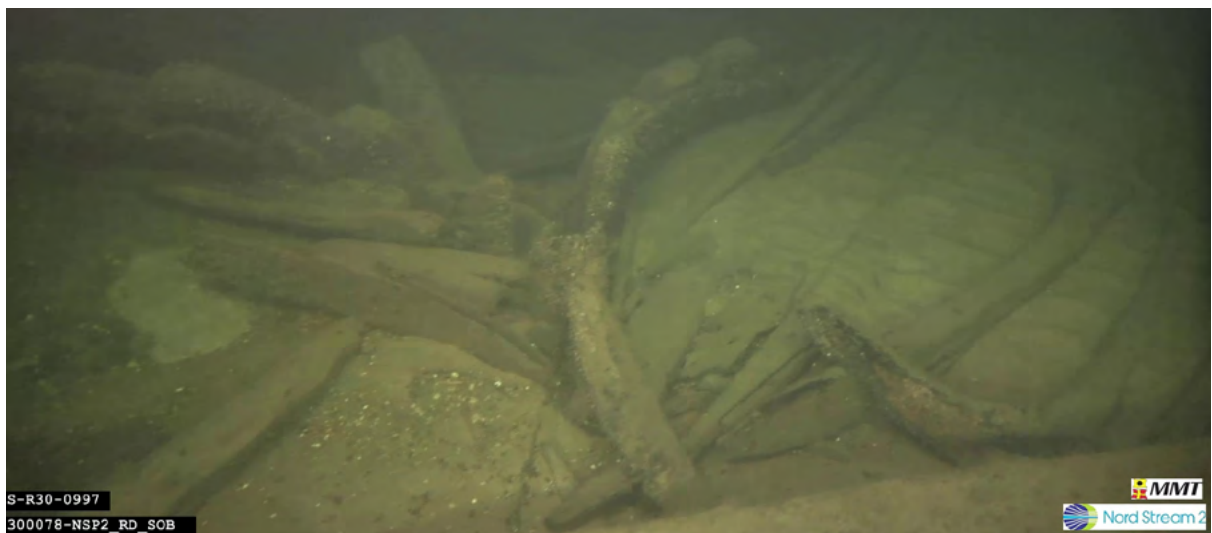
Figure 19. The rounded stern. The loose rudder is partly visible on the far lower right.

The object is a wooden wreck, 24 m long and 6 m wide. Based on earlier ROV images and bathymetry, the wreck was provisionally dated to the 18–19th century, and the size and hull shape has similarities with the fluit ship “Jutholmsvraket” from around 1700, or galiots from 18–19th century. Most of the interior of the wreck is filled with loose ship timbers, frames, planking and some blocks. Outside the wreck on the starboard side there is a gaff beam. Pictures of gaff-rigged sails appeared during the mid-17th century and became more common in the 18th century. The wreck is probably not older than late 17th century but is more likely to be from the 18th century /25/.

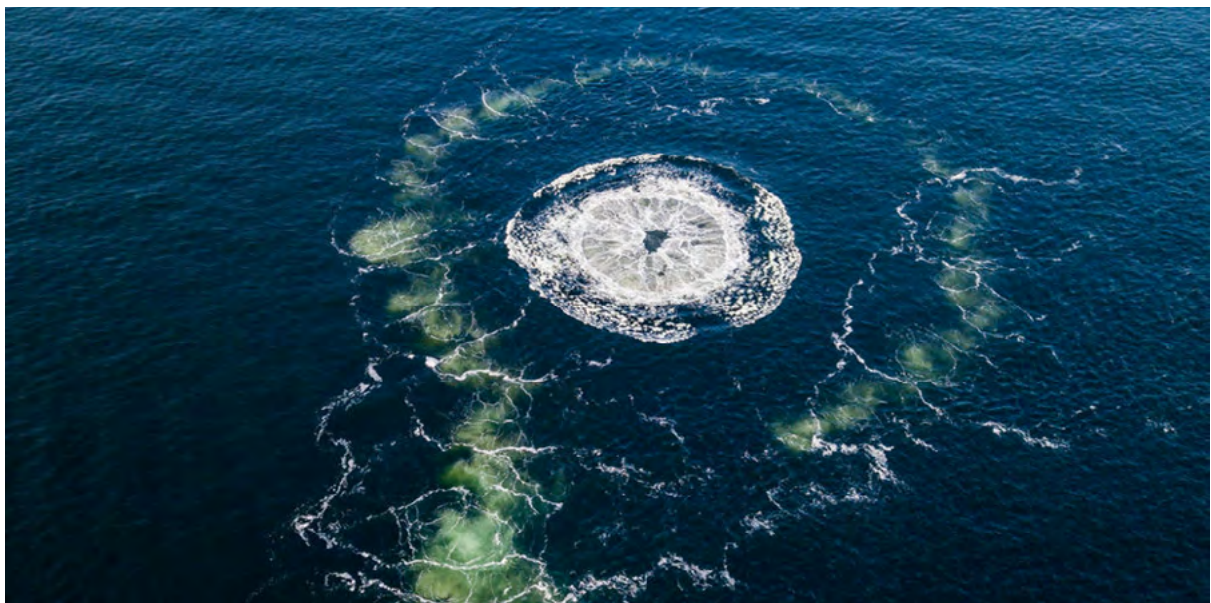
Figure 21. Big bubble curtain was applied to mitigate underwater noise of munitions clearance operations.

A combination of mitigation measures were established in order to ensure that no sensitive receptors were in proximity to the detonation site. For every cleared munition, acoustic deterrent devices, marine mammals observer, passive acoustic monitoring, fish finder and pressure wave sensor were in place, according to the permit application and the JNCC guidelines /26/. Additionally, in order to reduce or attenuate the acoustic noise from the detonation, bubble curtains were used for 58 munitions clearances (see Figure 21). Bubble curtains were used for larger detonations and in all cases in the eastern part of the Gulf of Finland, which is the habitat of the Baltic ringed seal.
