**Nord Stream 2 AG**

**W-PE-EMO-PSE-REP-805-M02018EN-06**

# **NORD STREAM 2 ENVIRONMENTAL AND SOCIAL MONITORING IN SWEDISH WATERS, 2018**

Revision **06.00**  
Date **2019-06-07**

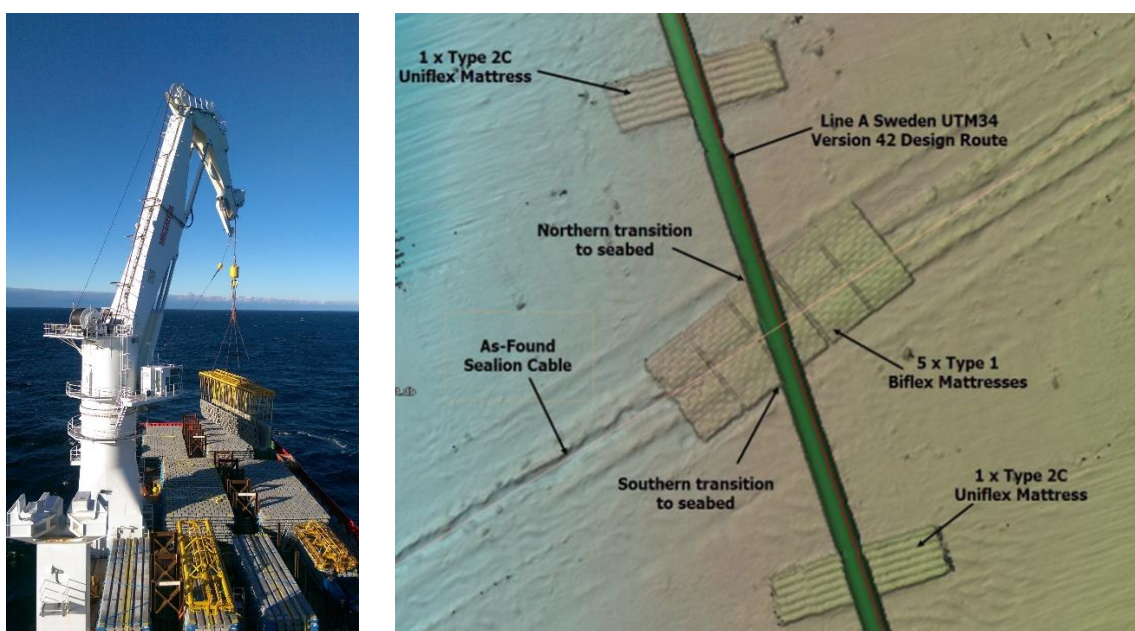
Figure 2 Mattresses being laid and as seen from above when lying on the seabed

The mattress installation activities for NSP2 was carried out by the company Allseas (the main pipelay contractor) and it utilised the vessel Oceanic to perform the work. The work took place at various times between 28 July and 20 October and the scope covered all cables and pipelines to be crossed, with the exception of the SwePol cables, for both pipelines. The mattresses over the SwePol cables are planned to be installed in the summer 2019. In Figure 2, the process of laying mattresses and how it looks on the seabed is shown.

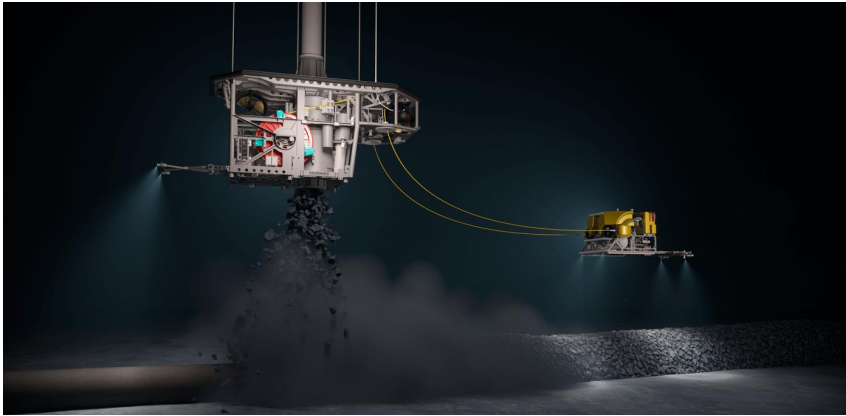
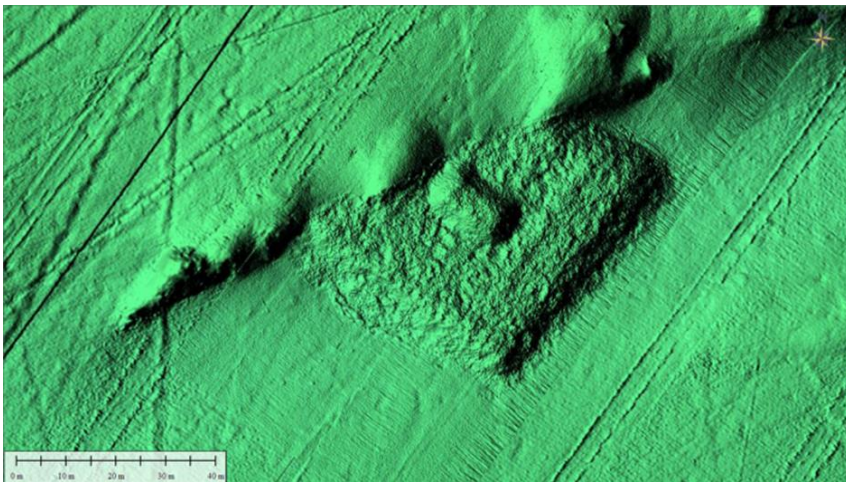
**Figure 3 Pre-lay rock placement, seen from above**

The contractor for the rock placement scope for NSP2 is the joint venture BoVo (the companies Boskalis and Van Oord). The vessels used for the Swedish pre-lay scope in 2018 were Bravenes and Nordnes. The rock placement activities were performed from 15 August (when Bravenes initiated its work) and onwards. The work scope also includes the rocks that are required for the crossings of the Nord Stream pipelines and the LVS1 telecom cable. The total amount of rocks placed within the Swedish sector in 2018 was around 110,000 tons, which equals approx. 75,000 m<sup>3</sup>. For most positions, the expected amounts of rock were placed, but a few berms needed additional loads in order for the technical specification criteria to be met. Figure 3 shows the rock placement process with a fallpipe and how a typical pre-lay rock berm looks on the seabed from above.

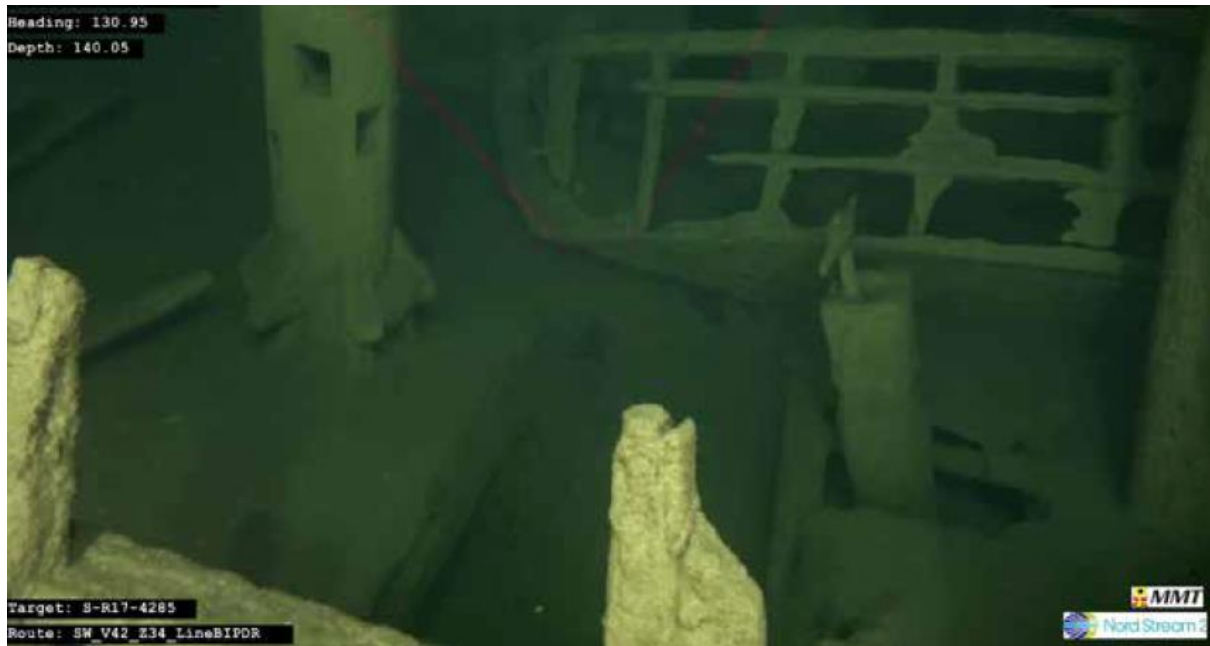
This is a wooden wreck that is 17 m long and 5 m wide. The construction, anchor, ships boat, capstan, details etc. indicates a 17th or an 18th century construction date. The wreck is carvel-built. It has two standing masts, a mainmast and a foremast in the bow. An anchor is hanging on the starboard side near the bow and one stands on the seafloor just off the bow. A "ship's boat"<sup>1</sup> lies on deck on the port side. The ships boat has a flat bottom and the sides are clinker built (Mikael Fredholm, 2019).

Figure 6 Photo from the starboard side. From the left: the capstan, the flat-bottomed ships boat, the bilge pump and to the right end the main mast

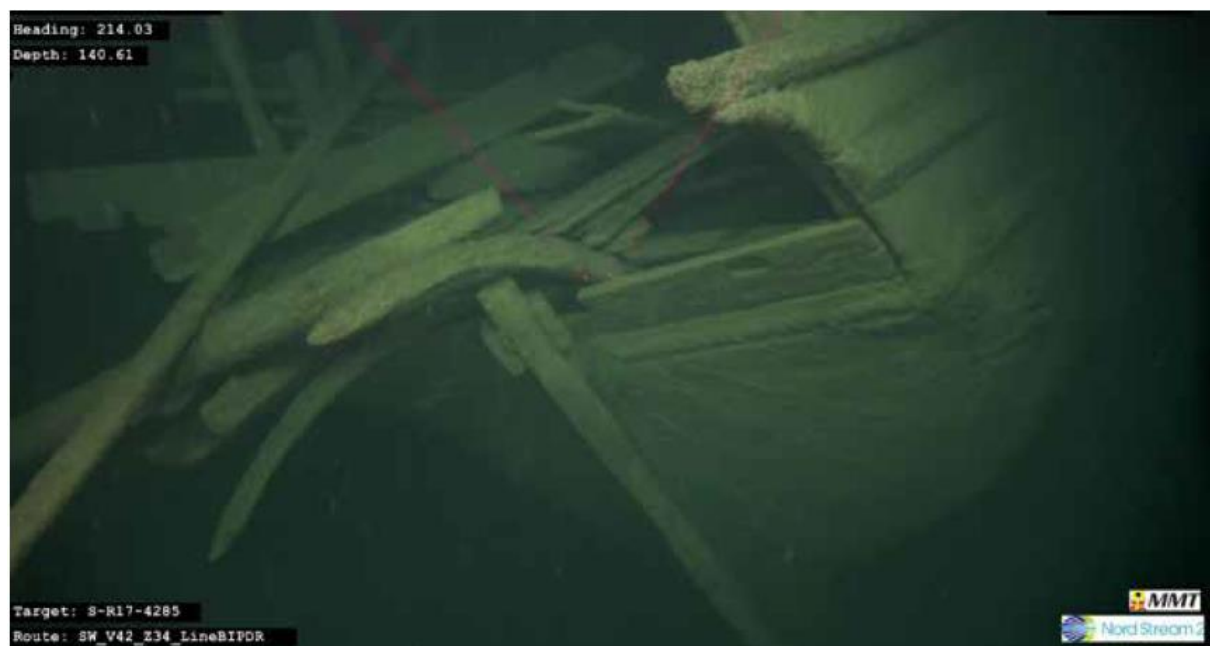
Figure 7 The stern

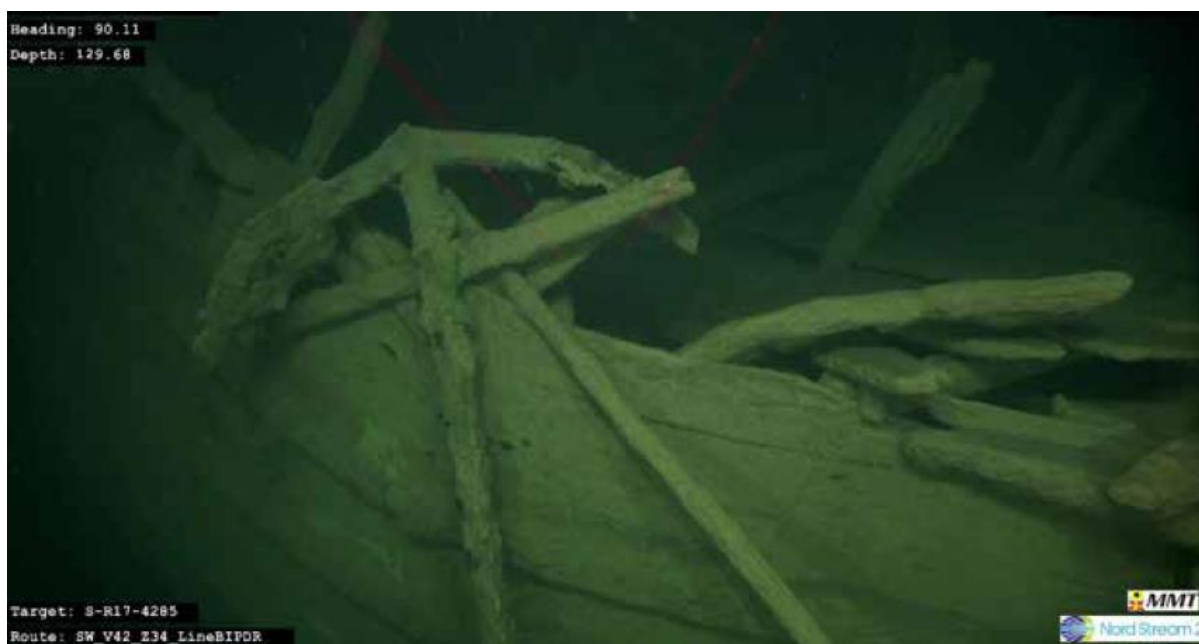
**Figure 8 The anchor on the starboard side**

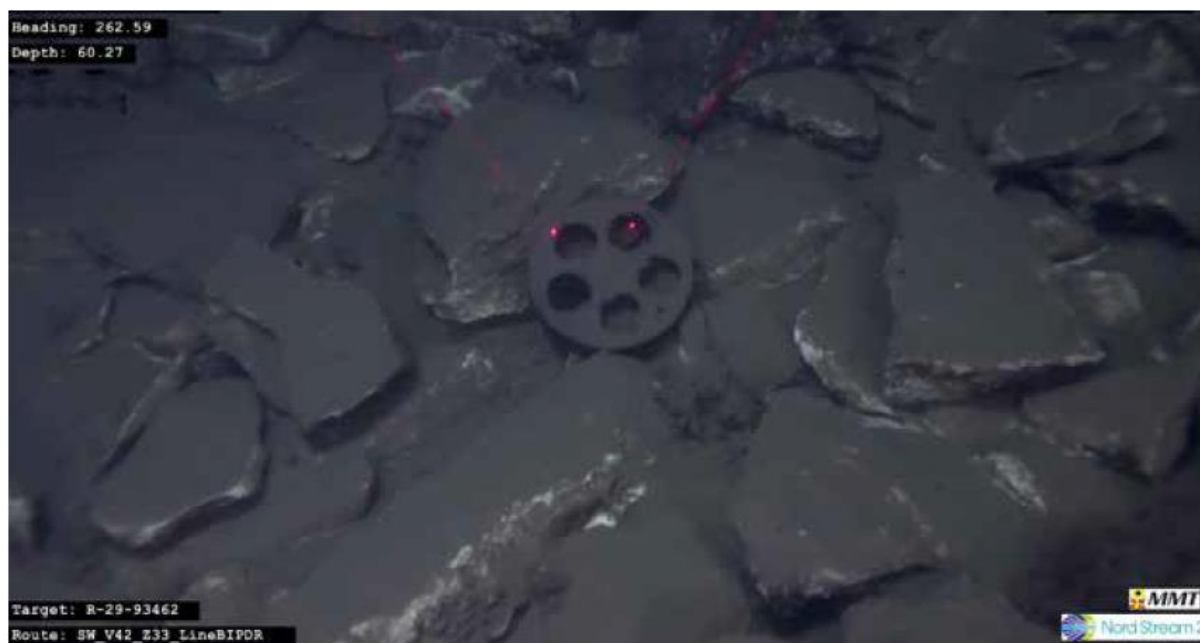
This wreck was already investigated for the Nord Stream project (then having the wreck number S-29-93462). It is a clinker built ship with a cargo (ballast) of lime stones and barrels with iron, possibly a so-called Osmund iron that was a common Swedish export commodity in medieval times until the 17<sup>th</sup> century.

The first inspection of the wreck took place in December 2009. During ROV-inspection in 2012, after the construction of Nord Stream, it was noticed that the sedimentation was different than in 2009, but the wreck itself was unchanged since 2009. The wreck as a whole does look unchanged between 2009 and 2019. An unknown circular object, a small wheel (with a diameter of approx. 20 cm) was filmed by ROV in 2019. This object was not noted during the first surveys in 2009. The wheel seems to be of a more modern type (probably made of metal) than the wreck itself. So, it might have been dropped on the site after 2009 (probably after 2012), or maybe sediments that have moved since 2009-2012, have made it visible (Mikael Fredholm, 2019).

**Figure 9** The cargo or ballast stones and an unknown small wheel

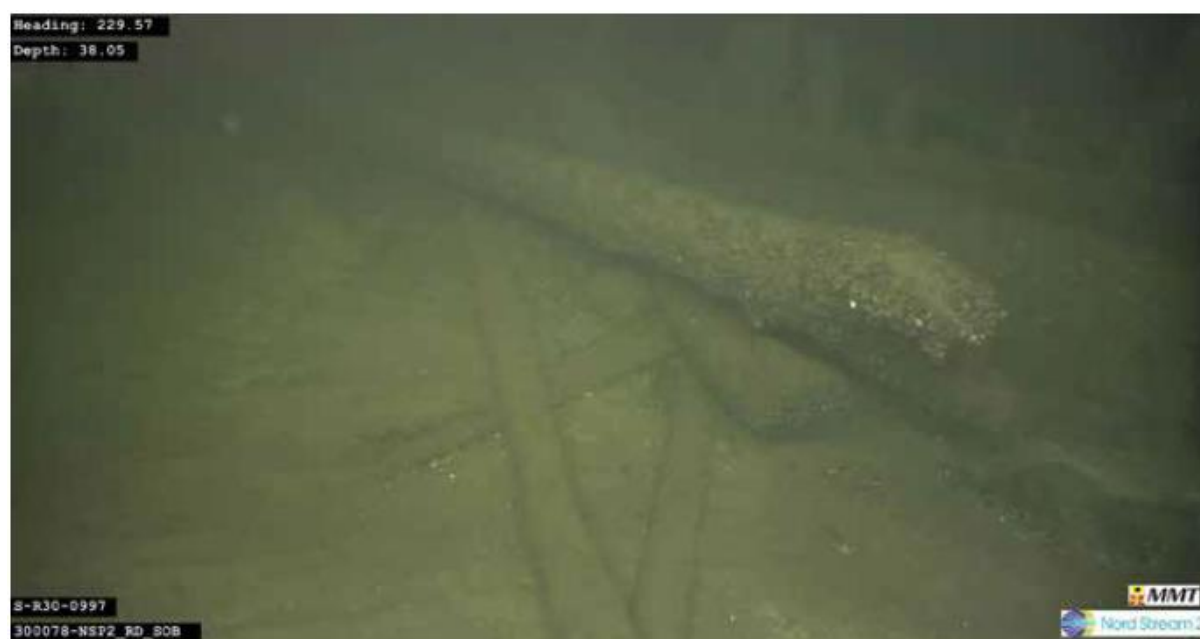
This is a wooden wreck, 24 m long and 6 m wide. Based on earlier ROV-pictures and bathymetry, the wreck was preliminary dated to the 18-19th century, and the size and hull shape has similarities with the fluit ship "Jutholmsvraket" from around 1700, or galiots from 18-19th century. Most of the interior of the wreck is full with loose ship timbers, frames, planking and some blocks. Outside the wreck on the starboard side there is a gaff beam. Pictures of gaff-rigged sails appeared during the mid-17th century and became more common in the 18th century. The wreck is probably not older than late 17th century but is more likely to be from the 18th century (Mikael Fredholm, 2019).

**Figure 10** Gaff beam

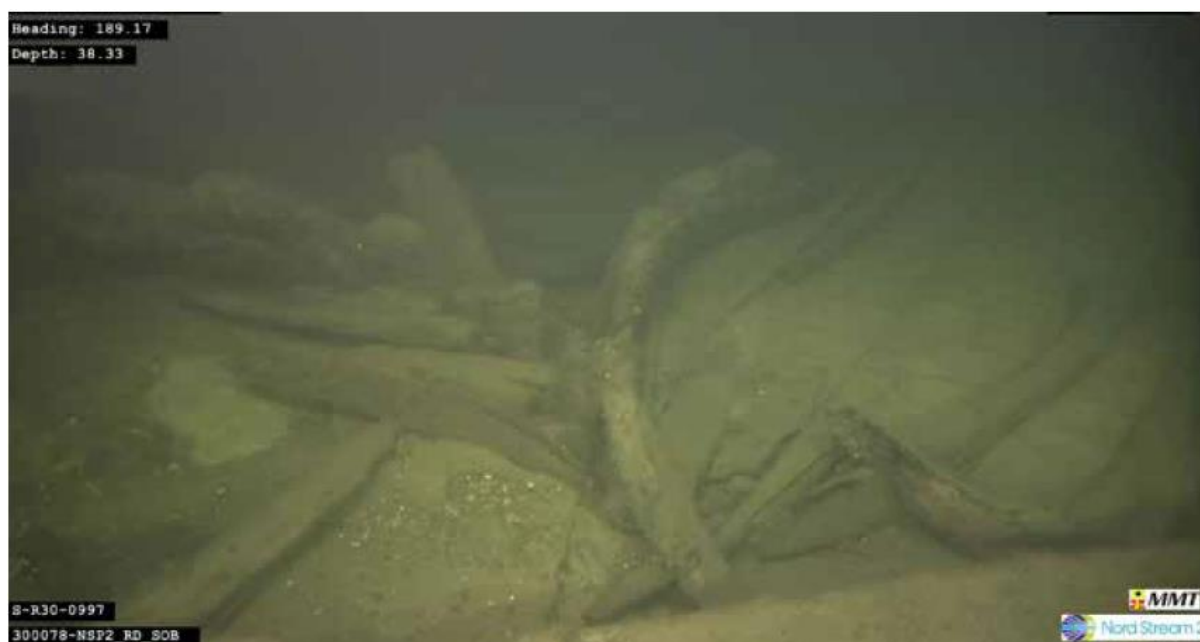
Figure 11 The rounded stern. The loose rudder is partly visible on the far lower right

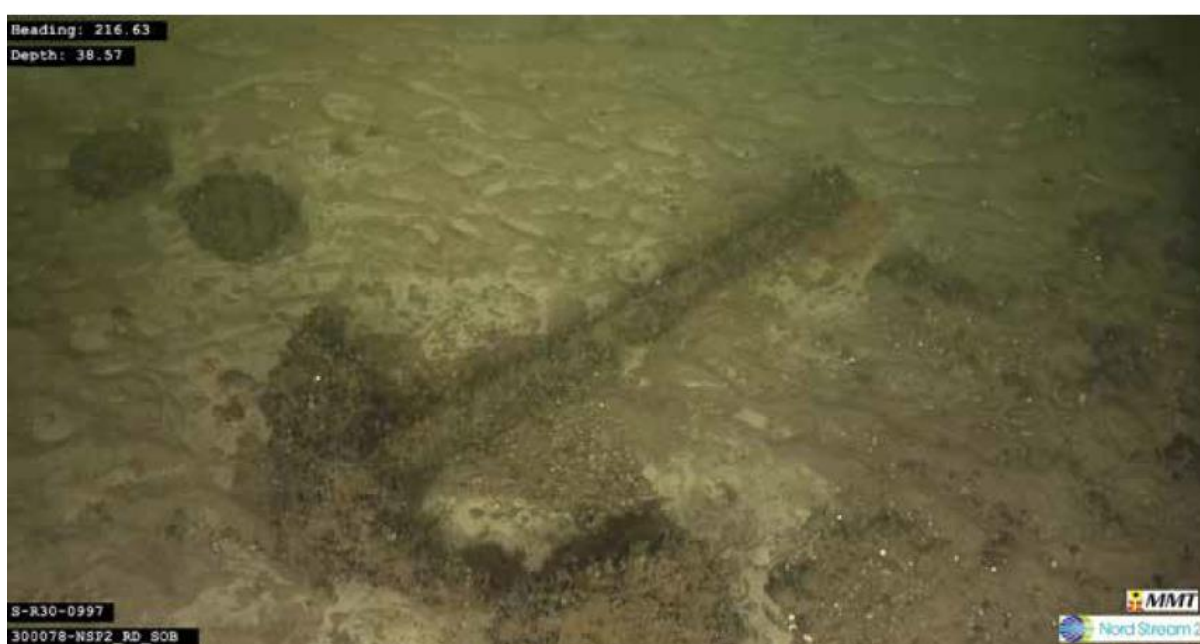
Figure 12 Anchor
