Overall Environmental Monitoring Report 2020

The Overall Environmental Monitoring Report 2020 presents the results of environmental monitoring related to construction of the Nord Stream 2 Pipeline in 2020. Nord Stream 2 environmental monitoring is based on the five national environmental monitoring programmes for Russia, Finland, Sweden, Denmark and Germany, which have been approved by the competent authorities. The monitoring work is designed to verify, as assessed, that there is no significant impact on the environment of the Baltic Sea from project implementation and to fulfil the requirements and commitments under the respective jurisdictions of the five countries in which the Nord Stream 2 Pipeline is built.

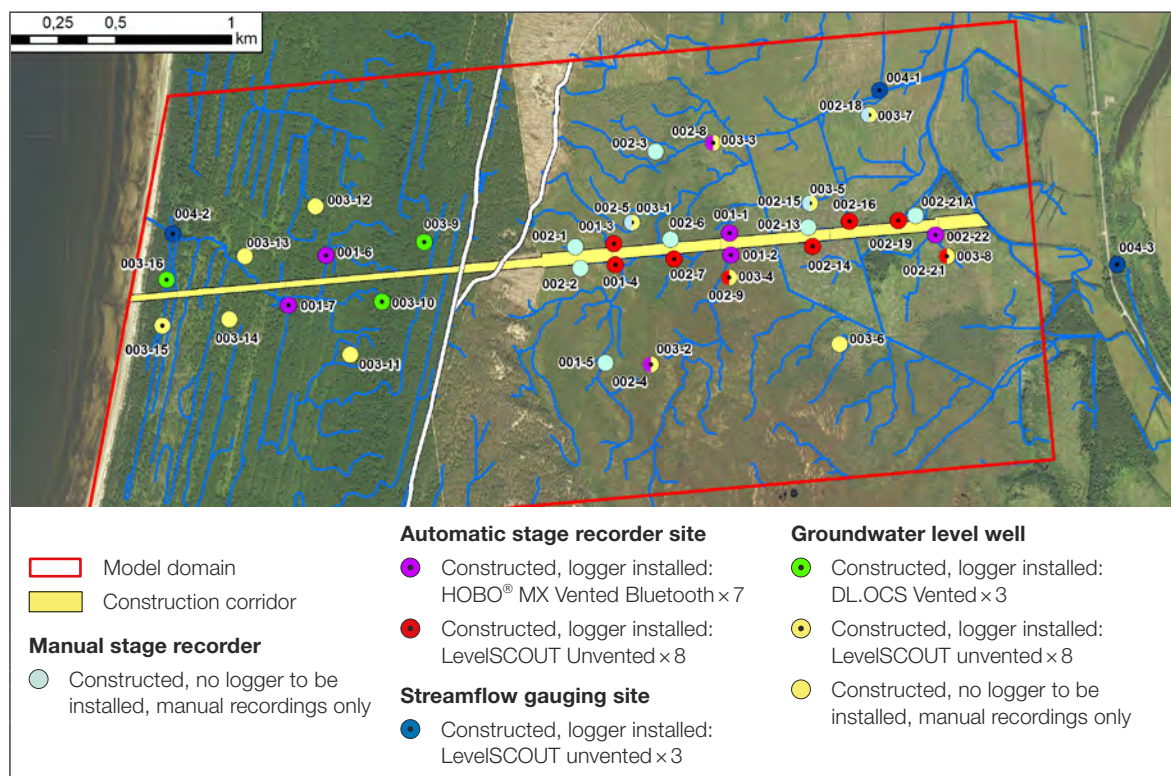
Furthermore, the presence of the pipeline, in particular when positioned perpendicular to the grid of water runoff lines (see Figure 5 and Figure 6), may cause changes in the flow characteristics of the micro-landscapes.

Figure 5. Location of the monitoring sites with respect to water runoff lines.

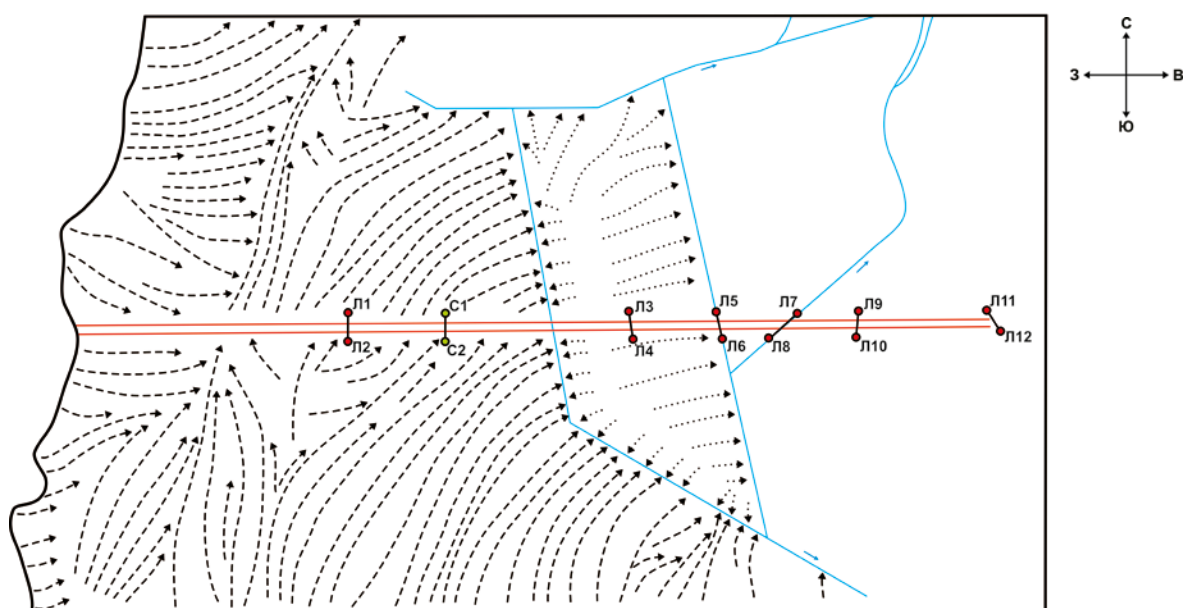
Figure 6. Grid of swamp water runoff lines and location of control cross-sections for monitoring the swamp water level.

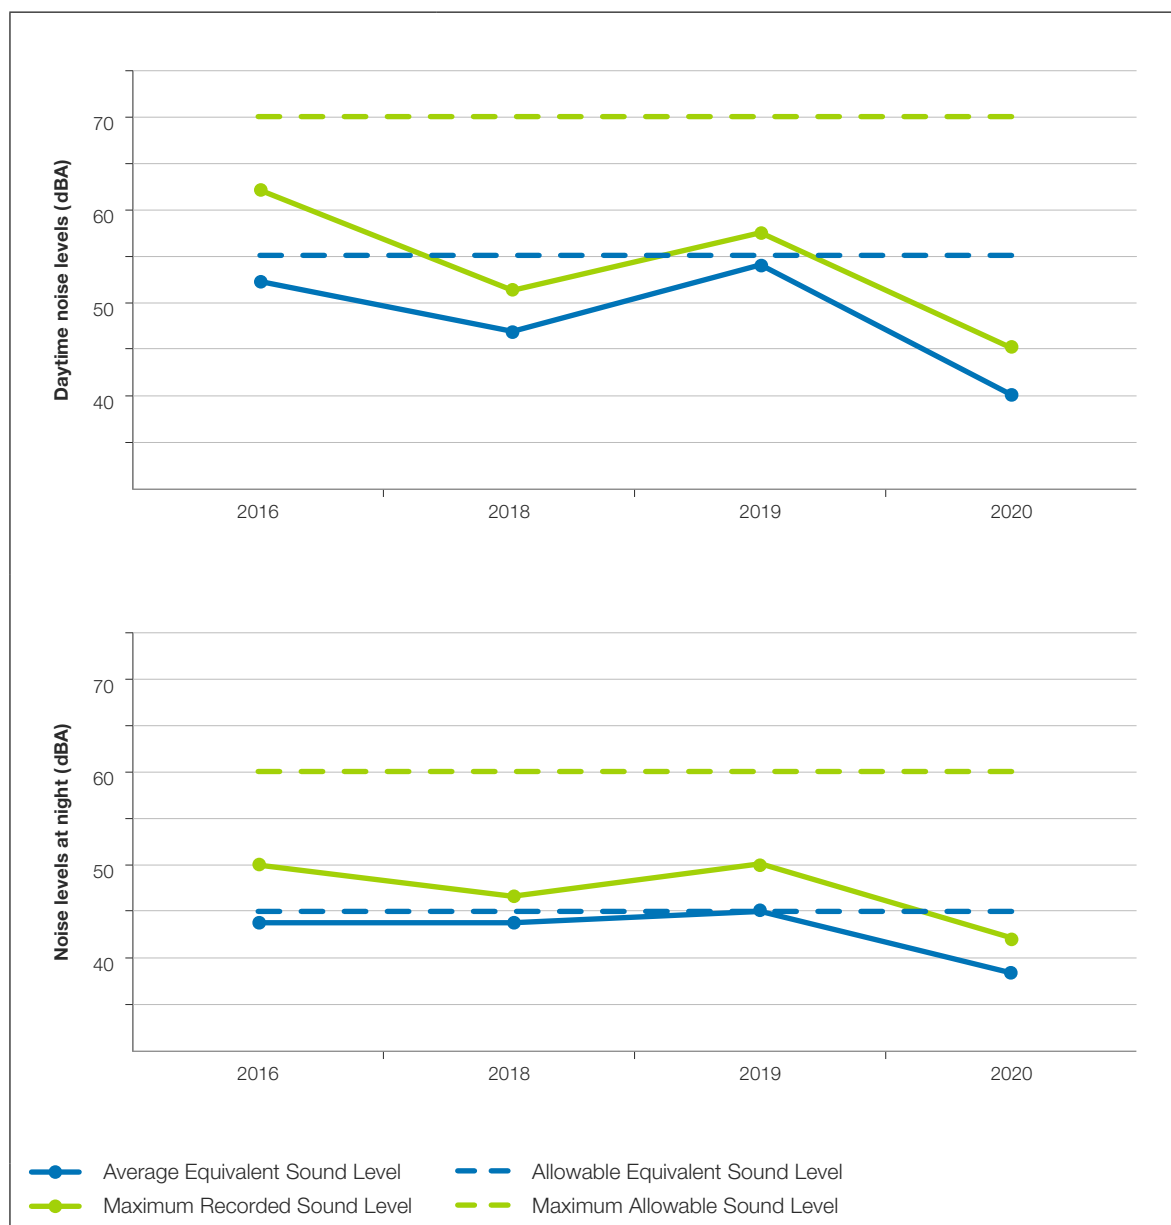
Compared to 2019, the noise level, both during the daytime and at night, has significantly decreased. The equivalent and maximum sound levels, both day and night, did not exceed the permissible sound levels for the residential area during the entire observation period.

Figure 17. Interannual variation of average and maximum recorded sound levels during day and night at the monitoring location (Khanike village boundary). Acceptable levels according to SN 2.2.4/2.1.8.562-96, applicable in 2020.

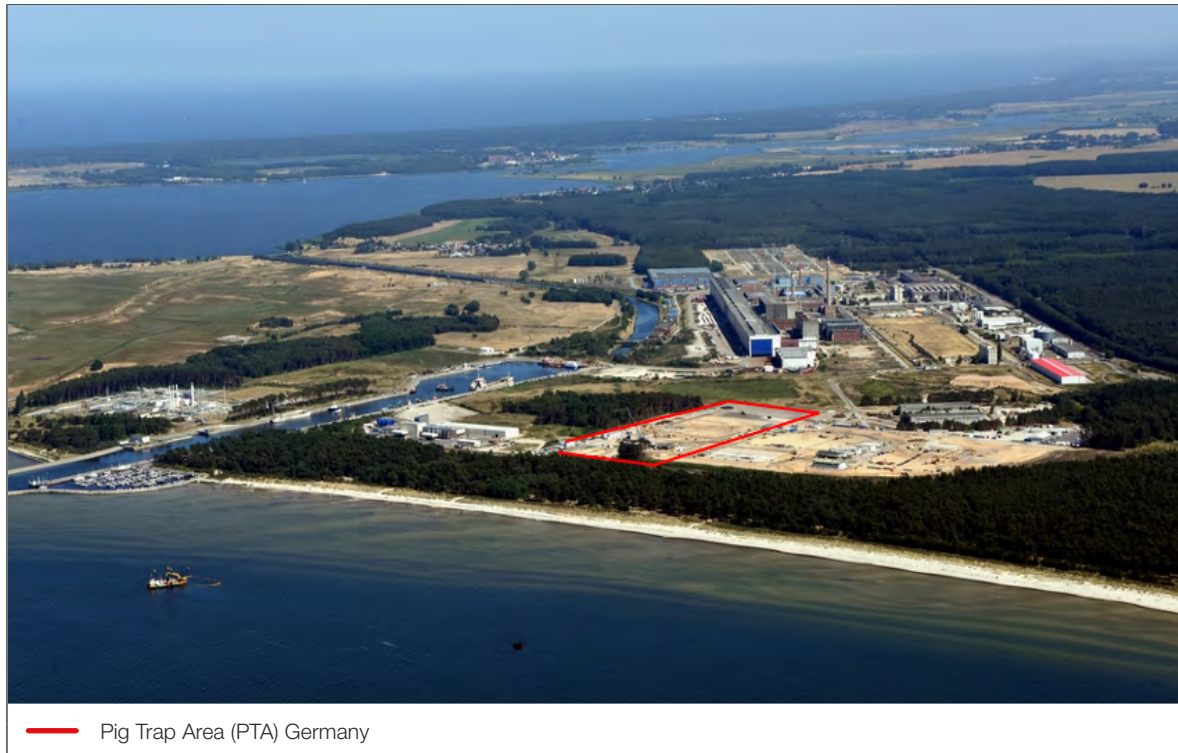
Figure 18. Pig Trap Area (PTA) Germany (red box) in the industrial park south of Lubmin industrial harbour in July 2018. The vessel in the foreground shows the location of the offshore exit pit of the shore crossing microtunnel.

Since the German landfall and the PTA are entirely located inside a designated industrial park (see Figure 18), monitoring requirements for onshore construction in Germany are characterised as low complexity compared with the requirements for the Russian landfall.

Onshore monitoring in Germany concluded in 2019. No onshore construction was conducted at the German landfall in 2020, with only minor reinstatement and finalisation works taking place. Since no civil works took place, no environmental monitoring was required in 2020 according to the German permit obligations. The temporary construction site outside of the plant area (the former tunnel pits) was reinstated during the second half of the year (see Figure 18 and Figure 19).

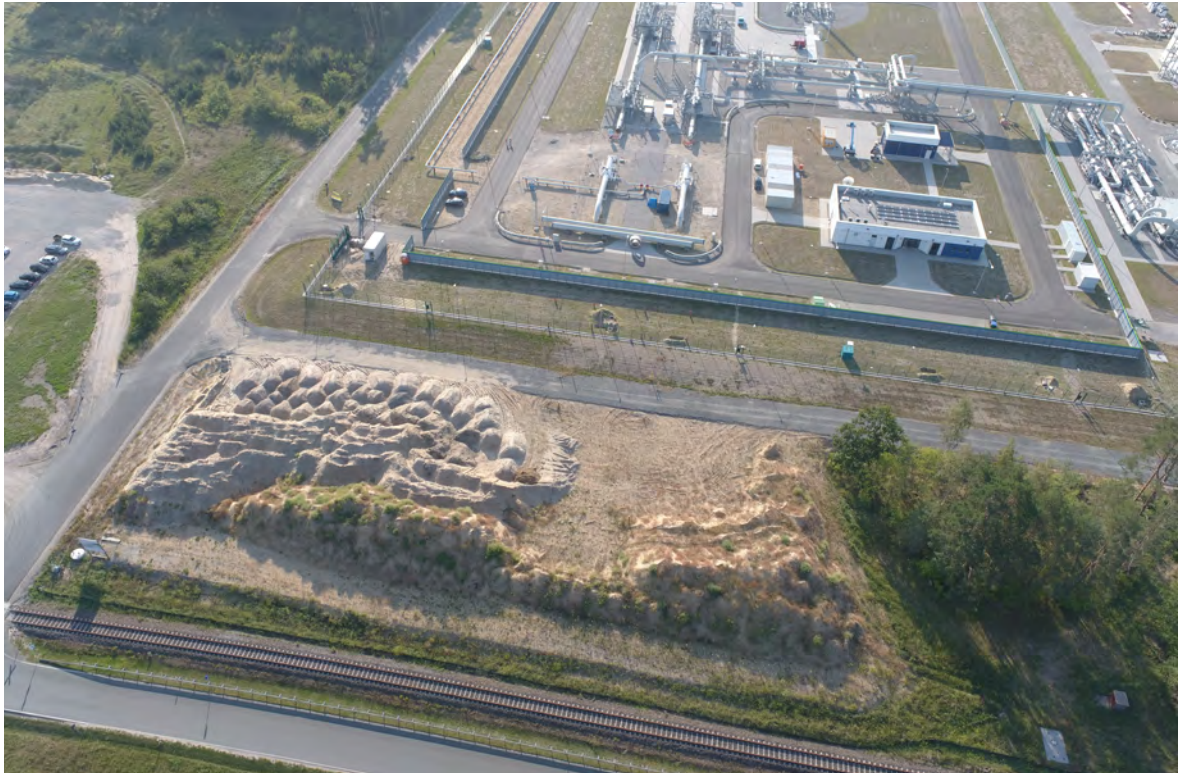
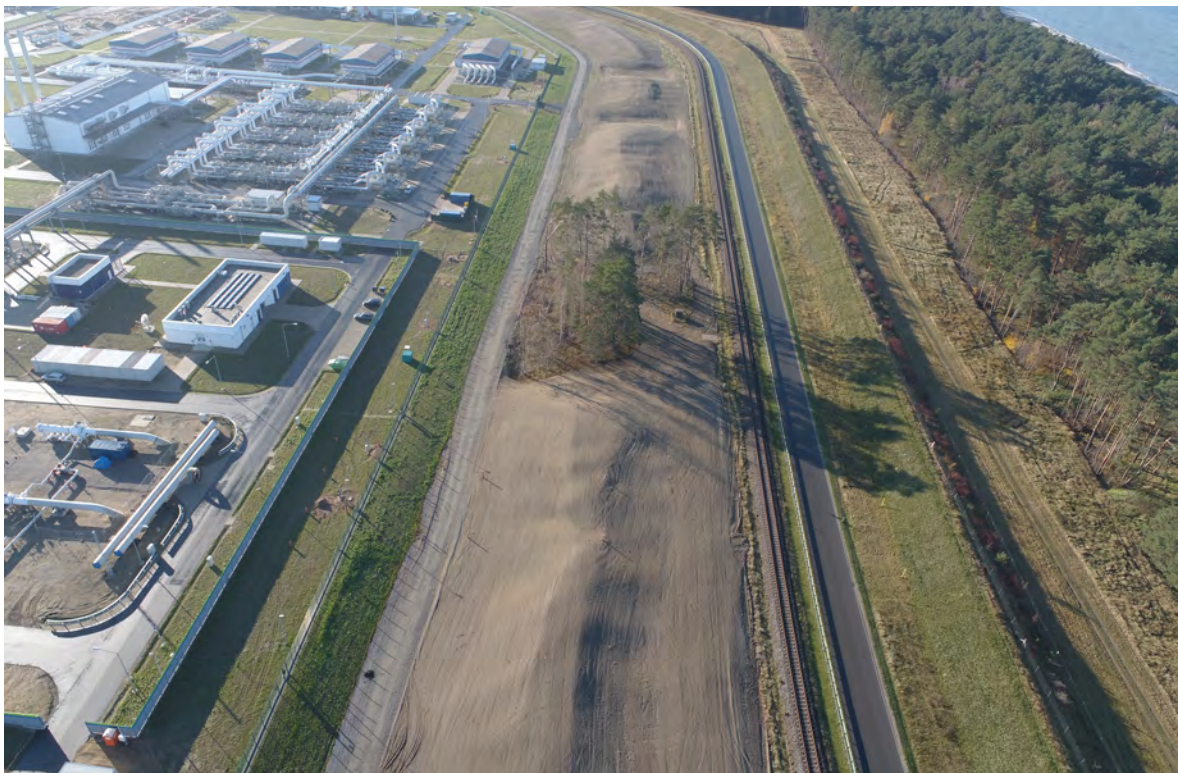
Figure 19. Transformation of a temporary construction sites (the former tunnel pit) beside the Pig Trap Area (PTA) Germany in the industrial park south of Lubmin industrial harbour into a semi-natural grey dune habitat in autumn 2020 (September above, December below).

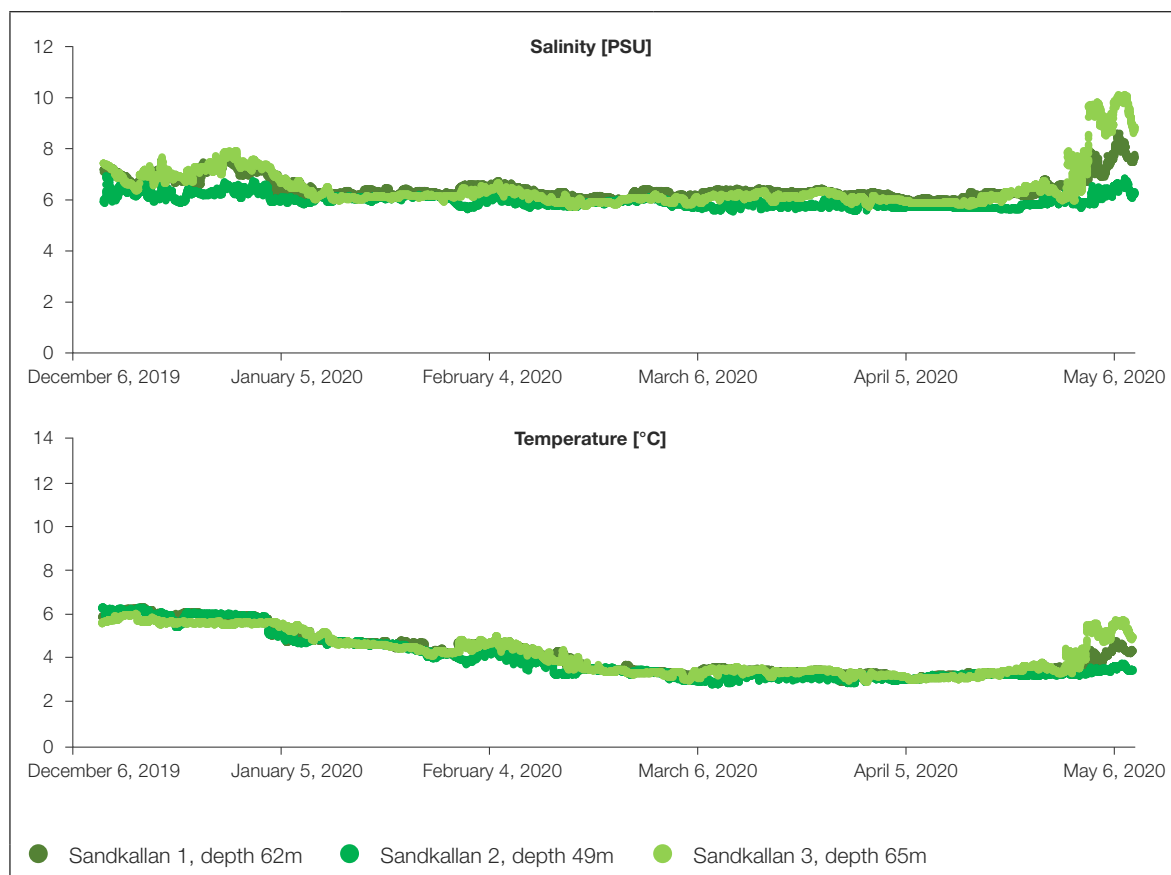
In 2020, practically no halocline was observed in winter or spring. Weak or missing halocline allows the transport of oxygen from the surface water to the near bottom waters. In the end of the monitoring period, the salinity in the deepest station, Sandkallan 3, reached the level of 10PSU again, indicating the re-establishment of the halocline (see Figure 21).

Figure 21. Temperature and salinity in 2020 measured 2 metres above the seabed in the long-term monitoring stations Sandkallan 1, 2, and 3.

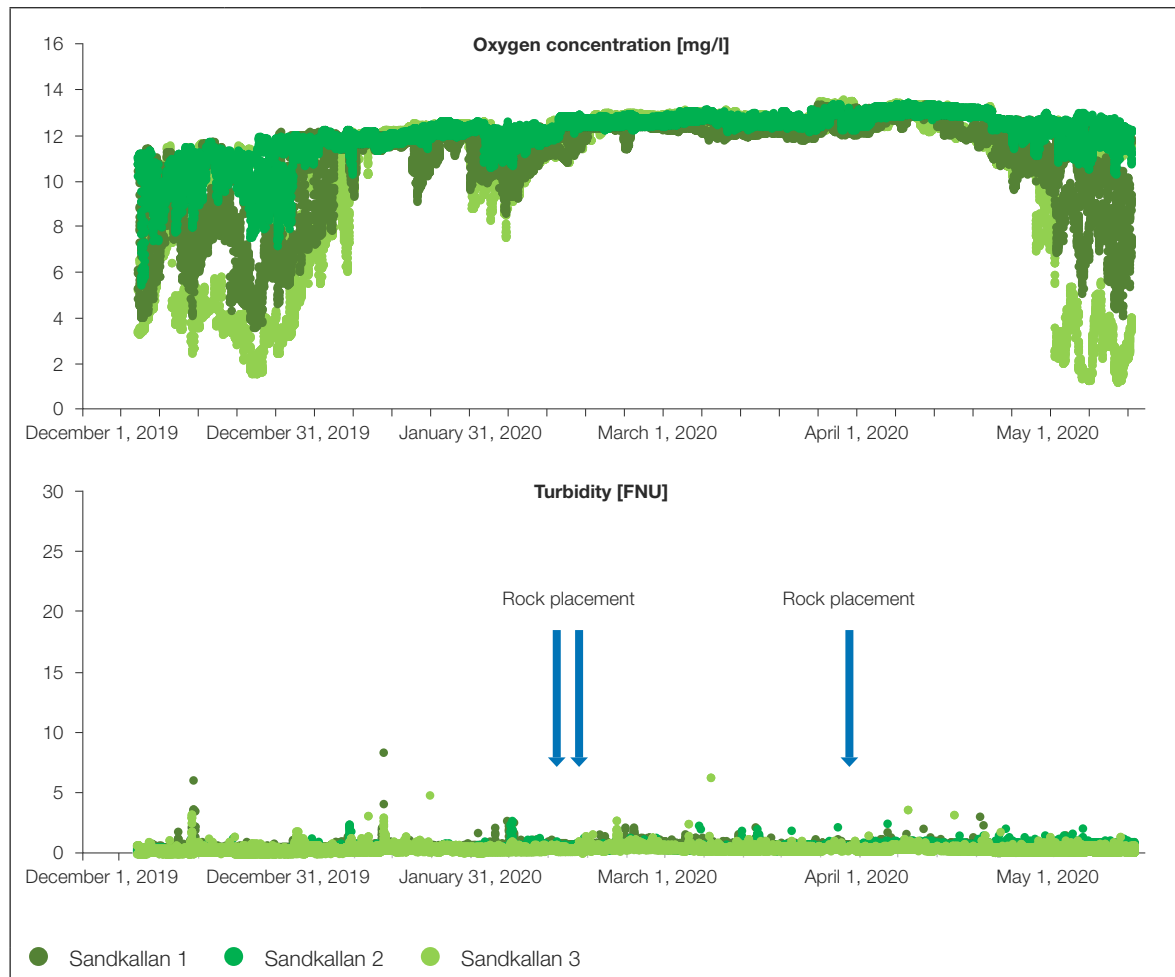
No impacts from construction activities were detected in water quality during the monitoring period (see Figure 22). The highest measured single turbidity value was 8 FNU, which is within the natural turbidity variation in the area. The average turbidity was below 1 FNU. Oxygen conditions were good at all three stations. No anoxic periods were measured. Weak or missing salinity stratification and stormy periods during ice-free winter improved the mixing of the water layers, leading to an increase in oxygen concentration in the deeper water layers.

Figure 22. Oxygen concentration and turbidity at the monitoring stations Sandkallan 1, 2 and 3. The images are combinations of all measurements carried out at the monitoring stations. They represent the depth range of 2–15 metres above the seabed. Rock berm construction within the radius of 10km of the stations is indicated by arrows.

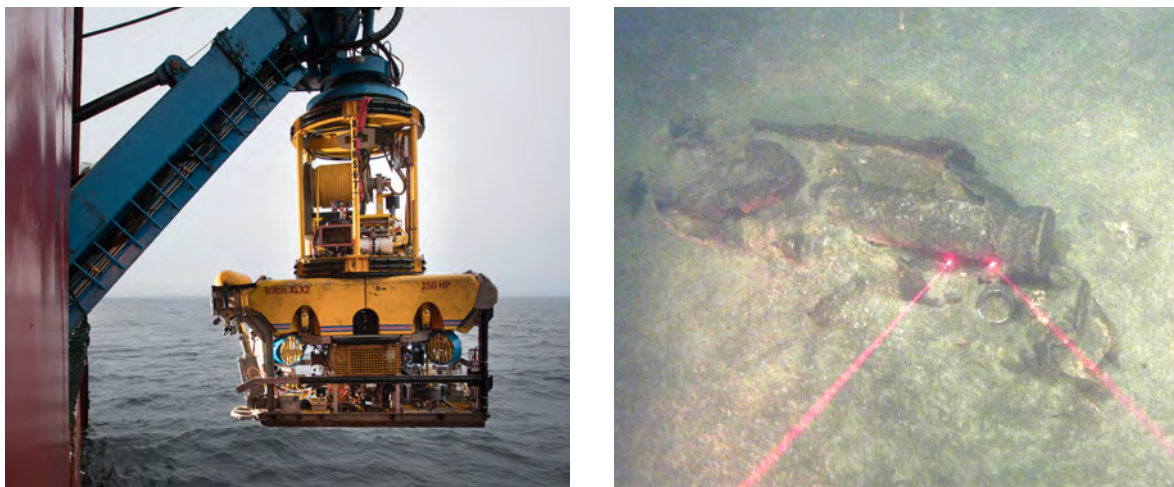
Figure 25. Left: Deployment of an ROV for inspection of a munition objects. Right: Example of munition object, showing a chemical mustard gas bomb with heavily corroded casing (re-routed around during the design phase).

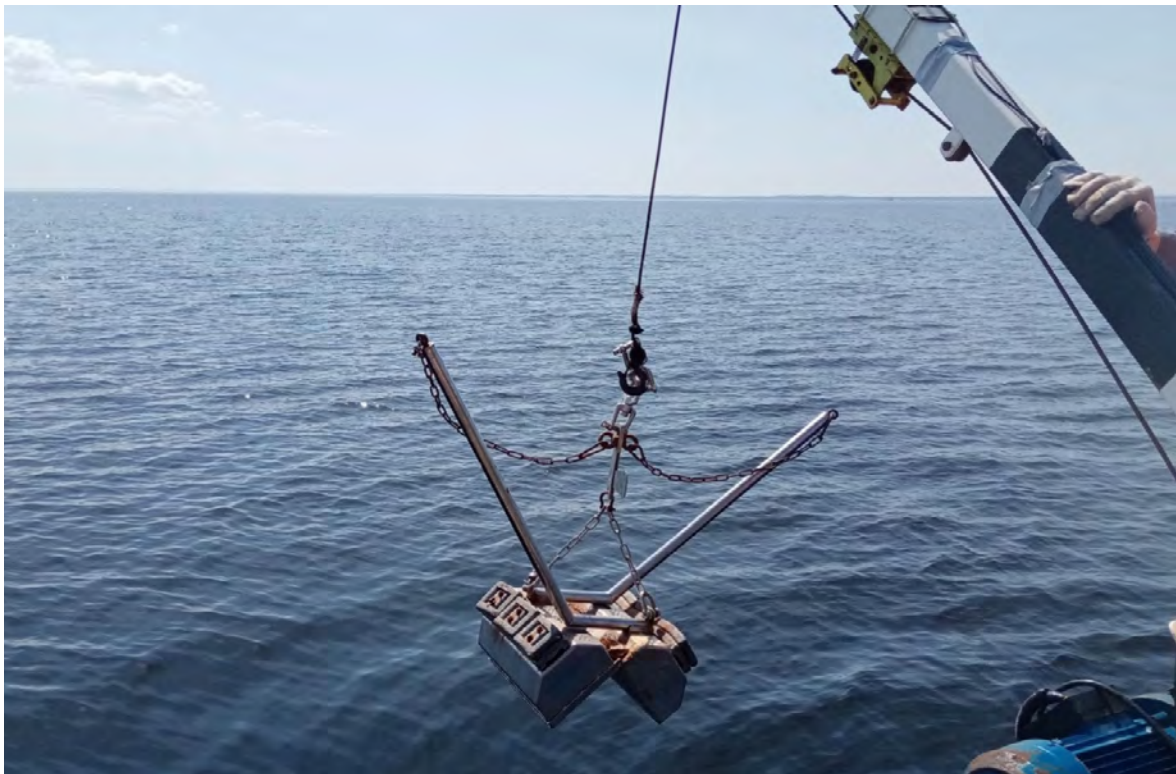
Figure 30. Bottom sediments sampling using Van Veen grab.

Bottom sediment sampling was performed at 12 stations along the pipeline route (same as water quality monitoring) using a Van Veen grab with a grab area of 0,025sq.m or 0,1sq.m (see Figure 30).

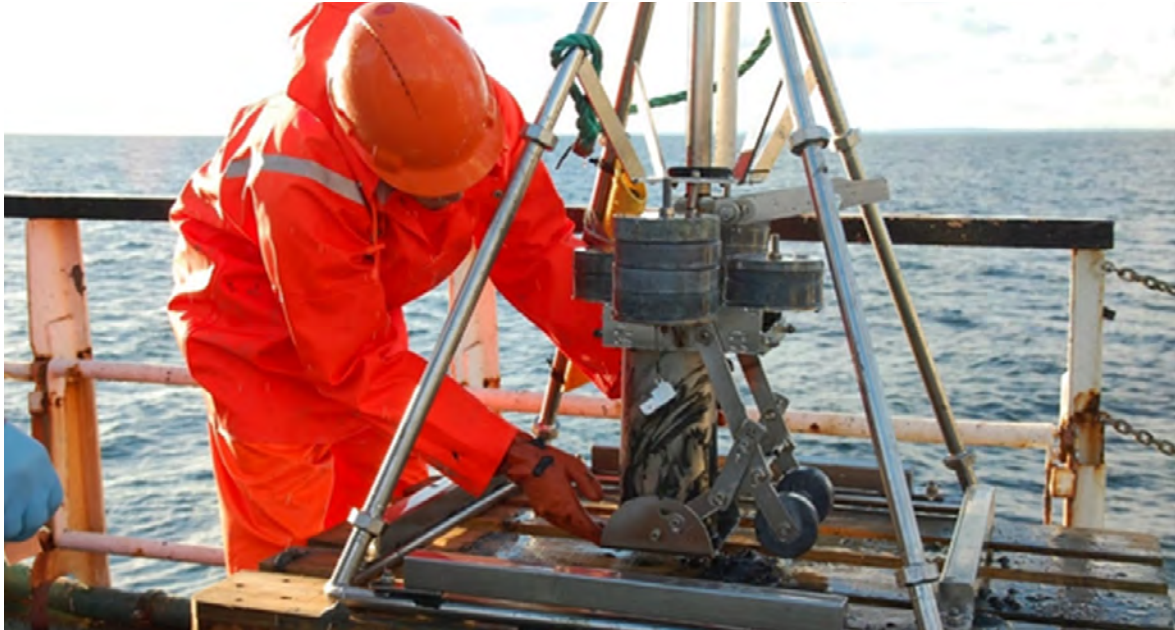
Figure 38. Sampling of seabed sediments using HAPS core sampler.

Seabed sediment samples were taken at 26 stations, CWA-01 to CWA-26. Each sampling position was inspected with an ROV before the HAPS core sediment sampler was lowered on the seabed to ensure that the area was clear of any hazardous objects, i.e. debris or munitions. A HAPS core sampler was used to collect seabed sediment samples and a ROV equipped with video and a CTDO system were used at each monitoring station, see Figure 38. On deck, the sediment samples were photographed and described. All samples have been analysed by the Finnish laboratory VERIFIN specializing on the CWA detection.

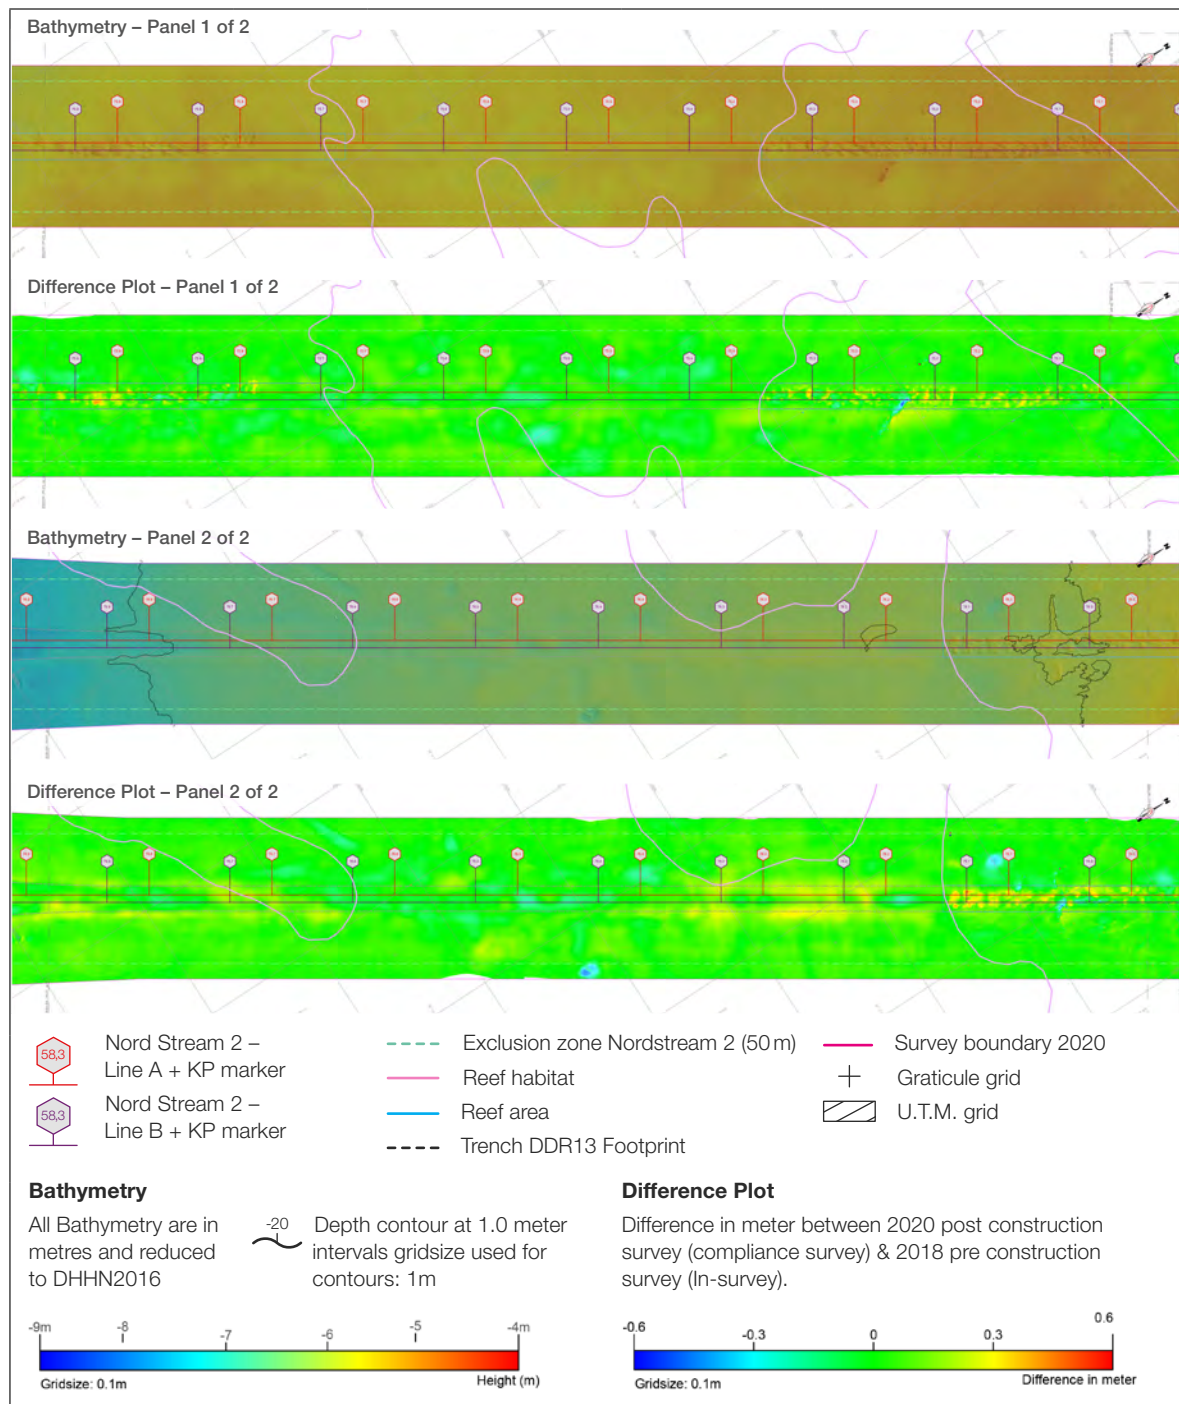
Figure 40. Example of an alignment chart for the visualisation of soft sediment and reef re-instatement 2 years after dredging, pipelay and backfilling in the Greifswald Lagoon. Reefs are still in place on the seabed as installed. Backfilled sand sections almost completely levelled out with surrounding untouched seabed bathymetry.

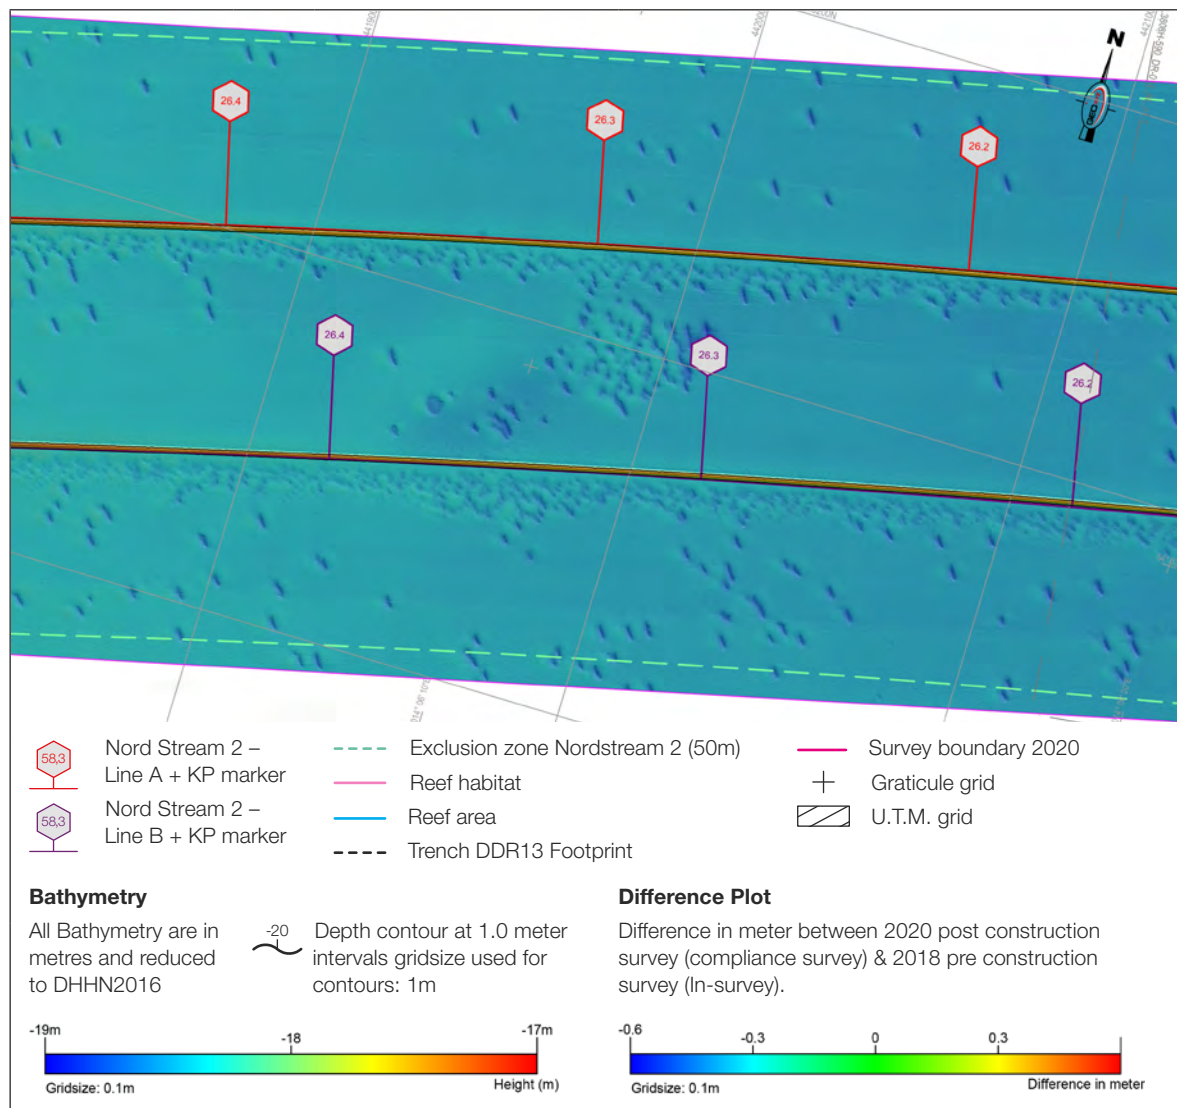
Figure 41. Example of pockmarks on the seabed in the Pomeranian Bay in autumn 2020.

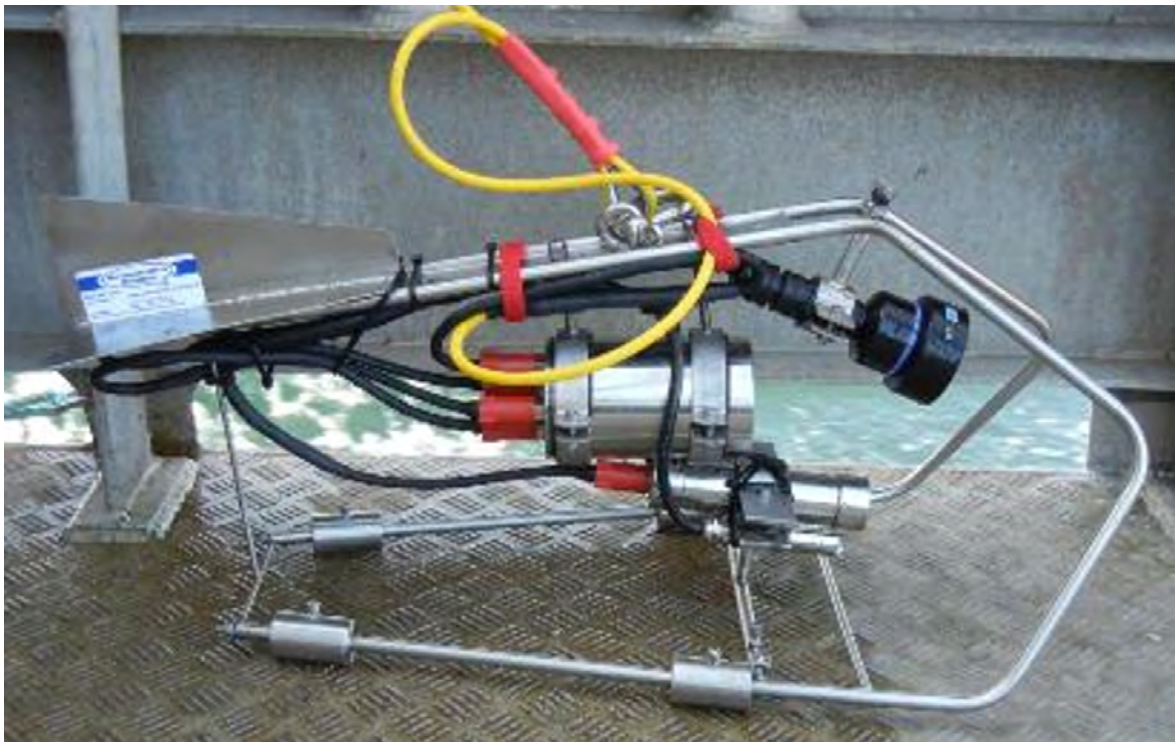
Figure 44. Towed underwater video camera system and drop camera for still images.

- > underwater video and still image surveys by means of a towed underwater video camera system and a drop camera for still images (see Figure 44);
- > sampling of epibenthic organisms attached to hard substrate (stones) by SCUBA divers.

The following parameters are quantified from underwater video and still images: stone cover, algae and hydrozoan cover, blue mussel *Mytilus* spec. cover and mussel length. Samples collected by divers are preserved with 4% borax-buffered formaldehyde and transferred into the laboratory for treatment using a stereomicroscope. Lab analysis includes species identification, counting of specimen per species and fresh weight measurements. In addition, shell length of bivalves will be measured. Finally, the data on reef epifauna obtained will be subject to a number of statistical analyses.

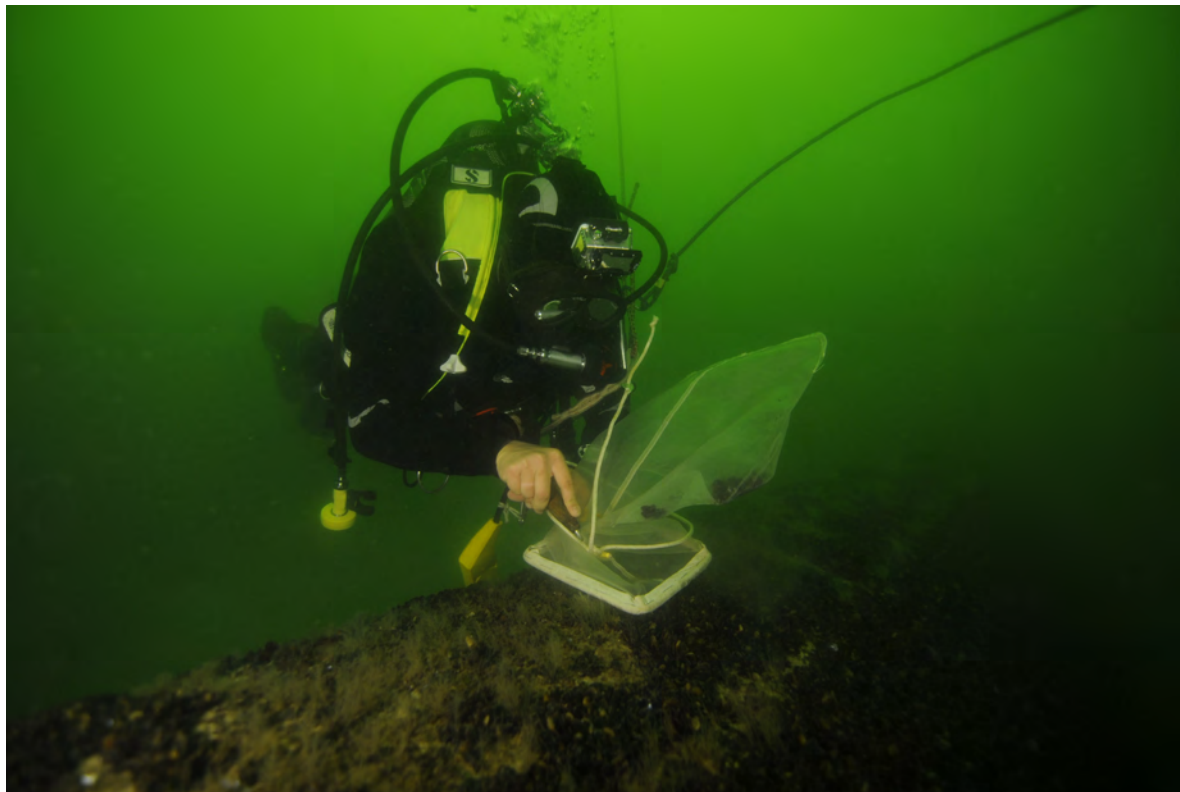
Figure 45. Scratch sampling by a SCUBA diver on the pipeline at 18.5 metres water depth.

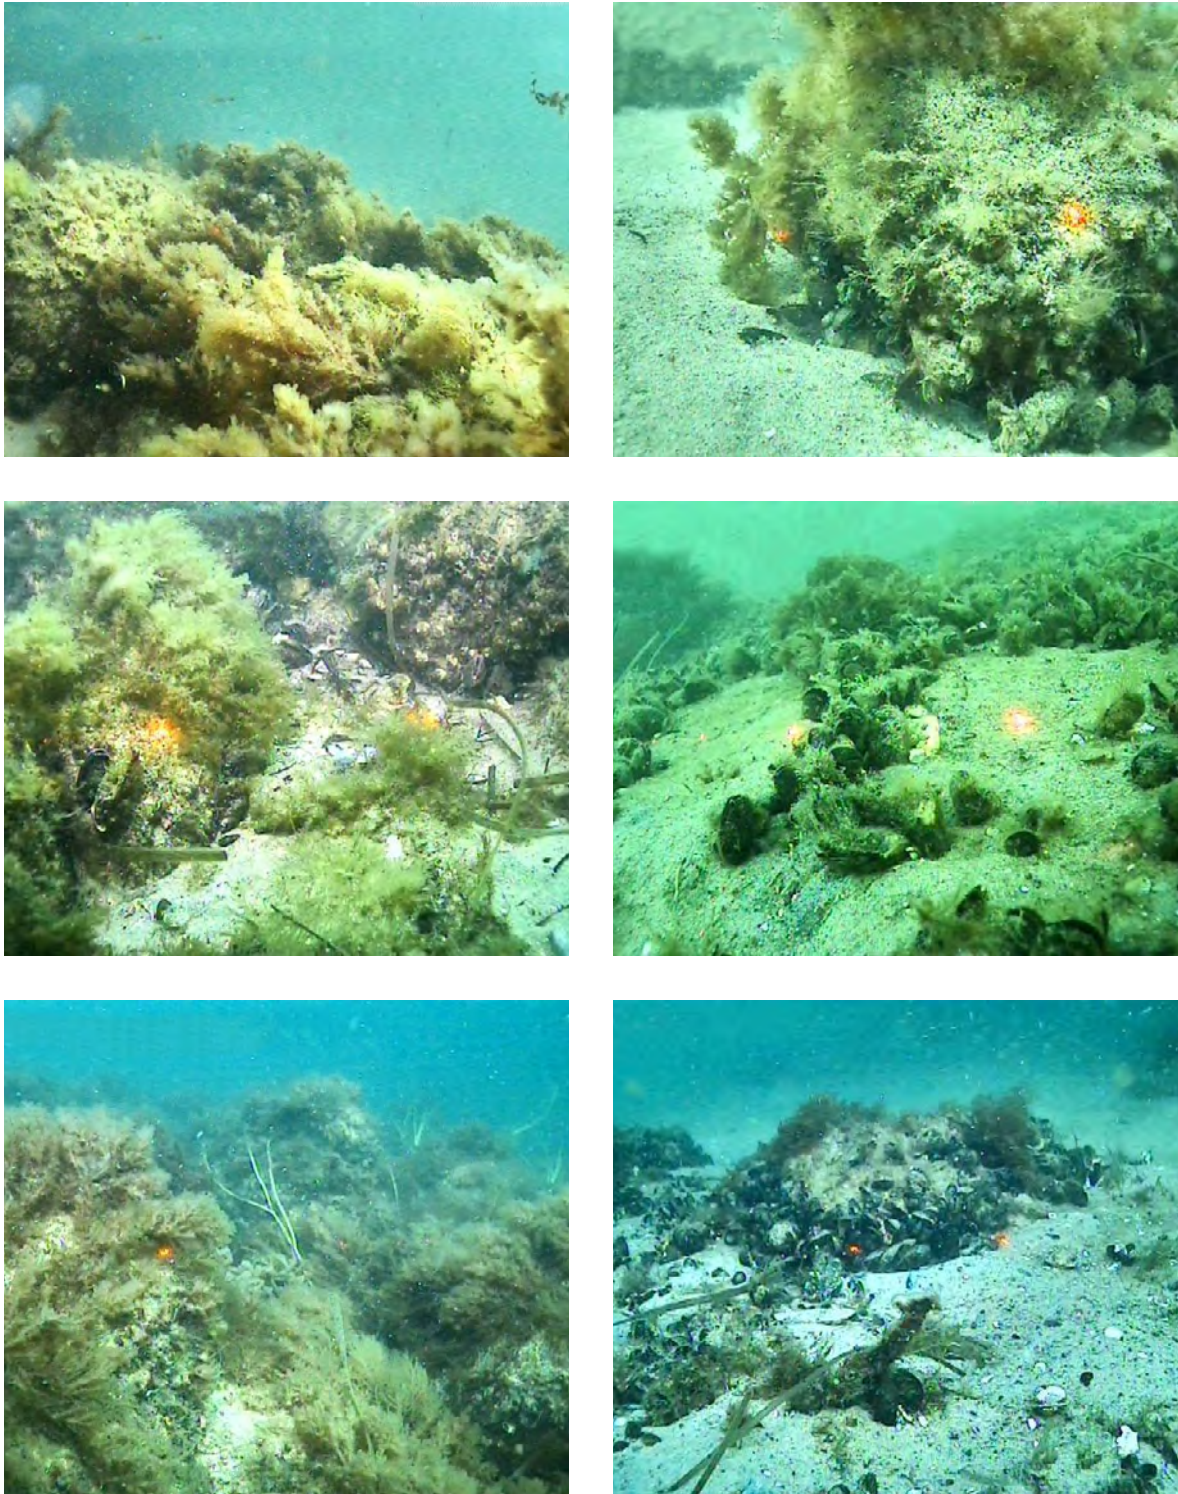
Figure 46. Still images of reinstated reefs (left) and untouched reference reefs (right) at the Boddenrandschwelle taken 1.5 years after pipeline construction. The remaining difference between sites is a lower biomass of large-sized Blue mussels (*Mytilus spec.*) at reinstatement sites.

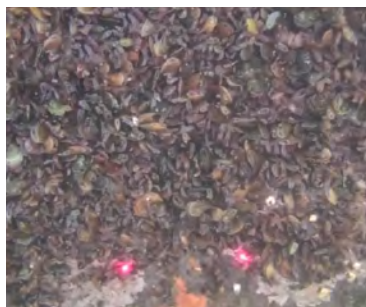
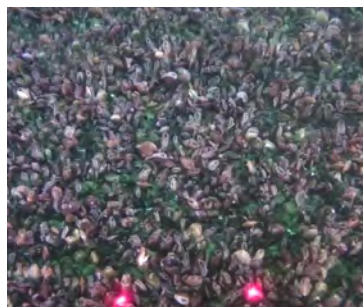
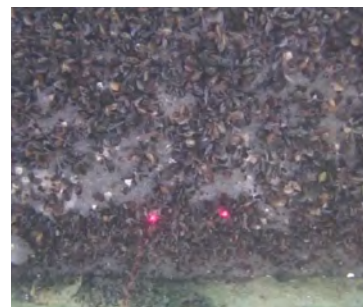
Figure 47. Still images of biofouling on NSP2 pipelines taken in August 2020, 1.5 years after pipeline installation.

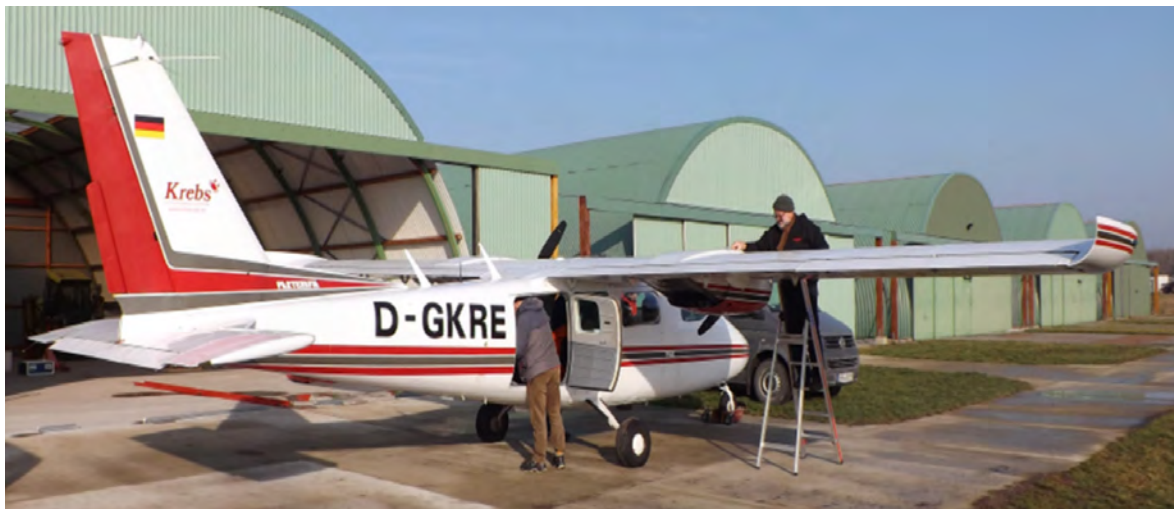
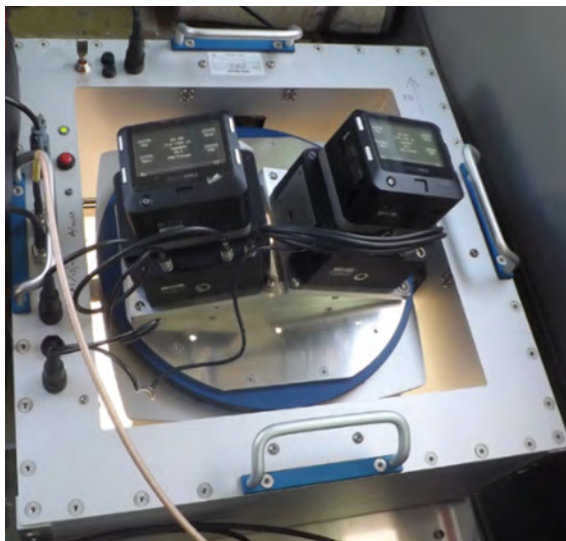
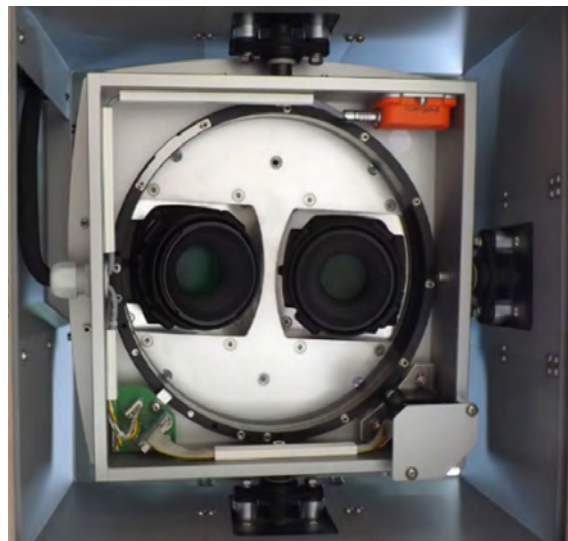
Figure 50. Survey platform for digital seabird surveys: Partenavia P68c. Detail views of the camera system.

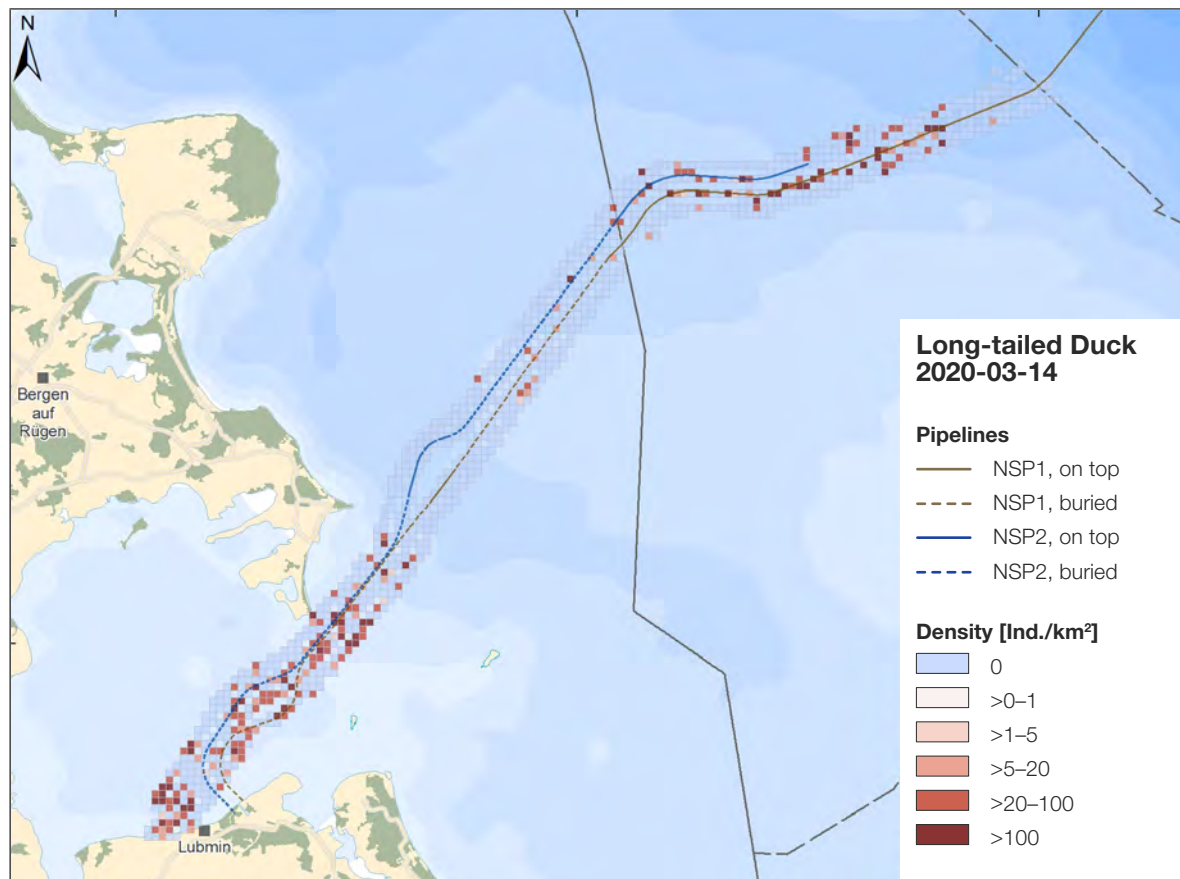
Figure 52. Distribution of long-tailed ducks (*Clangula hyemalis*) in the Pomeranian Bay in March 2020 along the NSP and NSP2 pipelines. Note the attraction of the NSP pipelines installed on the seabed in the EEZ. Digital imagery flights.

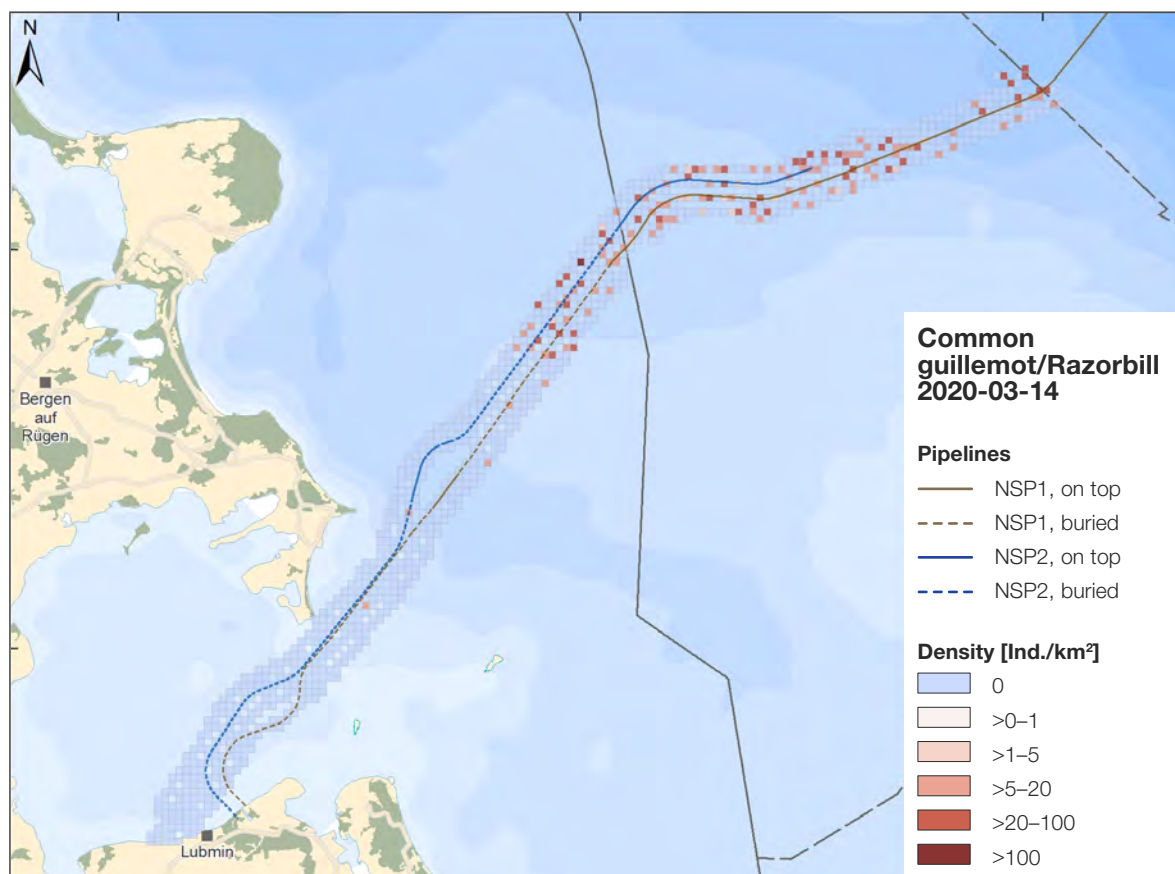
Figure 53. Distribution of auks (Razorbill *Alca torda* and Common guillemot *Uria aalge*) in the Pomeranian Bay in March 2020 along the NSP and NSP2 pipelines. Note the attraction of the NSP pipelines installed top of seabed in the EEZ. Digital imagery flights.
